Tohoku Chapter, Architectural Institute of Japan Reconnaissance Report (03) of Sendai City
The 2011 off the Pacific Coast of Tohoku Earthquake
Released on March 22, 2011

Professor Masato Motosaka, Tohoku University
(Translated by Shunsuke Otani, University of Tokyo)

March 12, Saturday, Preliminary Investigation

Preliminary Investigation on March 13, 2011

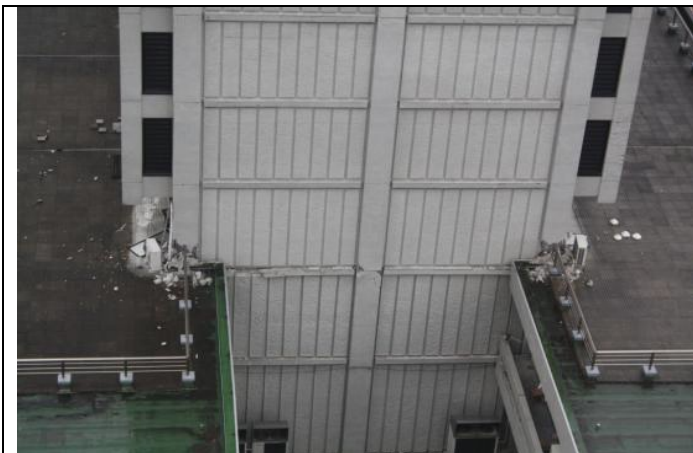
The damage of the east end walls is shown in Photos 1 and 2. The base of the third story columns in the east and west end walls suffered heavy damage due to high axial forces caused by the overturning moment. Non-full web steel element was exposed and buckled in a steel encased reinforced concrete column, and longitudinal reinforcement was either fractured or buckled (Photo 3). After the failure at column bases, the rocking vibration of the building must have occurred. Exposed longitudinal reinforcement at the base of damaged columns revealed new fracture by this earthquake and old fracture of rusted reinforcement by the previous earthquake.

Photo 1: Damage of end walls from roof of the adjacent building

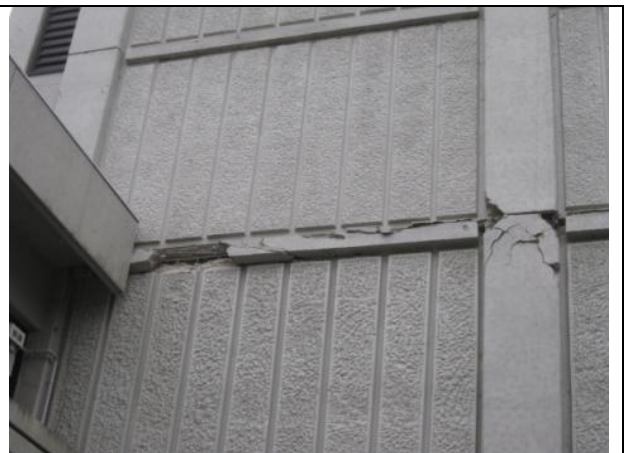
Photo 2: Damage of end walls from the ground

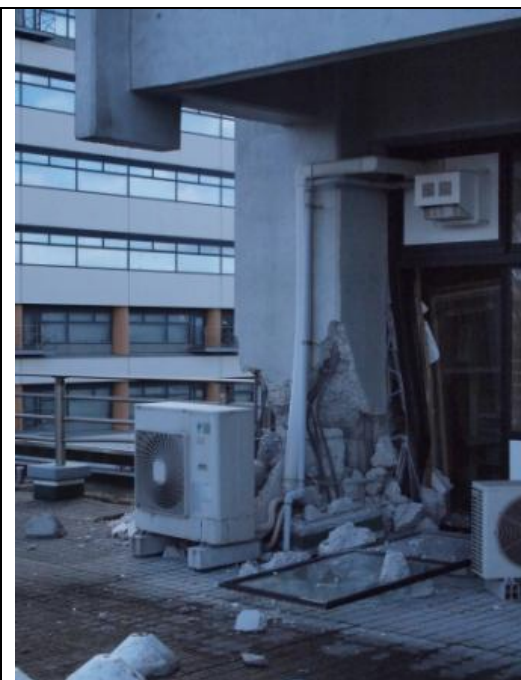
Photo 3: Damage of north-east corner column

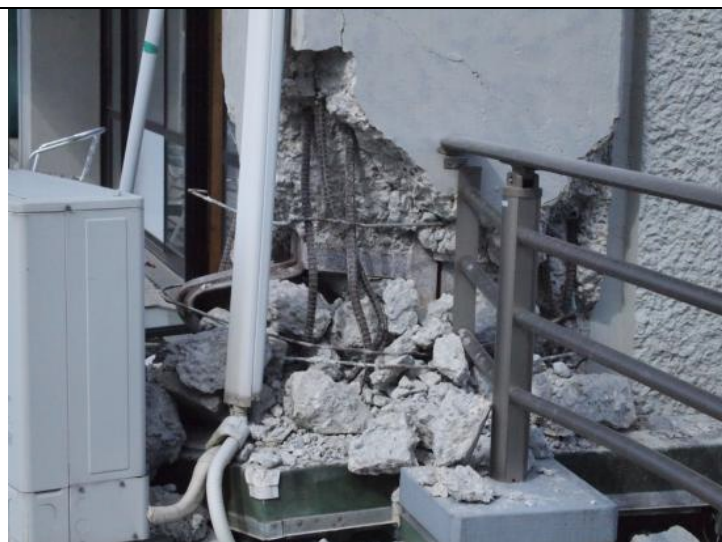
Photo 4: Damage of south-east corner column

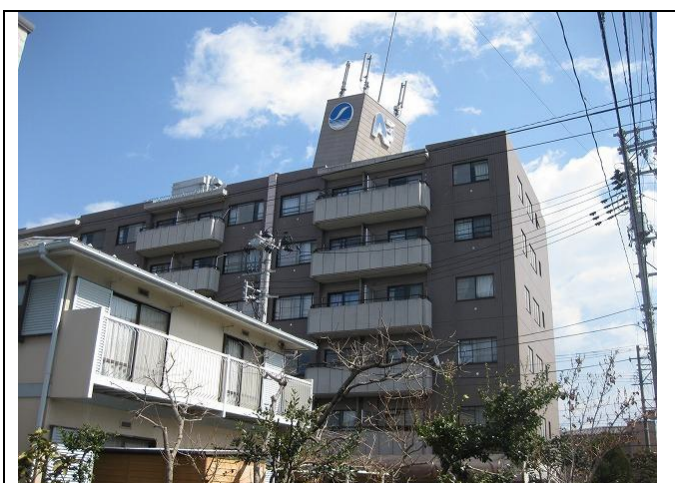
The information of building damage was obtained at the disaster headquarter of Wakabayashi Municipal Office. The penthouse of a six-story reinforced concrete building tilted in Narita-machi (Photo 5); the building did not show any other damage.

Photo 5: A tilted penthouse of a six-story reinforced concrete condominium building

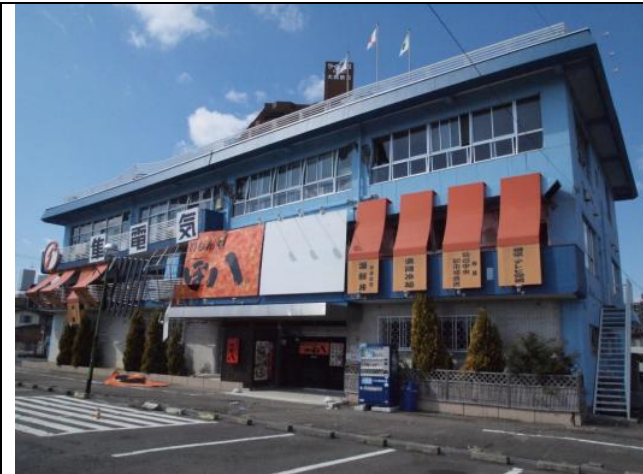
Three-story reinforced concrete building collapsed in the second story in Yamato-machi 5-chome (Photos

6 and 7), probably caused by torsional oscillation.

Photo 6: Collapse in the second story of a three-story reinforced concrete building in Yamato-machi 5-chome.

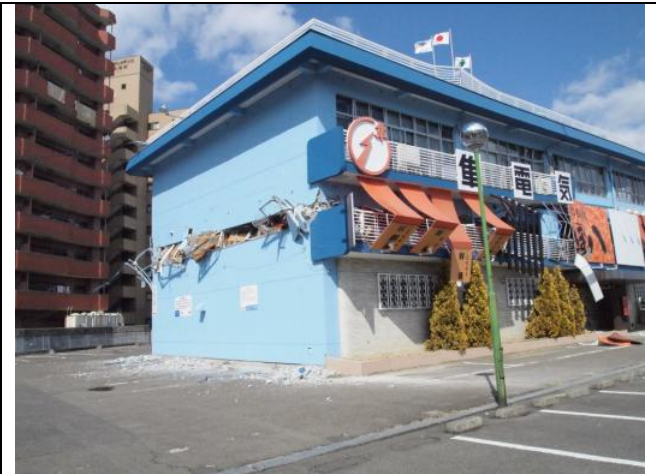
Photo 7: Collapse in the second story

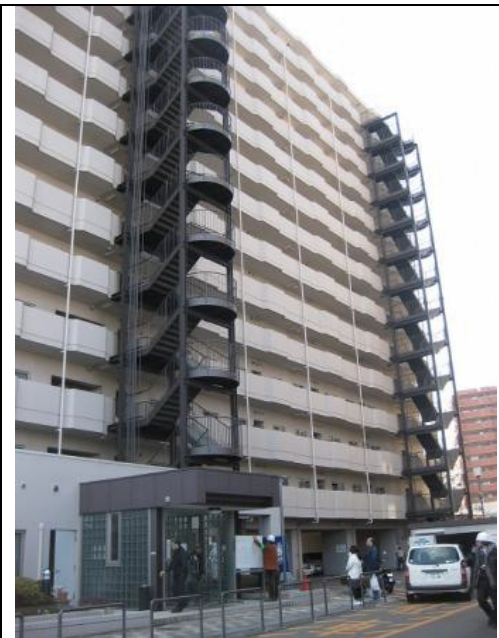
X-shaped shear cracks were observed in non-structural walls facing the hall way from second to nine stories in a fourteen-story reinforced concrete condominium building sold in 1981, Yamato-machi 5-chome (Photo 8); no such damage was observed in the first story (pilotti: soft first-story) and 13 and 14th stories. Doors are not located in the non-structural walls and could be opened.

Photo 8 (a) A 14-story reinforced concrete building

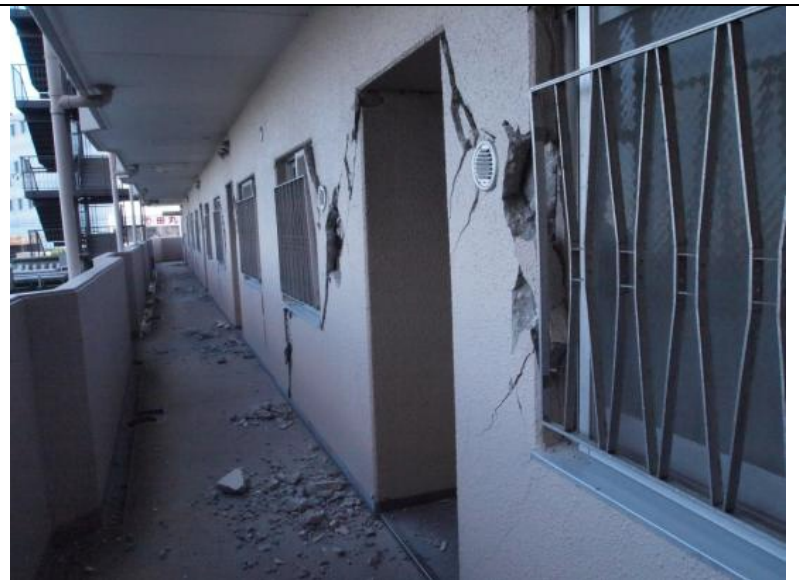
Photo 8 (b): Damage of non-structural walls in the hall way

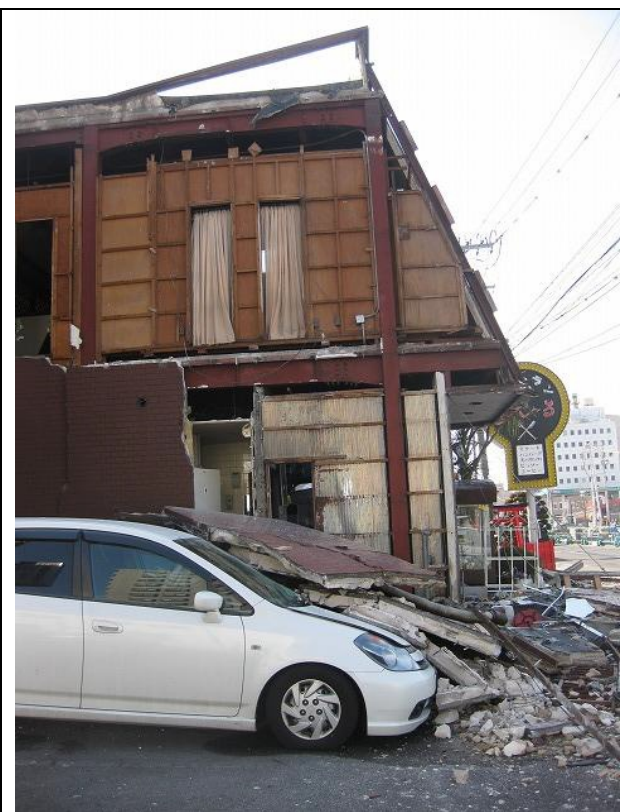
Along the Shinterakouji in Yamato-machi 5-chome, exterior wall finishing fell from a two-story steel construction (Photo 9) and roofing materials fell from a two-story steel building (Photo 10); poor detailing of connection between the finishing and structural members (Photo 11).

Photo 9: Exterior finishing fell from a two-story steel building

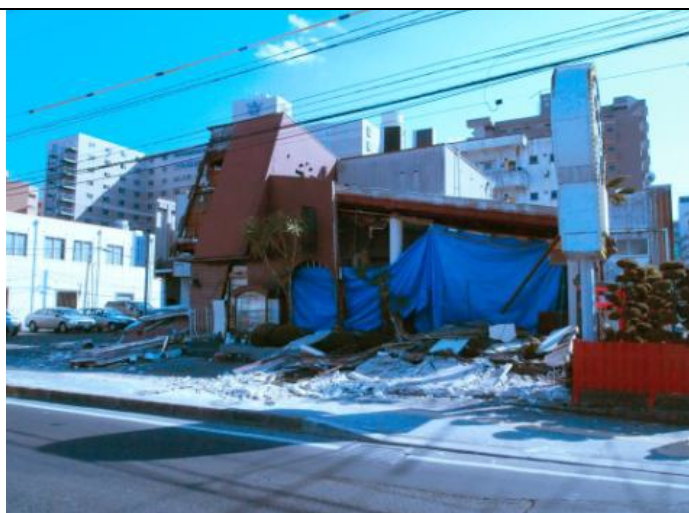
Photo 10: Fall of roofing materials from a two-story steel building

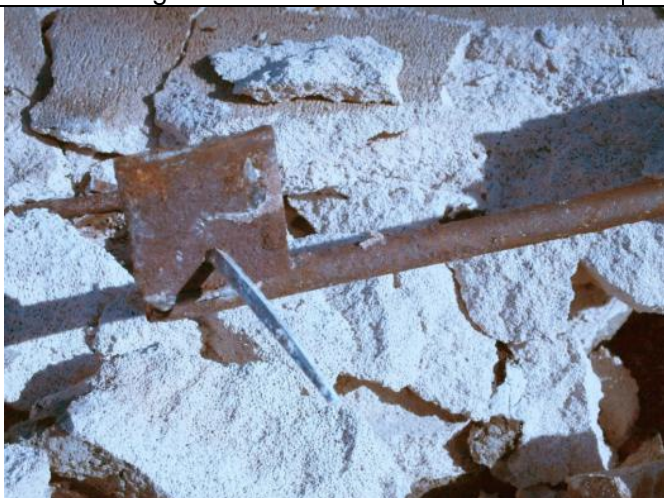
Photo 11: Detail of fastener (anchor) of fallen ALC exterior wall

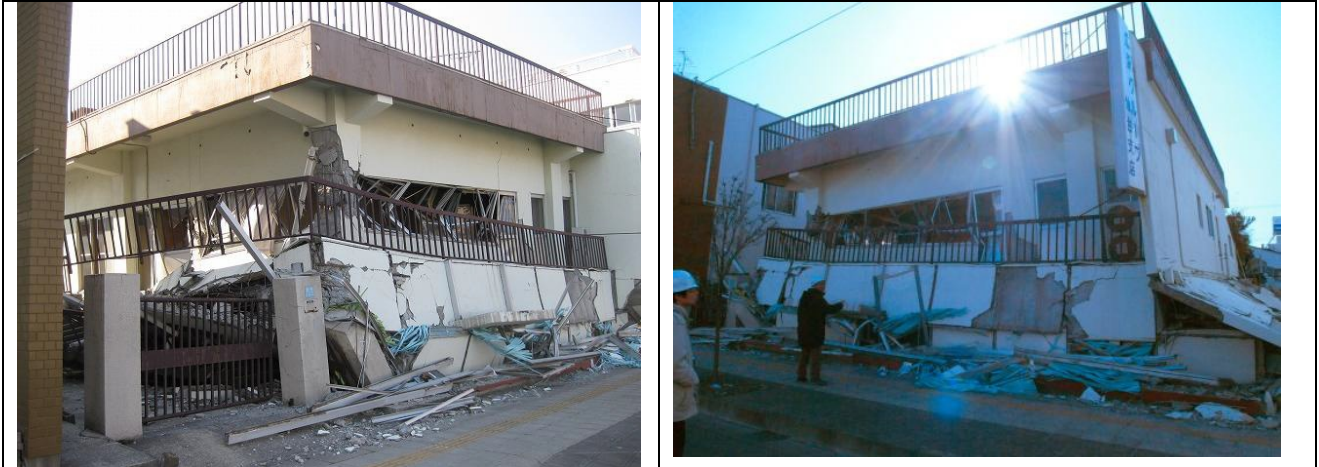
The first-story of a two-story reinforced concrete building collapsed in Oroshim-machi 2-chome (Photo

12); the first story is box wall construction, and the second-story is moment-resisting frame construction. The first story failed in the weak (out of plane) direction of the walls, and second-story columns failed in shear.

Photo 12: Collapse of a two-story reinforced concrete building in Oroshi-machi 2-chome, Wakabayashi-ku

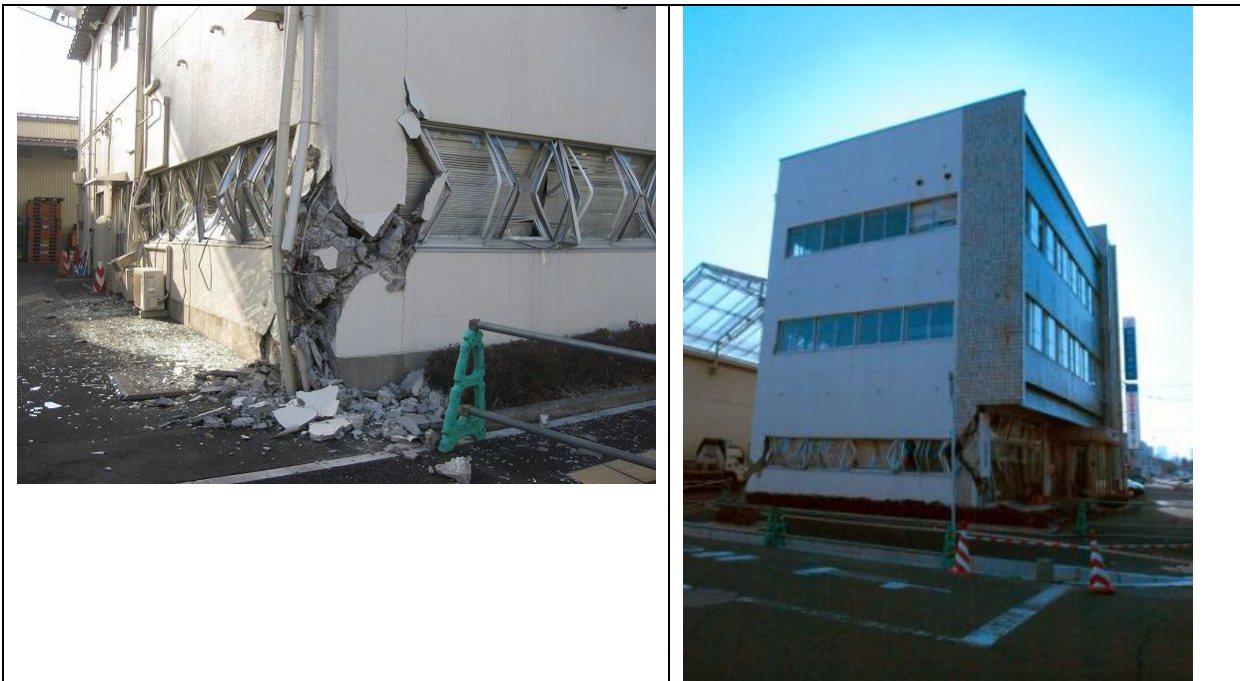
A part of the first story of a three-story reinforced concrete building collapsed in Oroshi-machi 3-chome (Photo 13); the diameter of plain longitudinal reinforcement was 19 mm, and tie reinforcement of diameter 9 mm at 250 mm on centers. The core of the building suffered slight damage, but the building was twisted by eccentricity and exterior columns failed in shear.

Photo 13: Collapse of a three-story reinforced concrete building in Oroshi-machi 3-chome, Wakabayashi-ku

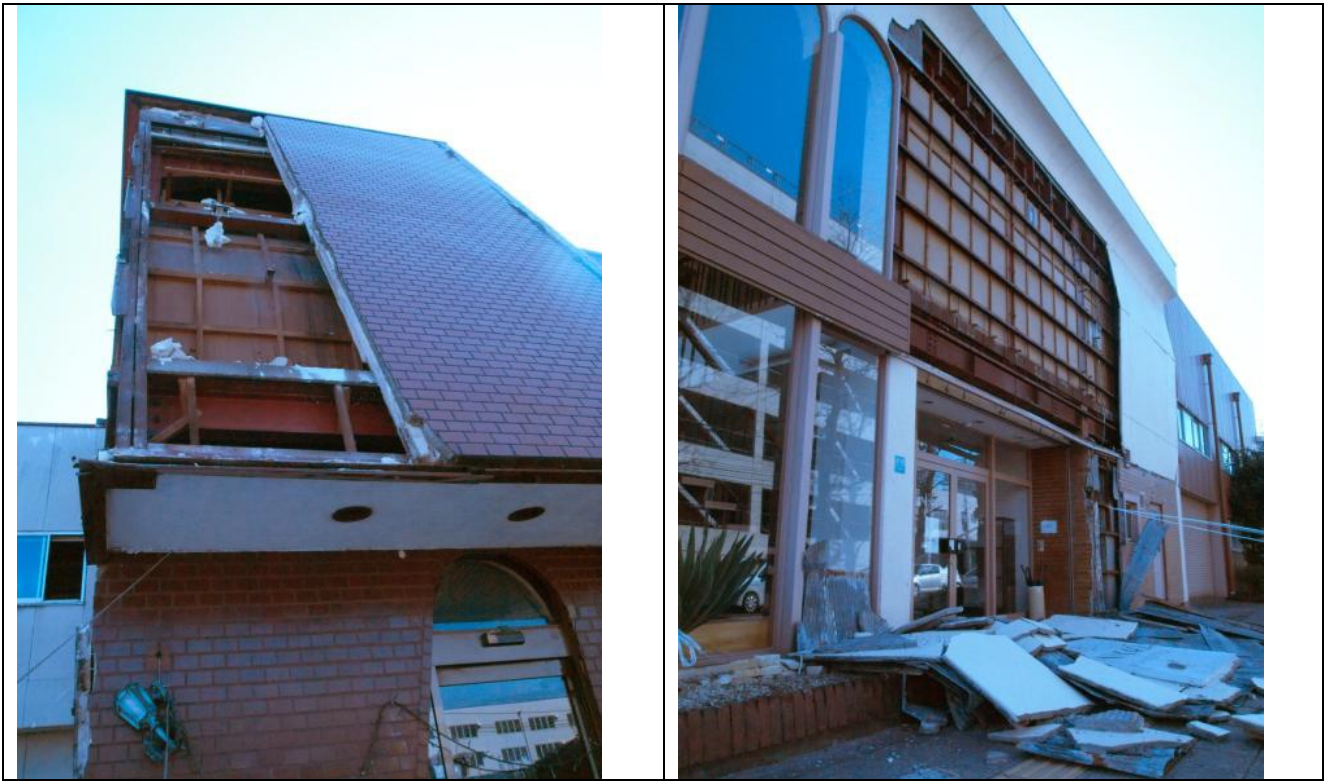
Many exterior curtain walls were observed to fall in Oroshi-machi (Photo 14). Concrete block fences were overturned in many locations (Photo 15).

Photo 14: Fall of exterior curtain walls in steel construction

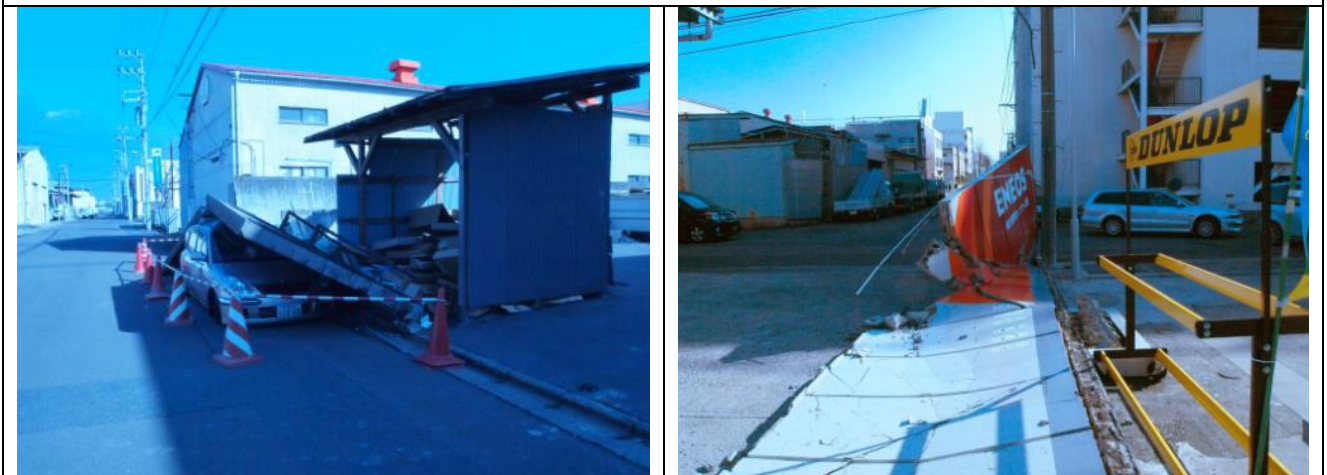
Photo 15: Overturned concrete block fences in Oroshi-machi, Wakabayashi-ku

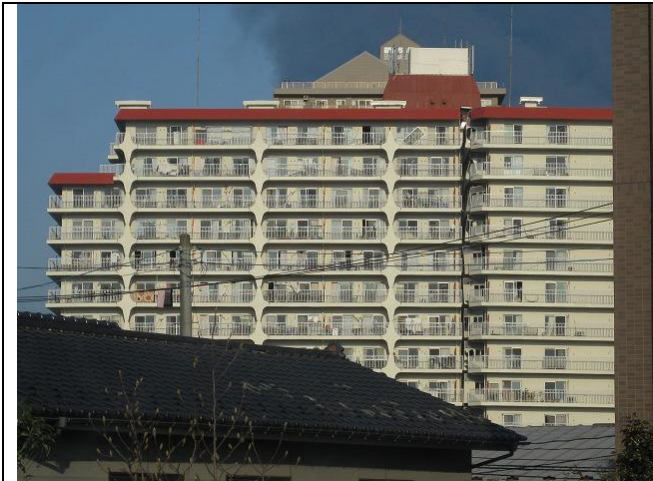
This high-rise condominium buildings suffered damage in pile foundation during the 1978 Miyagi-ken Oki Earthquake. There are two buildings. A building located normal to Route 45, suffered slight structural damage although non-structural partitions failed in shear; no tilting was observed in this building. A building facing to Route 45 showed tilting in the short direction (confirmed on March 12) although the

damage in the upper stories appeared light; non-structural exterior walls showed shear cracking in the longitudinal direction; the tilting rotation was observed in the short direction and the residual lateral displacement at the 14-th floor was estimated to be 400 mm by visual observation. The first floor indicating inclination; the pile might be damaged. The investigation team told the occupants that further detailed investigation might be necessary. The occupants by their own method monitored the separation of the expansion joints, and the tilting is reported to increase (March 15). The damage in piles is suspected.

Photo 16: Condominium buildings in Takasago, Miyagino-ku

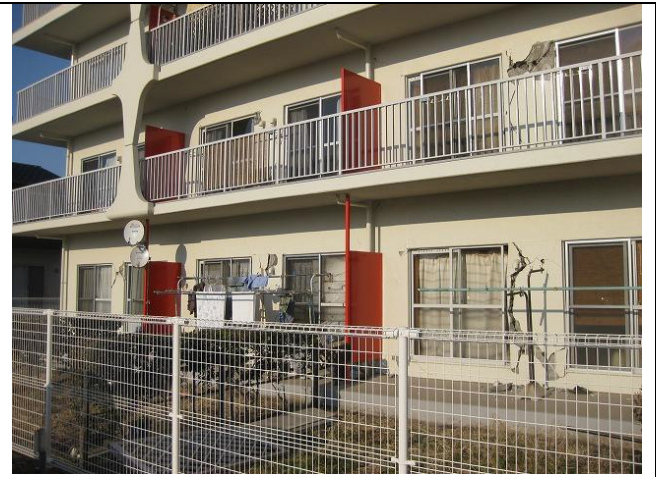
Photo 17: Shear failure of non-structural exterior walls

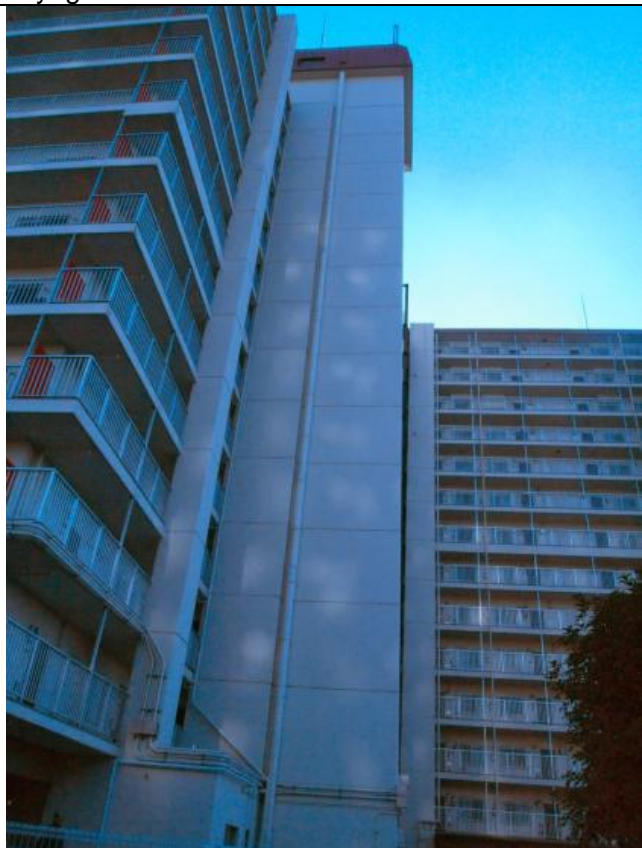
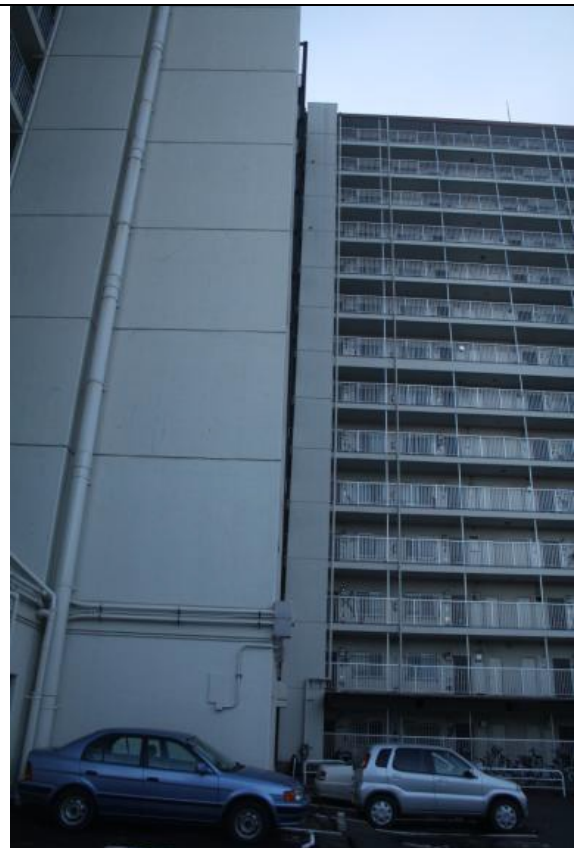
Photo 18: Expansion joint between two buildings (left on March 12, and right on March 16)

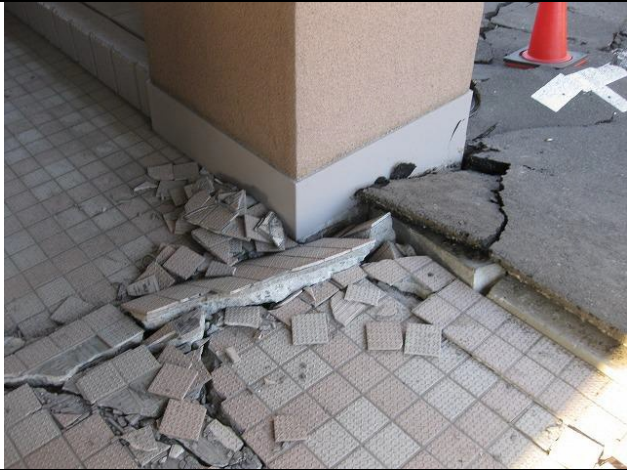
Photo 19: Damage at the base of a first-story column

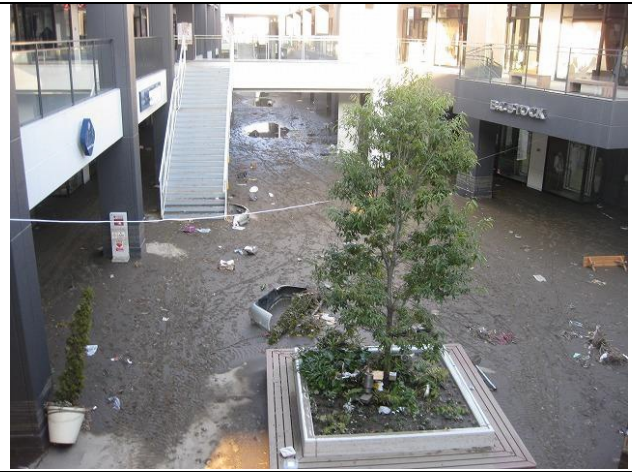
Photo 21: Damage of the Mitsui Outlet Mall building by the tsunami (Second floor deck)

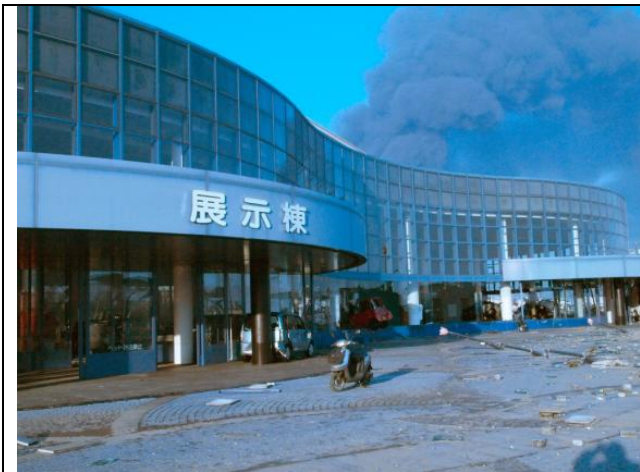
Some cars were floated and moved into the exhibition hall of Miyagi Yume Messe, and broke exterior glasses (Photos 22 and 23). No damage of the building was observed caused by the vibration of the earthquake.

Photo 22: Damage of Miyagi Yume Messe by tsunami

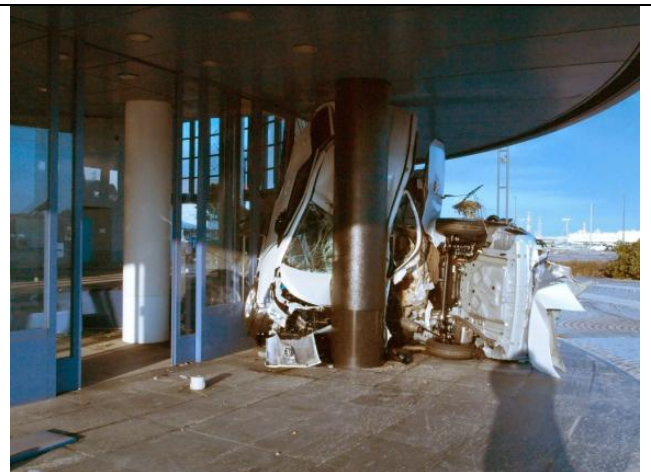
Photo 23: Cars were carried into the exhibition building by tsunami wave

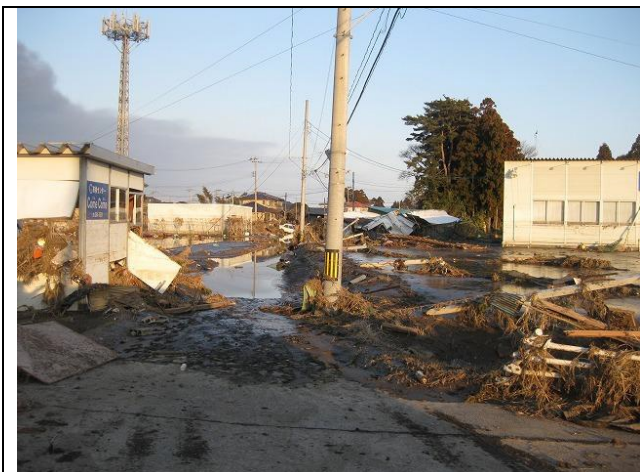
Photo 24: Damage of Gamoh residential area due to tsunamis

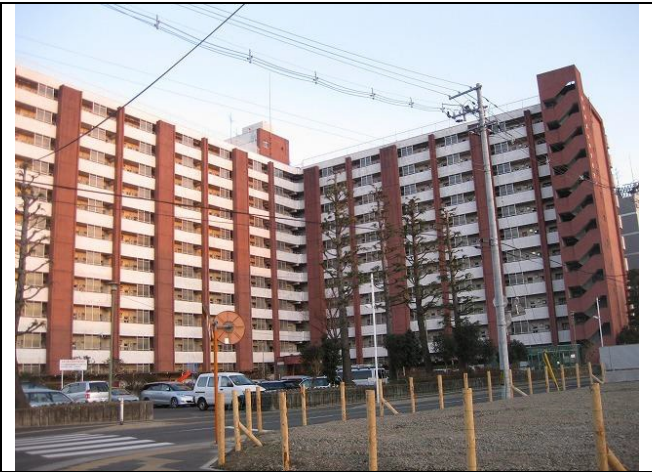
A 11-story reinforced concrete condominium building, which tilted attributable to the damage in piles after the 1978 Miyagi-ken Oki Earthquake, suffered no damage. The 11-story reinforced concrete building normal to the longitudinal building showed the trace of rocking motion, and cracking was observed in the ground along the base, no residual displacement was observed at the expansion joint; no inclination of the building was detected (Photo 25). The damage in piles appeared slight if any.

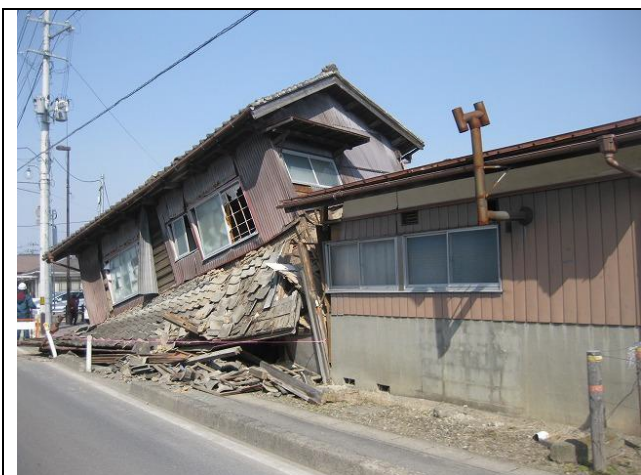
Photo 2: Collapse of a two-story timber house

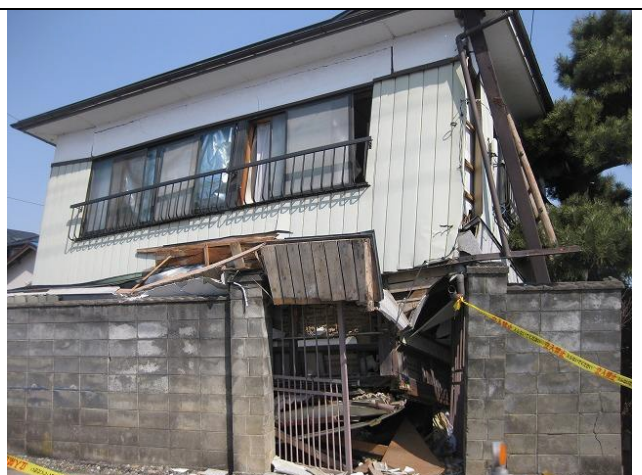
Photo 3: Collapse of a two-story timber house

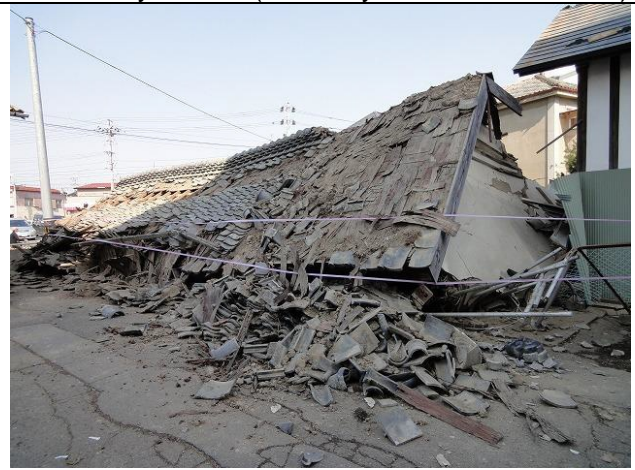
Fig. 7: Collapse of a Godown, adjacent to Ohsaki City Municipal Building

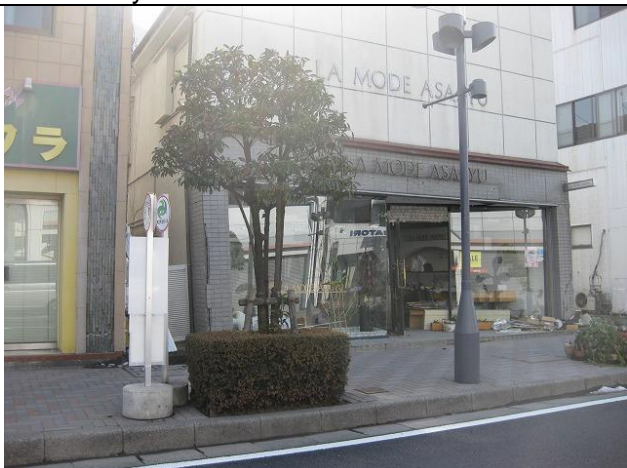
Photo 8: A tilted two-story house for combined use for shop and residence

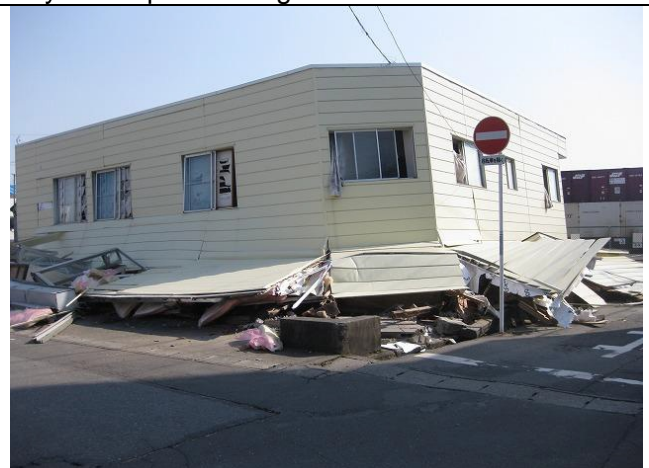
Photo 9: Collapse of a two-story house for combined use for shop and residence

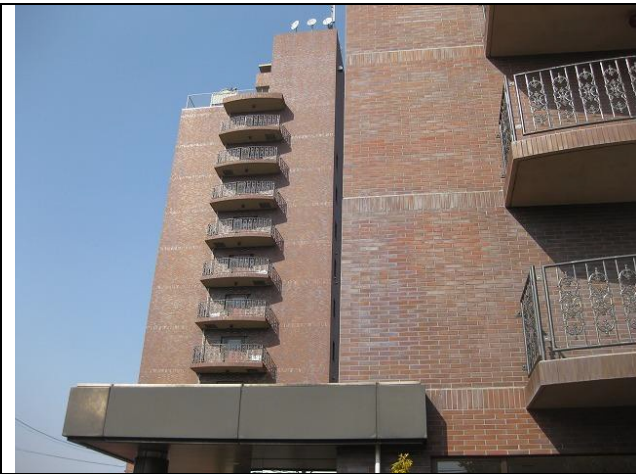
There is a 11-story reinforced concrete hotel in front of Furukawa Station. No structural damage in the

super structure is observed, but the tilting of the building is observed probably due to ground movement (Photos 10 and 11).

Photo 10: Tilting of a 11-story reinforced concrete hotel building

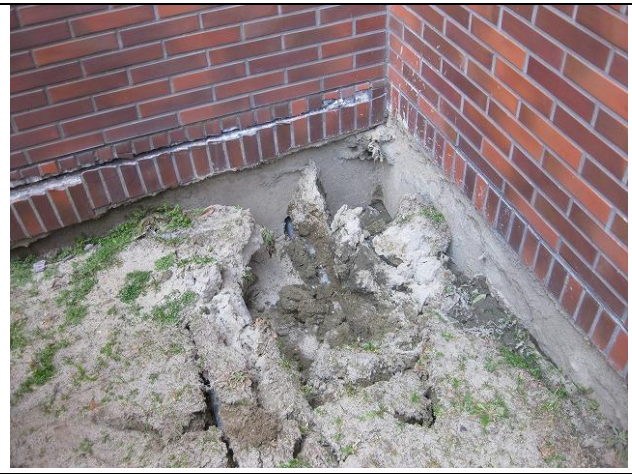
Photo 11: Boundary of foundation and ground at the base of the 11-story reinforced concrete hotel building

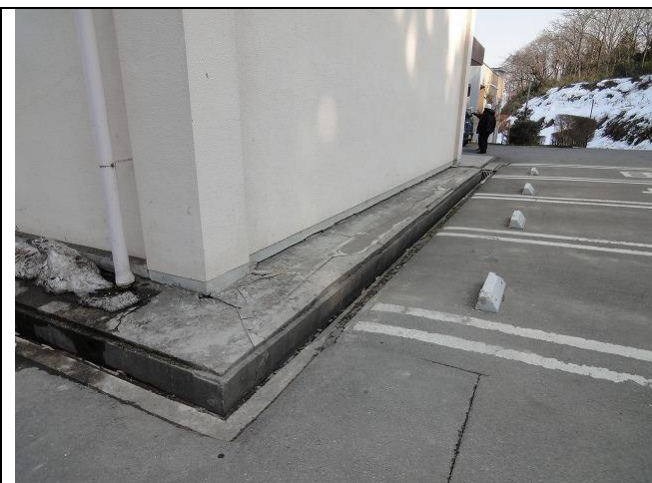
Damage of roof tiles was observed in a very limited number of houses, but not serious damage, In the Iwadeyama High School, ground fissure was observed along the scarcement of f the building (Photo 12), but no serious structural damage was detected.

Photo 12: Ground cracking along the periphery of

the building	
--------------	--

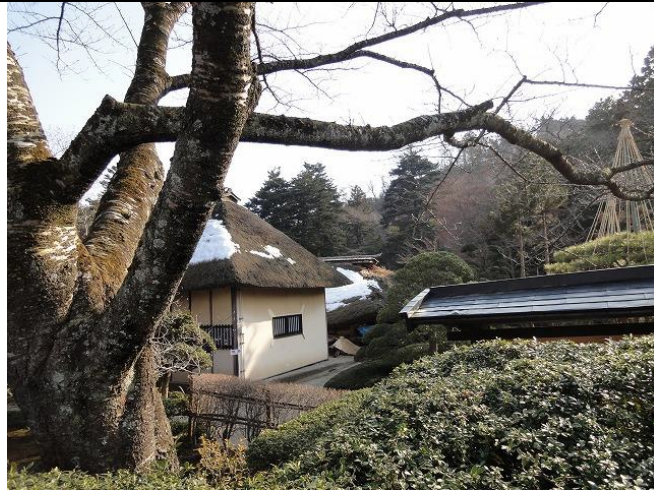
The Yuhbi-kan, a traditional farm house with thatch roof, collapsed completely in Iwade-district of Ohsaki City.

Photo 13: Collapse of the Yuhbi-kan in the back of the picture

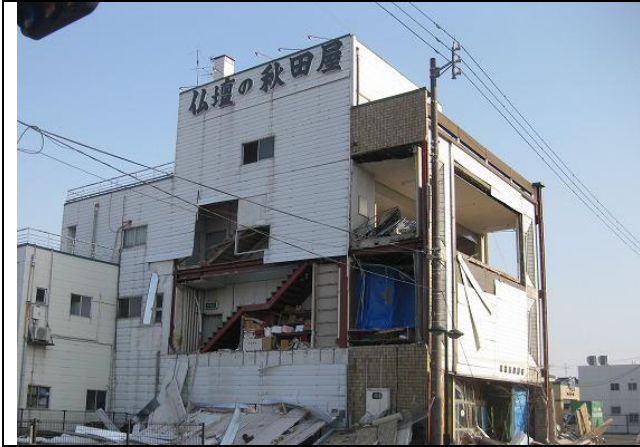
No structural damage was observed from Kaminome Elementary School to National Route 457. In the urban area of Kami-machi Nakaniida District, many external non-structural walls fell from a three-story steel commercial building.

Photo 15: Fall of external non-structural walls from a three-story steel commercial building
