Tohoku Chapter, Architectural Institute of Japan
Reconnaissance Report (10) of Tsunami Height in Arahama District, Sendai City
The 2011 off the Pacific Coast of Tohoku Earthquake
Released on March 29, 2011

Professor Reiji Tanaka, Tohoku Institute of Technology
President of AIJ Tohoku Chapter
Mr. Ryota Yamaya, Guest Researcher
Tohoku Institute of Technology
(Translated by Shunsuke Otani, University of Tokyo)

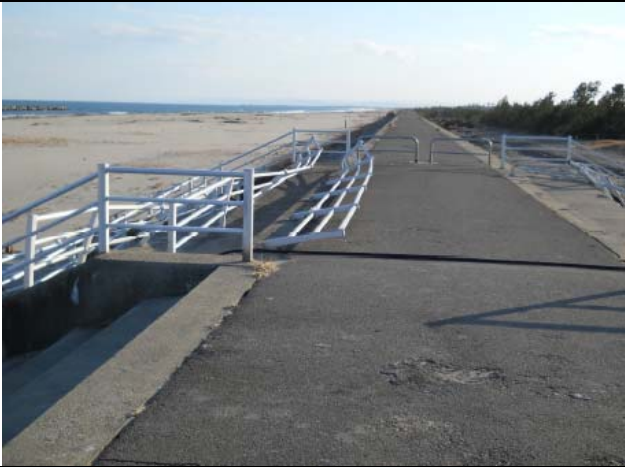
Photo 1: Hand rails on the embankment suffered no damage in the direction parallel to the tsunami wave and heavy damage normal to the wave.

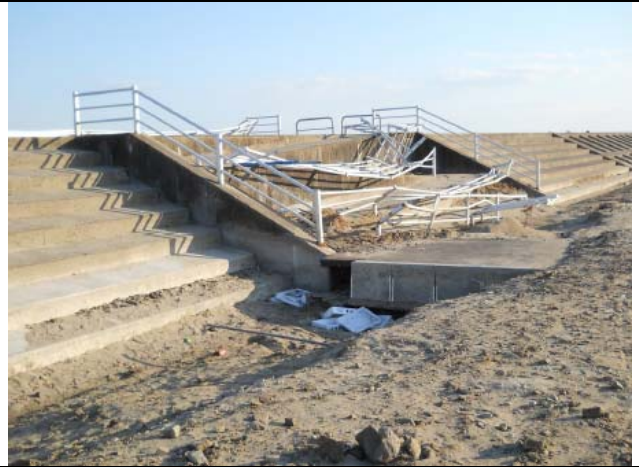
Photo 2: Tsunami wave flew normal to the coast line.

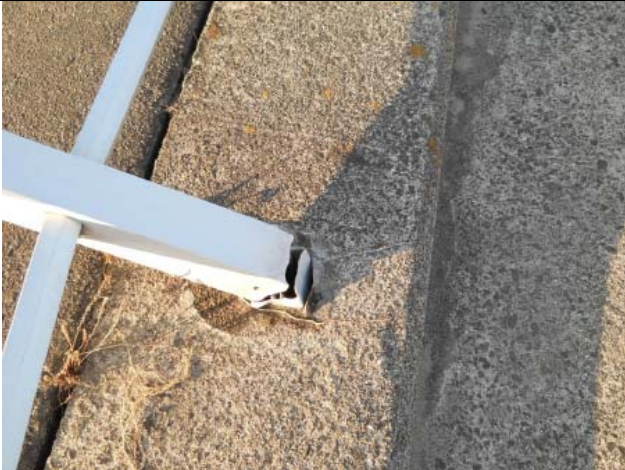
Photo 3: The fracture at the base of a hand rail.

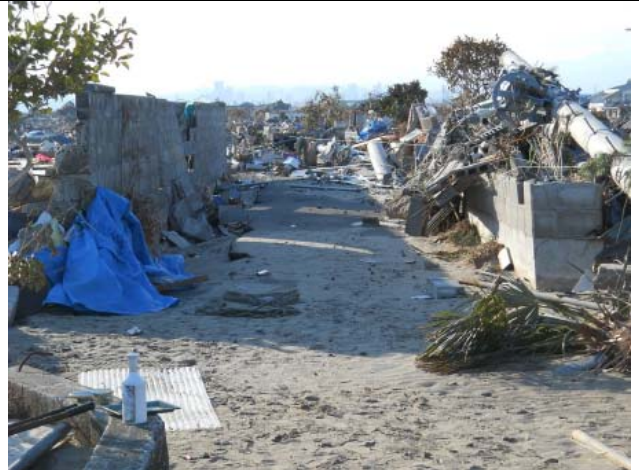
Photo 4: All electric poles fell in the same direction, normal to the coast line. Concrete block masonry wall normal to the tsunami flow did not fail.

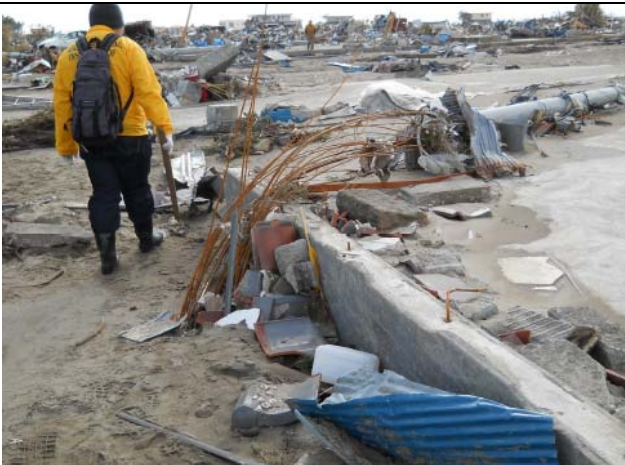
Photo 5: All electric poles fell in the same direction, normal to the coast line.

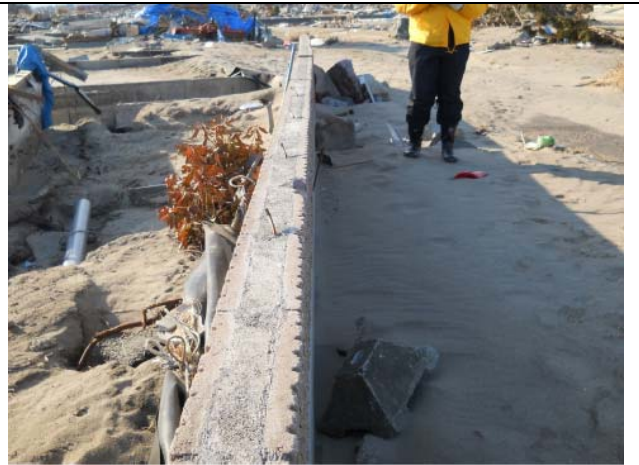
Photo 6: All anchor bolts on the surface of foundation were bent in the direction normal to the coast line.

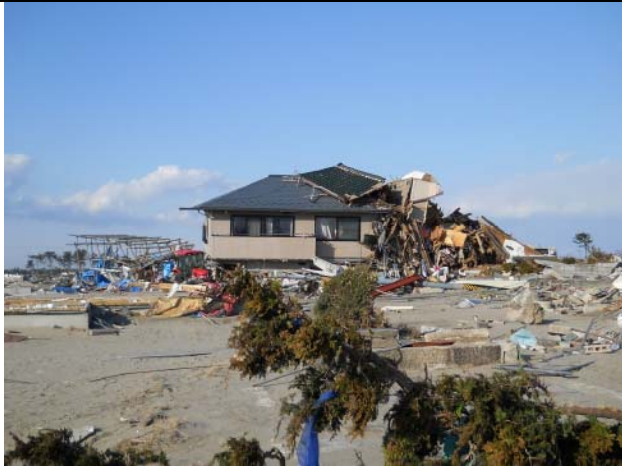
Photo 7: All outflow items remain on the face normal to the coast line.

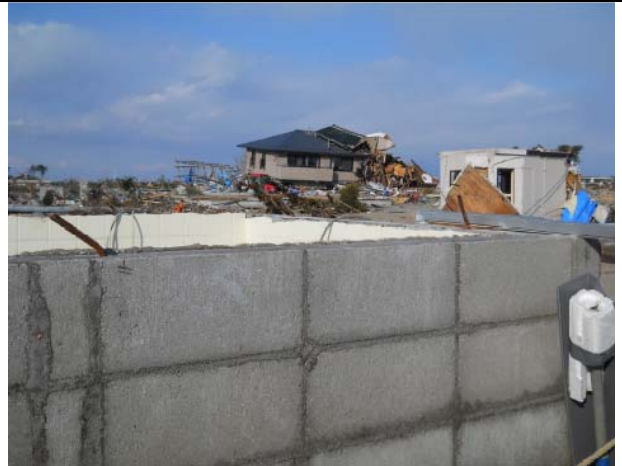
Photo 8: The bent direction of anchor bolts and face direction on outflow materials coincided.

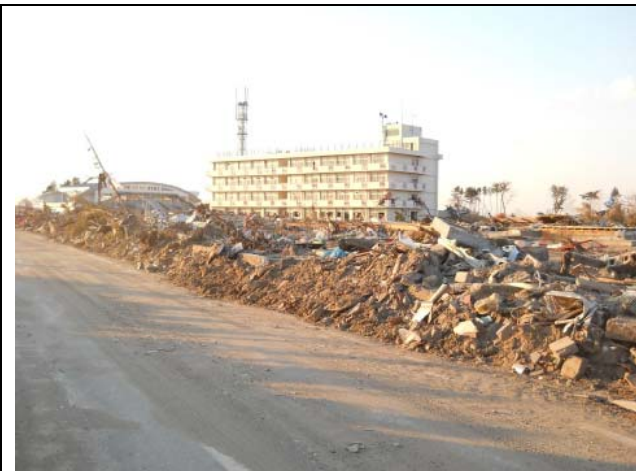
The tsunami wave height reached as high as 4 m at the Sendai Municipal Arahama Elementary School (Photo 9). The tsunami wave height was estimated to be 4 m from the water traces on steel houses (Photos 10 and 11).

Photo 9: Tsunami wave height was estimated to be 4 m at Arahama Elementary School.

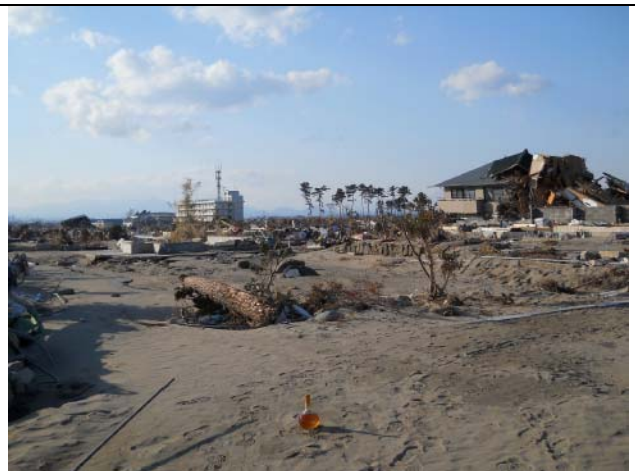
Photo 10: Tsunami wave reached the second floor of a steel skeleton house.

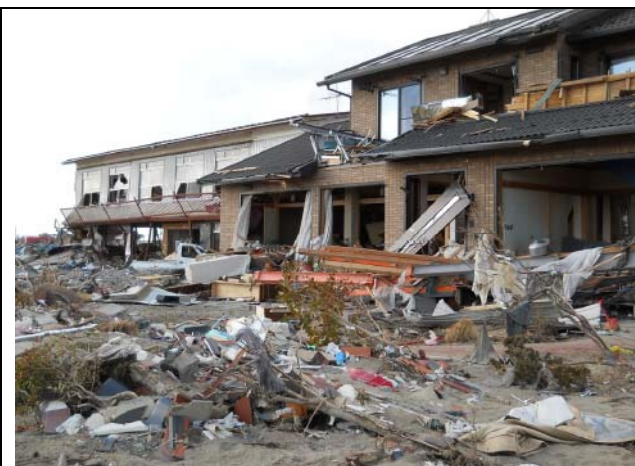
Photo 11: Tsunami wave reached the second floor of a steel skeleton house.

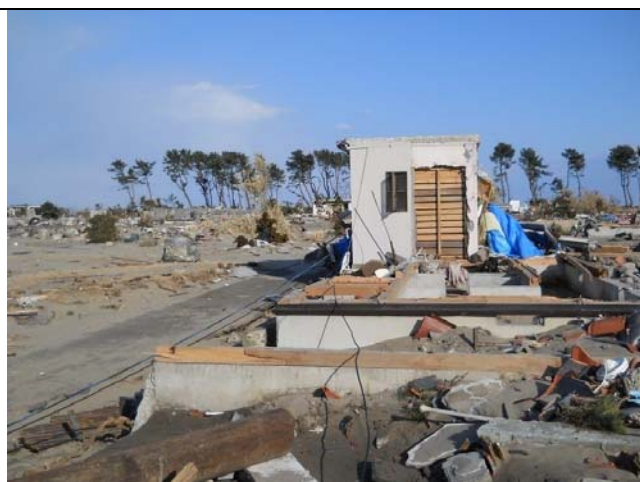
Photo 13: West side of Building A, approximately 900 m from the coast.

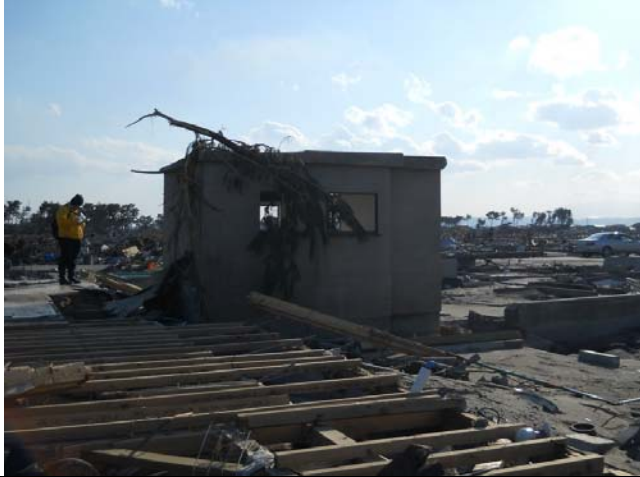
Photo 14: North side of Building B; approximately 900 m from the coast

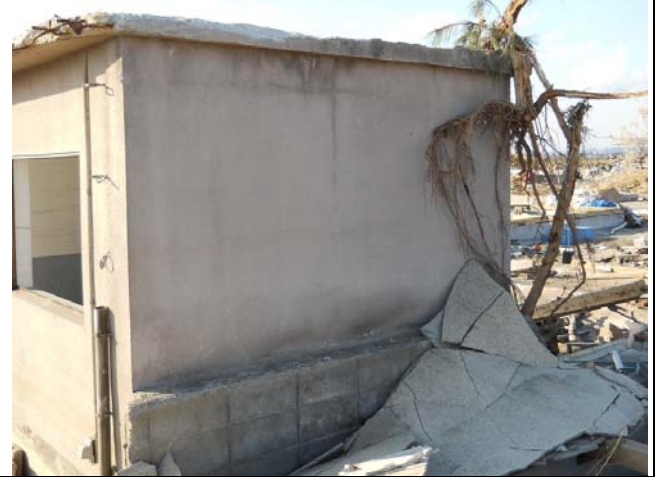
Photo 15: East side of Building B, no opening facing the tsunami flow.

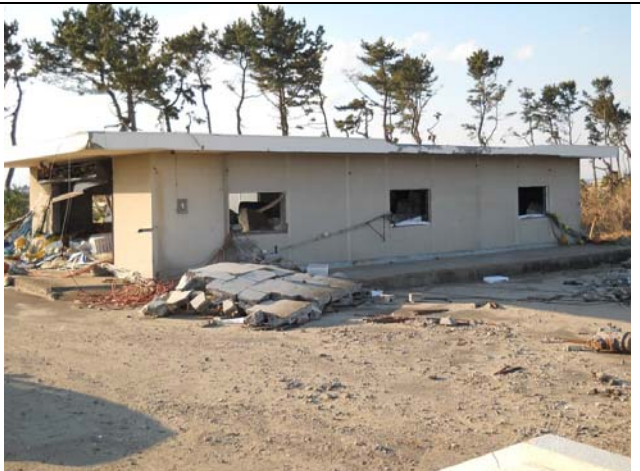
Photo 16: East side of Building C, facing to the tsunami flow.

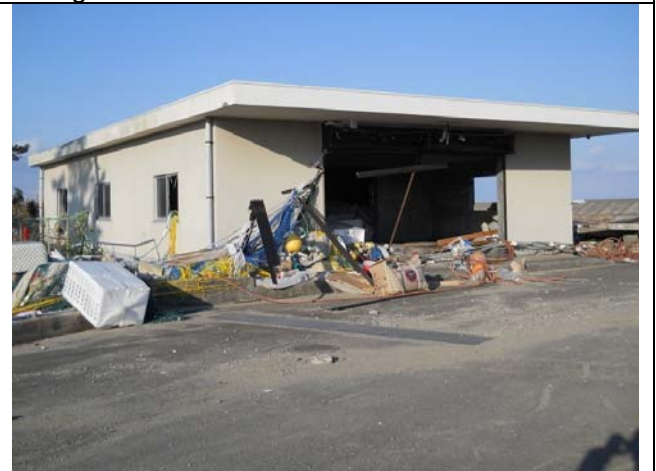
Photo 17: South side of Building C, approximately 400 m from the coast.
