Tohoku Chapter, Architectural Institute of Japan
Reconnaissance Report (11) on Building Damage in Kurihara City
The 2011 off the Pacific Coast of Tohoku Earthquake
Released on March 28, 2011

Professor Masato Motosaka, Graduate School of Engineering,
Tohoku University
(Translated by Shunsuke Otani, University of Tokyo)

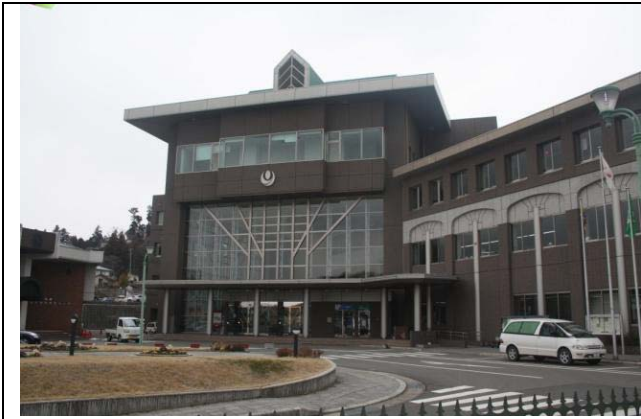
(a) Overall view of the Kurihara City Municipal Office Building

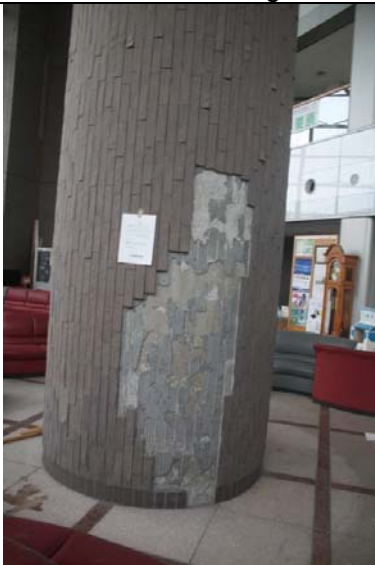
In the Kurihara City Municipal Office Building (4-story reinforced concrete building), the ceiling of City Municipal Assembly Hall fell in the fourth floor and finishing tiles on a reinforced concrete column fell; no structural damage was observed (Photo 1).

(c) Fall of finishing tiles on a column

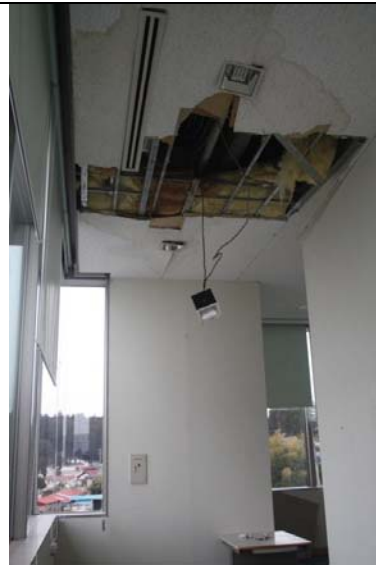
(d) Fall of ceiling of Municipal Assembly Hall (2)

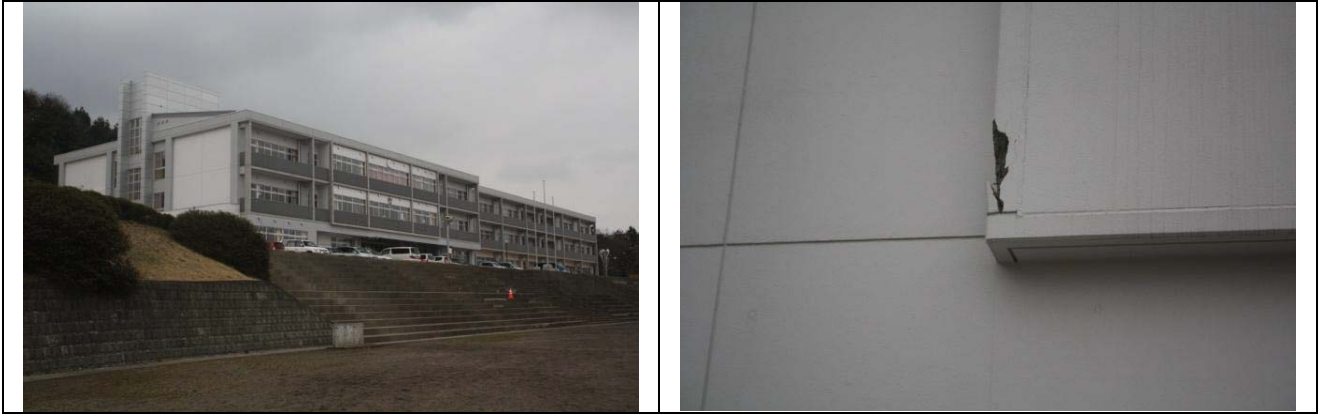
Two buildings near the K-NET Tsukidate station were selected for the damage investigation; Kurihara City Municipal Tsukidate Junior High School (new construction, Photo 2) and Kurihara City Municipal Tsukidate Gymnasium Center Building (Photo 3), the latter suffered non-structural damage during the 2008 Iwate-Miyagi Inland Earthquake. No damage was observed in both buildings.

Photo 2: Tsukidate Junior High School Building with minor non-structural damage

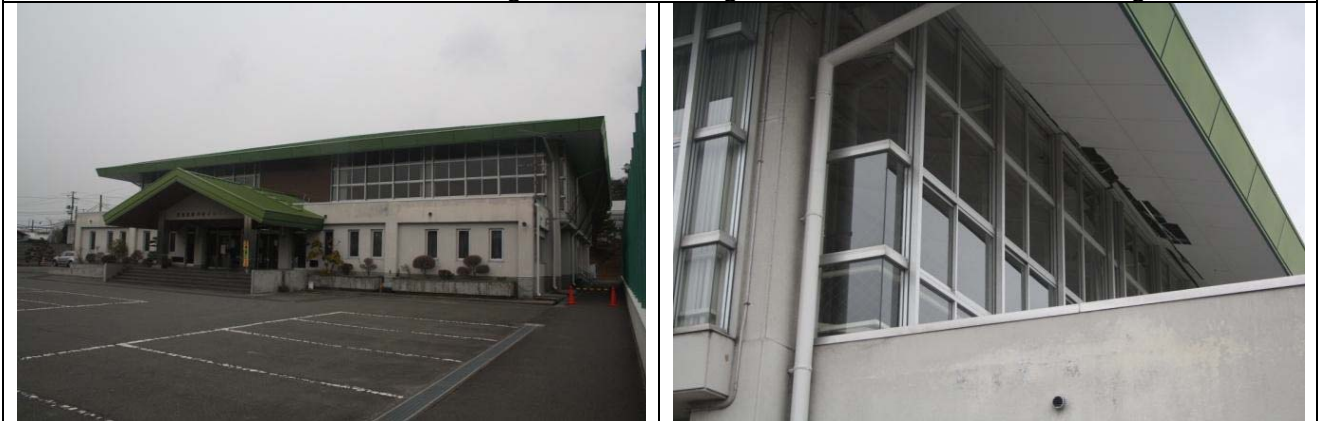
Photo 3: Tsukidate Gymnasium Center Building with minor non-structural damage

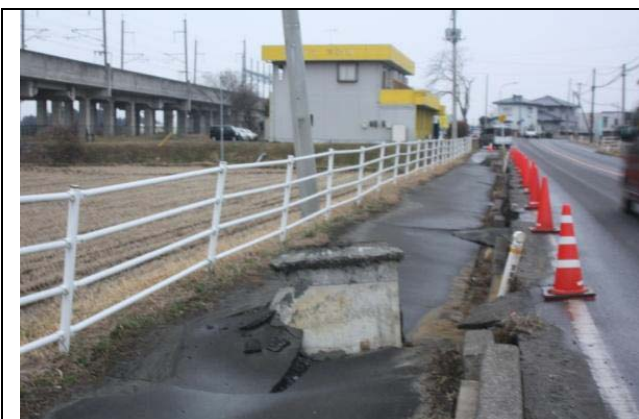
Soil liquefaction phenomena were observed on the road to National Route 398 in Shiwahime District; i.e., a man hole was lifted (Photo 4). Fall of masonry walls along the plot periphery was seen in several locations (Photo 5). Concrete block walls did not fall, but heavy masonry walls fell down (Photo 6). When the investigator asked an old man at a parking lot near Shiwahime Municipal Branch how he compared the intensities of ground motion of the 2011 Tohoku earthquake and the 1978 Miyagi-ken Oki Earthquake, he said “the ground motion intensity of this earthquake was larger and the duration was longer. Compared with the 2008 Iwate-Miyagi Inland Earthquake, the ground motion intensity of this earthquake was larger.”

Photo 4: Lifting of a man hole due to soil liquefaction near Shiwahime

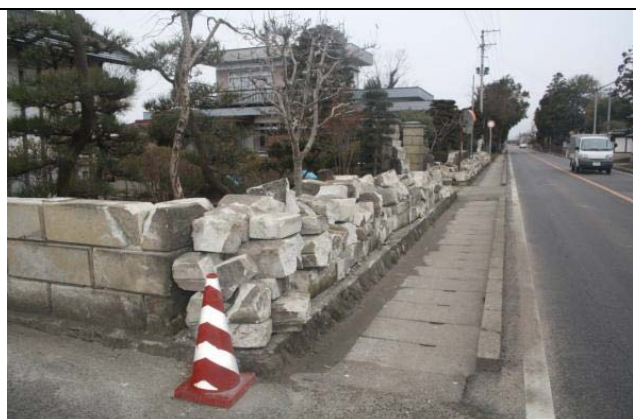
Photo 5: Fall of masonry walls

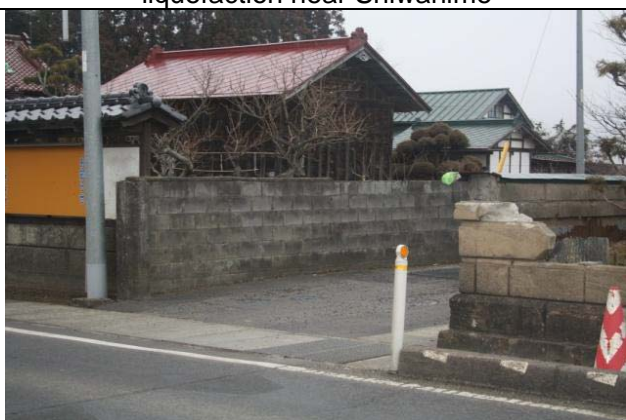
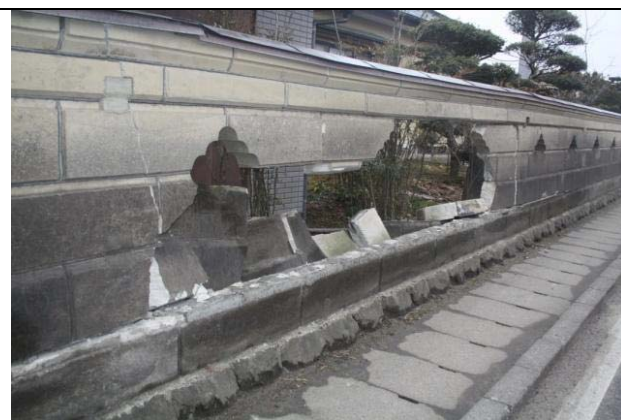
Photo 6: Undamaged concrete block walls and damaged masonry walls

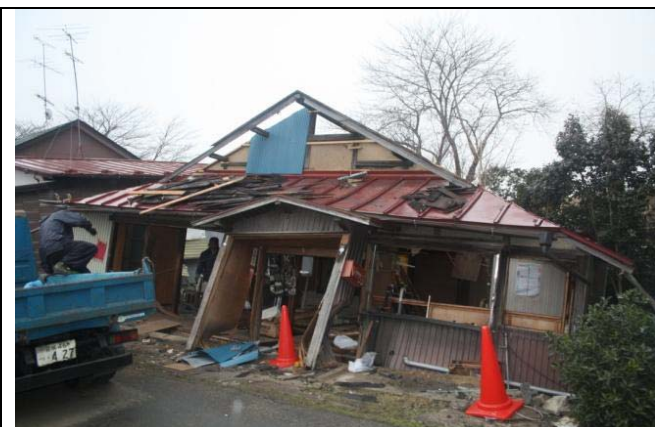
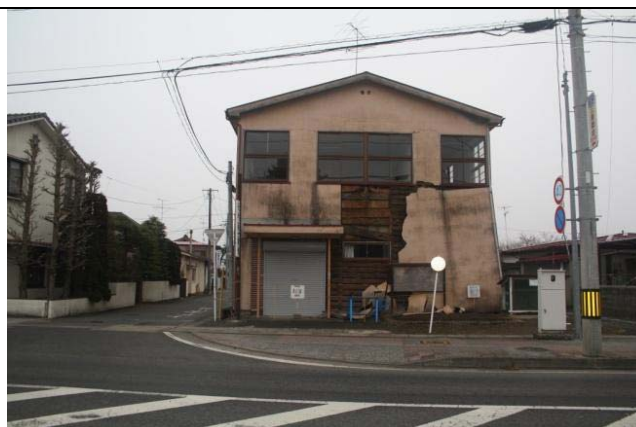
Along the Hazama River in Wakayanagi-machi, the damage of old timber houses was observed (Photo 7)

Photo 7: Damage of houses in urban area of Wakayanagi-machi

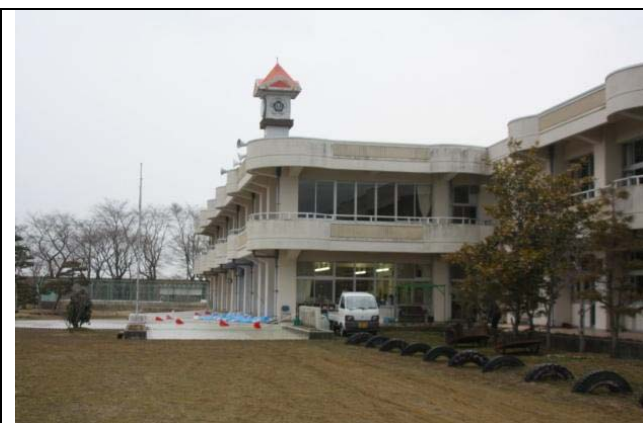
No damage was observed in the two story reinforced concrete Kurihara City Municipal Wakayanagi Elementary School Building, supported by pile foundation. Due to the soil settlement, 20 cm deep opening was observed (Photos 9 and 10). A statute fell down (Photo 11). The school master said “the large motion was felt in the east-west direction. The length of piles was told to be 30 m.” The gateposts of the Kanro-ji temple fell to the west near the school (Photo 12), and a large masonry lantern fell in a similar manner. The dominant frequency of the (H/V) ratio of horizontal to vertical spectra of micro tremor measurements at the Wakayanagi Elementary School after the 2008 Iwate-Miyagi Inland Earthquake was observed to be 0.8 Hz. In the neighborhood of the school, utility poles were tilted (Photo 13), cracking on the road, severe tilting of a timber house (Photo 14) in the second story were observed,

Photo 9: Overall view of Kurihara City Municipal Wakayanagi Elementary School

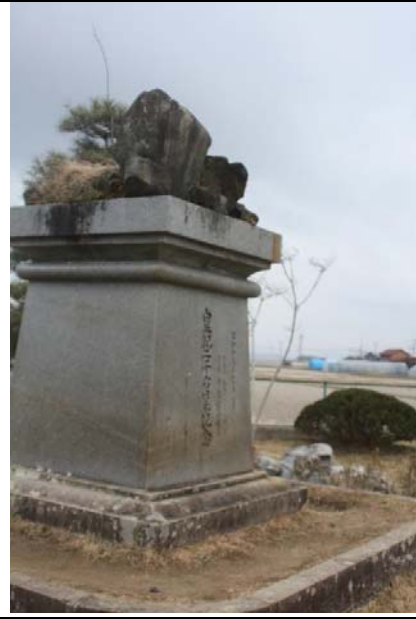
Photo 11: Fall of a statue
