Tohoku Chapter, Architectural Institute of Japan
Reconnaissance Report (12) on Tsunami
The 2011 off the Pacific Coast of Tohoku Earthquake
Released on April 3, 2011

Disaster Committee, Tohoku Chapter
Dr. Reiji Tanaka, Professor
Mr. Ryota Yamaya, Guest Researcher,
Tohoku Institute of Technology
(Translated by Shunsuke Otani, University of Tokyo)

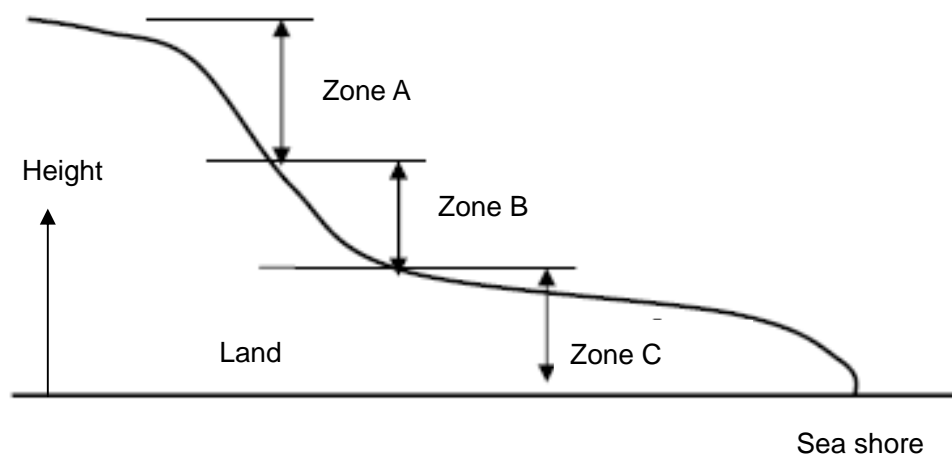
Fig. 1 : Tsunami Damage Zones

In Motoyoshi-machi and Ohya Coast, those houses on the hill did not suffer damage, whereas many houses suffered heavy damage in the tsunami attack zone. The areas of different degrees of damage may be classified into three zones depending on the height of the construction sites (Fig. 1).

Zone A: Houses on the hill, no damage from tsunami nor by ground shaking;

Zone B: Houses where tsunami wave reached as high as 1 to 3 m, but some did and others did not suffer damage from tsunami wave; and

Zone C: Houses could not resist tsunami wave attacks and were completely destroyed and washed away.

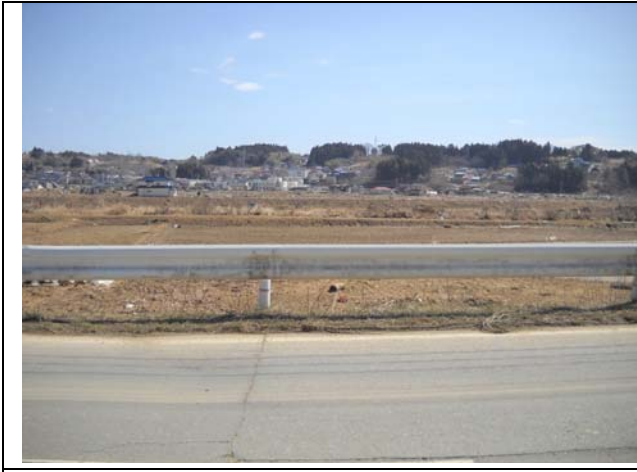
The zoning worked well in the Ohtani Coast as shown in Photo 1. Similar damage distribution was observed in Kesen-numa City.

Photo 1: Houses on the hill suffered no damage.

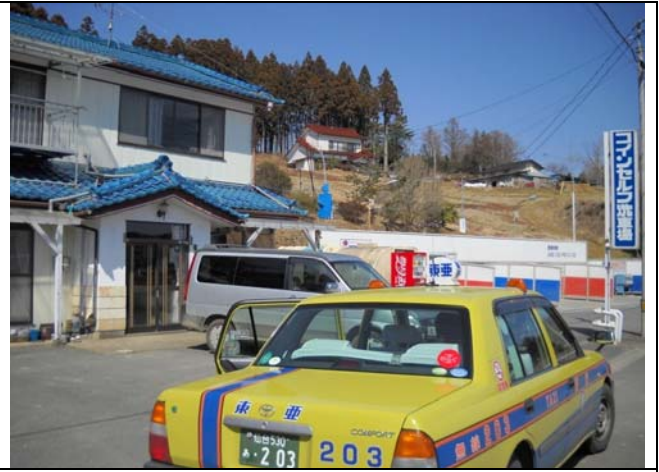
A houses on the hill side (Photo 2) at the edge of Motoyoshi-machi toward the Ohtani Coast, suffered no damage. In the area lower than this hill side, tsunami water inundated above the floor (Photo 3); the inside of tsunami inundated houses was filled with flown out garbage (Photos 4 and 5).

Photo 2: Houses on the hill suffered no damage (2).

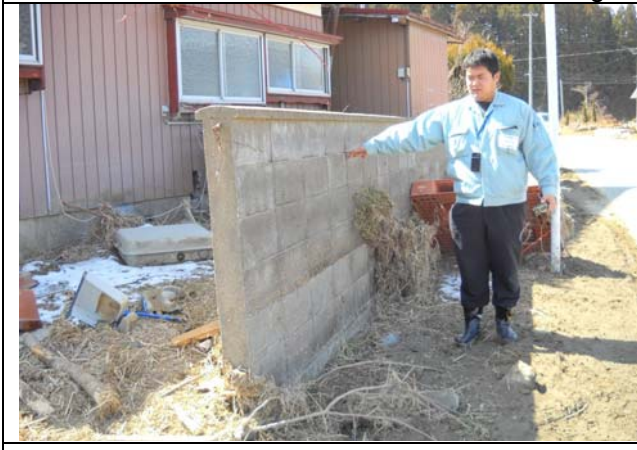
Photo 3: The level of tsunami wave above the floor.

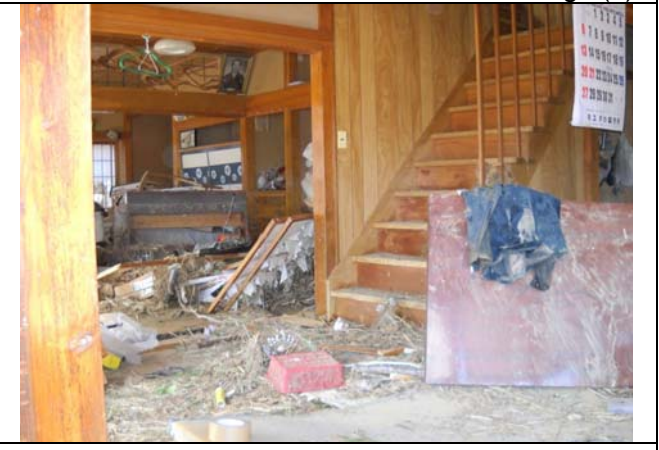
Photo 4: Inside of a house inundated by water.

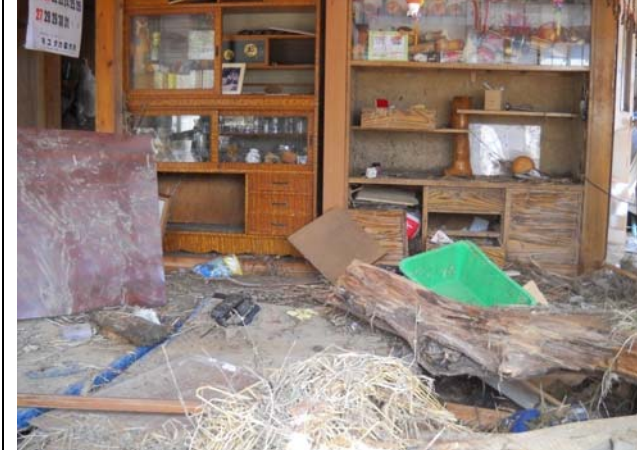
Photo 5: The inside of a house filled with garbage

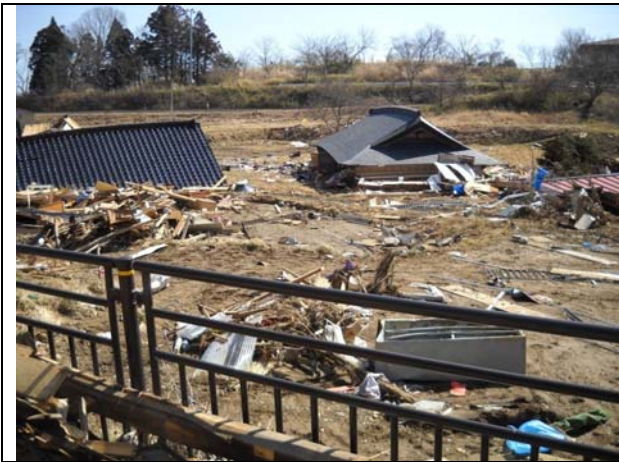
In the area of lower height, the flown out garbage fill the ground. Broken and wrecked houses were also flown out (Photos 6 and 7). Houses on the hill were not touched on the Ohtani Coast.

Photo 6: Houses were flown out.

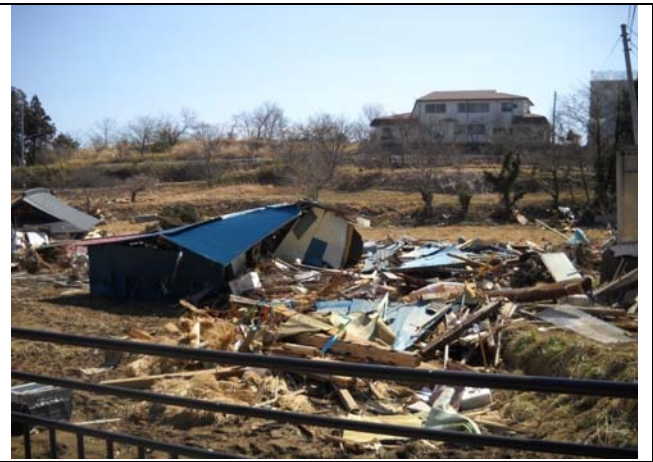
Photo 7: Broken houses in the low land and an untouched house on the hill.

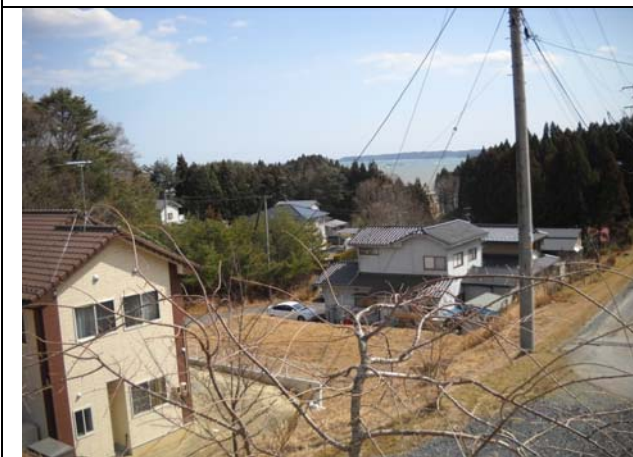
Photo 8: Untouched houses on the hill at the Ohtani Coast (1).

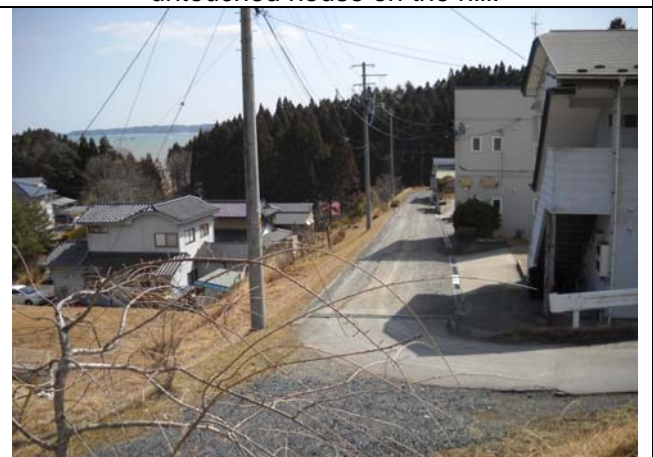
Photo 9: Untouched houses on the hill at the Ohtani Coast (2)

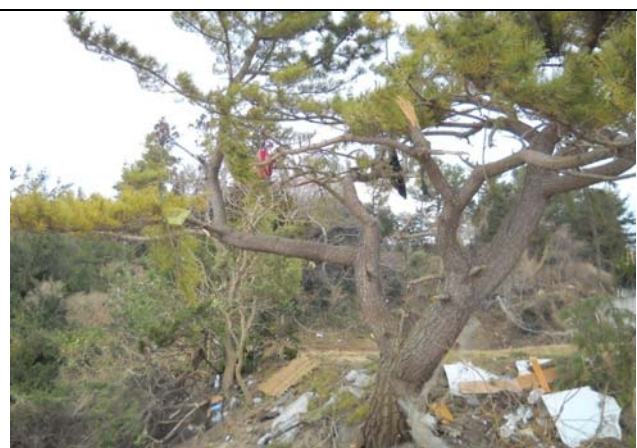
Photo 11: Flown out objects in the forest.

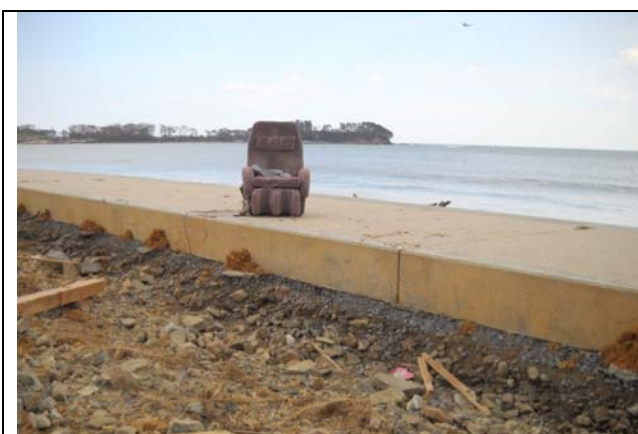
Photo 12: A chair on the breakwater bank.

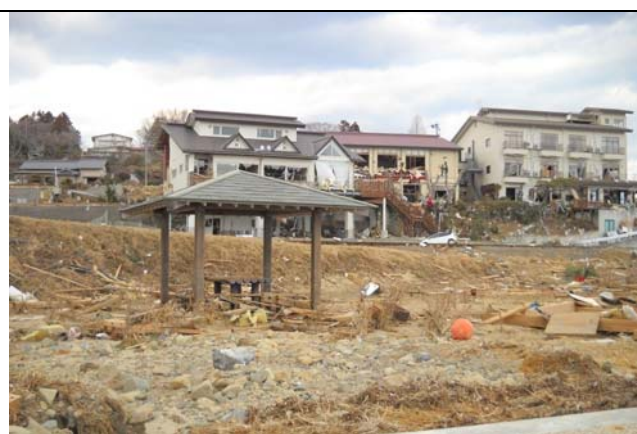
A sofa was found on the breakwater bank (Photo 12). A view from the water break bank to the hill in the Ohtani Coast (Photo 13), in which an arbor is shown supported by four thin timber columns in the low land. The arbor was not damaged. A thin structural member did not attract wave pressure of the tsunami. The dimensions of the column was 200mm square.

Photo 13: A view from the breakwater bank

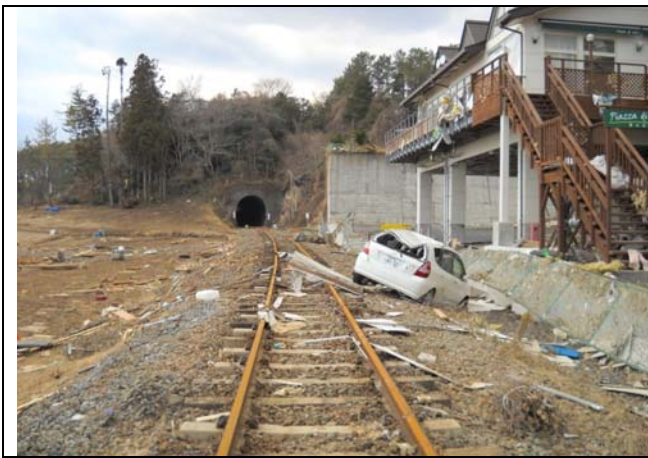
A train runs on the hill (2.5 m high) behind the arbor shown in Photo 13. An automobile was flown out across the rail road (Photo 14); a tunnel in the photo was not damaged. The view from the tunnel to the opposite side is shown in Photo 15. A railway bridge collapsed, and in this area. A three-story hotel building on the hill behind the arbor in Photo 13 is shown in Photo 16; the second floor veranda is supported by three columns in the front, and the windows in the second story were broken. A view of the hotel from the hill side is shown in Photo 17. The second and third stories are of steel construction. From the damage in the second story, the tsunami wave height must have reached approximately 20.5 m (see Fig. 2). There was a concrete block warehouse at 10 m from the sea level (Photo 18); the building was undamaged. There was a timber house next to the concrete block warehouse, but the house was washed away leaving only the foundation (Photo 19). As can be seen in Photo 19, there is a reinforced concrete retaining wall near the concrete block warehouse. There is a two-story reinforced concrete old-age home

Photo 14: A view toward a tunnel.

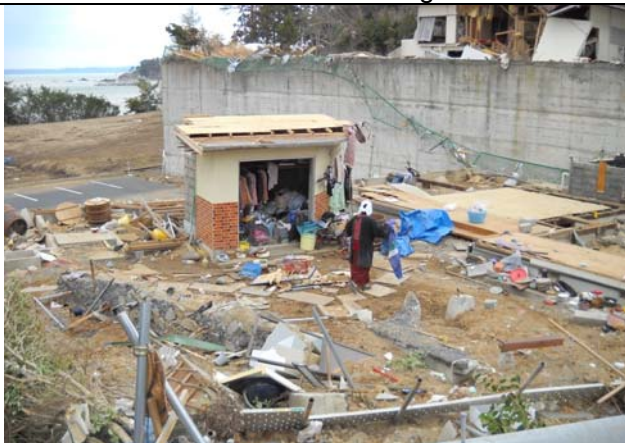
Photo 18: A concrete block warehouse below the hotel building

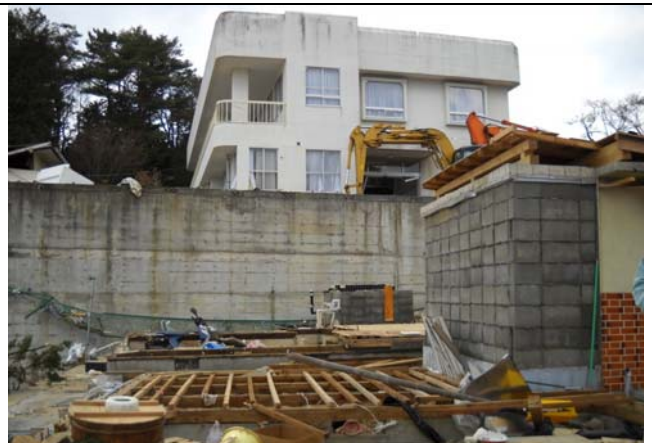
Photo 19: A timber house was washed away leaving the foundation, next to the warehouse.

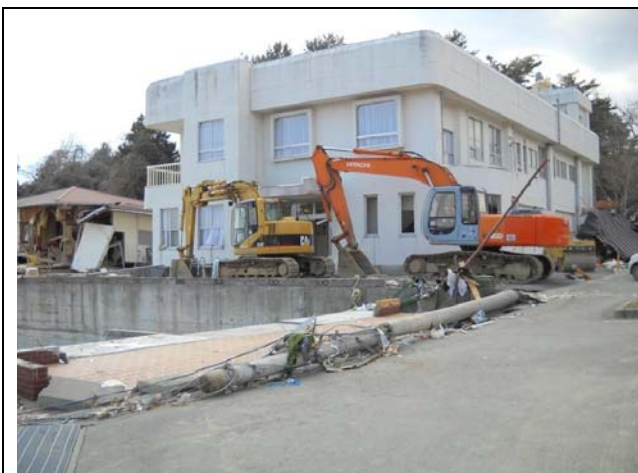
behind the retaining wall (Photo 20). The first story of the old-age home was inundated with tsunami water, but suffered no cracking. The first story of the old-age home is shown in Photo 21.

Photo 20: A two-story reinforced concrete old-age home

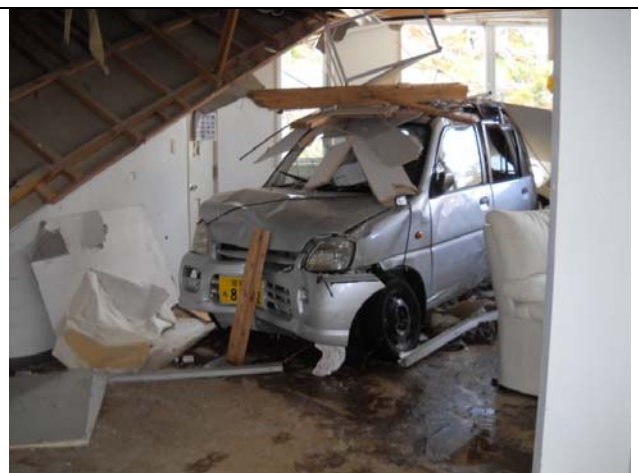
Photo 21: A car was brought into the first story of the old-age home.

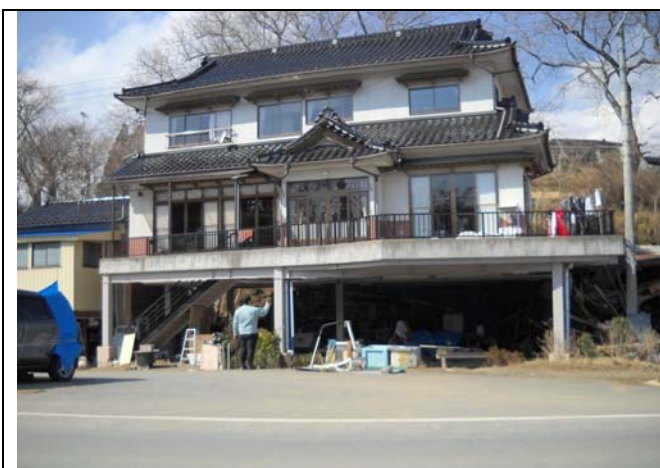
Behind the hotel and the old-age home, and across national route 45 (see Fig. 2), there is a two-story timber house standing on a one-story reinforced concrete elevated foundation (Photo 22); the tsunami wave came to the one-story foundation, but the timber house did not suffer any damage from tsunami wave attacks. The occupants of the house live an ordinary life. An adjacent timber house suffered heavy damage from the tsunami (Photo 23). Building a house on an elevated reinforced concrete foundation is a possible way to avoid tsunami wave attacks.

Photo 22: A timber house on one-story reinforced concrete foundation

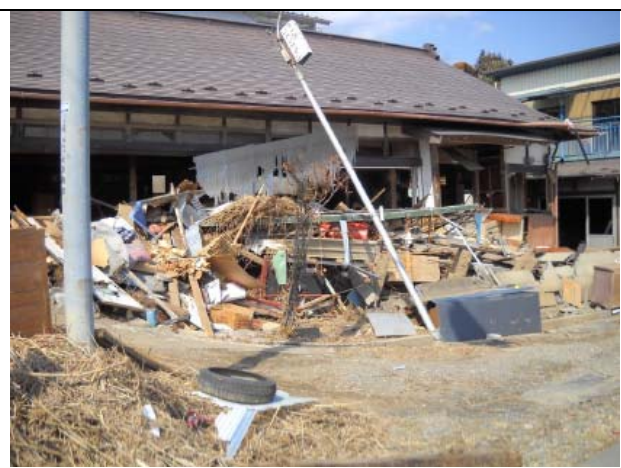
Photo 23: Damaged adjacent timber house
