Tohoku Chapter, Architectural Institute of Japan
Reconnaissance Report (15) on Tsunami Damage in Sendai City
The 2011 off the Pacific Coast of Tohoku Earthquake
Released on April 12, 2011

Disaster Investigation Committee

1. Damage in Nagamachi District, Taihaku-ku (Ward), Sendai City

2. Damage in Oritate District, Aoba-ku, Sendai City

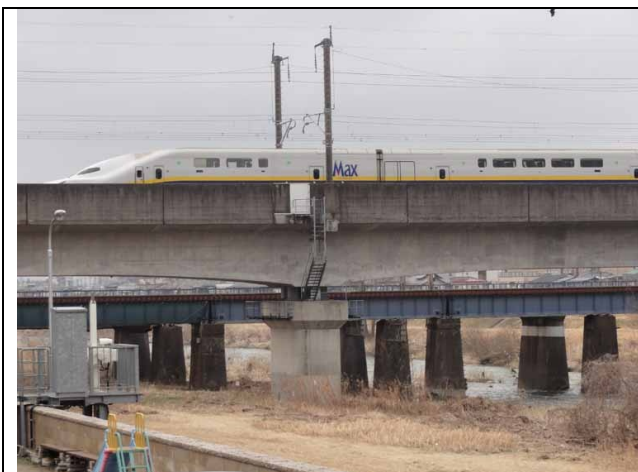
Nagamachi 1-chome, Taihaku-ku

Photo 1: A Shinkansen train stood still on Hirose-gawa side viaduct

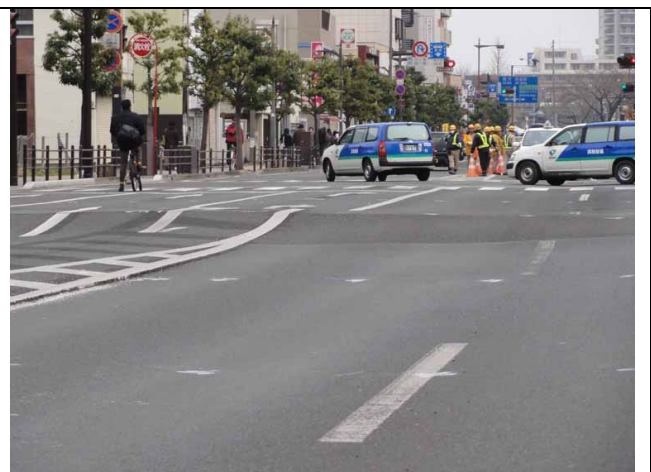
Nagamachi 1-chome, Taihaku-ku

Photo 2: Ground settlement of the old National Road No. 4.

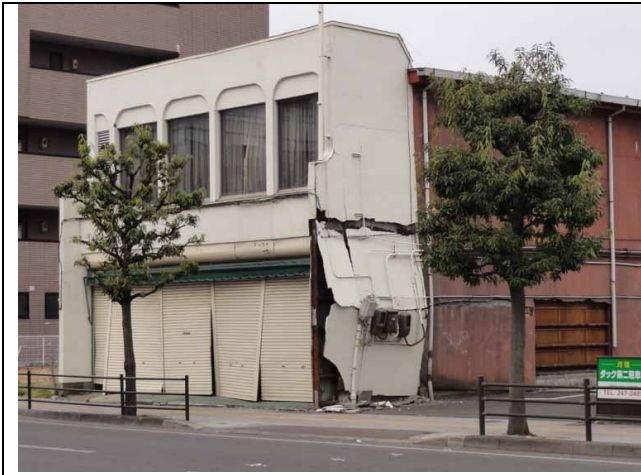
Nagamachi 4-chome, Taihaku-ku

Photo 3: Fall of exterior finishing from a timber house

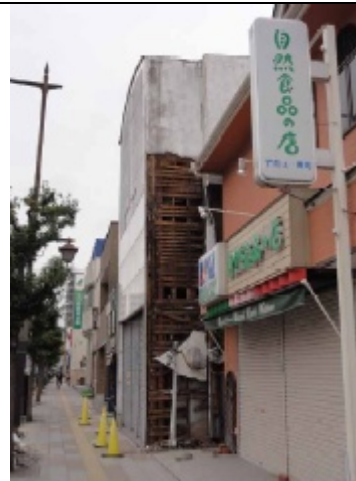
Nagamachi 4-chome, Taihaku-ku

Photo 4: Fall of mortar finishing from a timber house

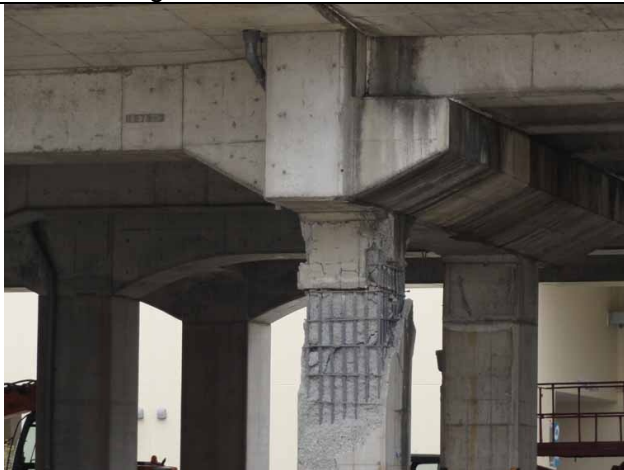
Asuto Nagamachi 2-chome

Photo 5: Viaduct of the Shinkansen Line, shear failure penetrated to the concrete core of the pier.

The damage of the Shinkansen Viaducts, shown in Photos 5 to 8, were re-visited on April 6 (Wed) at

Asuka Nagamachi 2-chome. The repair work was completed by this time.

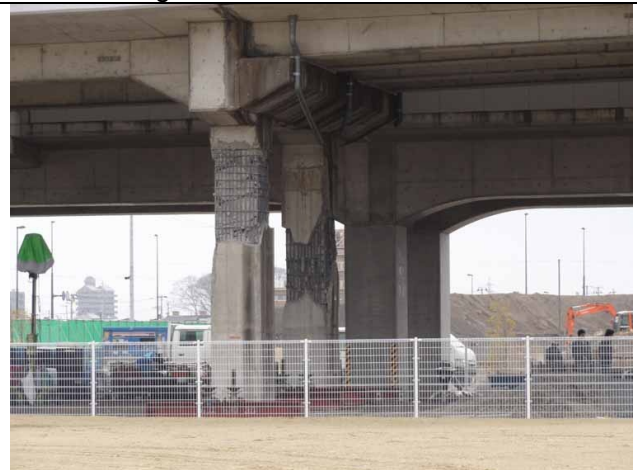
Asuto Nagamachi 2-chome

Photo 6: Piers of viaducts for the Shinkansen (built in 1982) and the Tohoku Line (built in 2006)

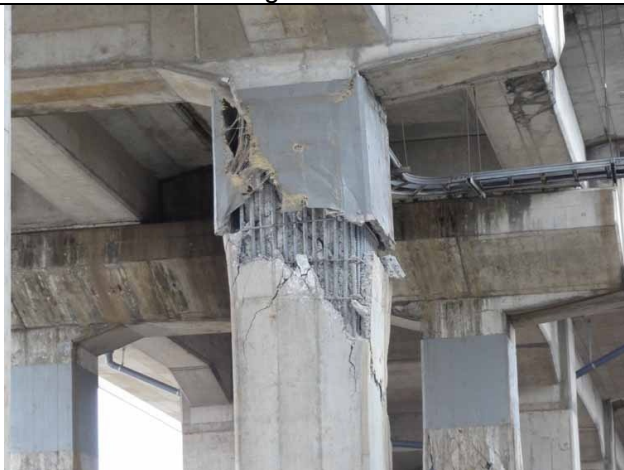
Asuto Nagamachi 2-chome, Taihaku-ku

Photo 7: Fracture of retrofit fiber reinforcement sheet of a pier of the Shinkansen Viaduct

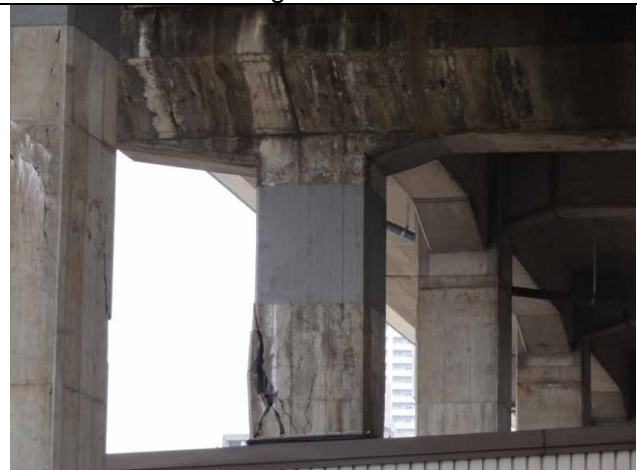
Asuto Nagamachi 2-chome, Taihaku-ku

Photo 8: Shear failure of a pier below the fiber reinforcement retrofit of the Shinkansen Viaduct

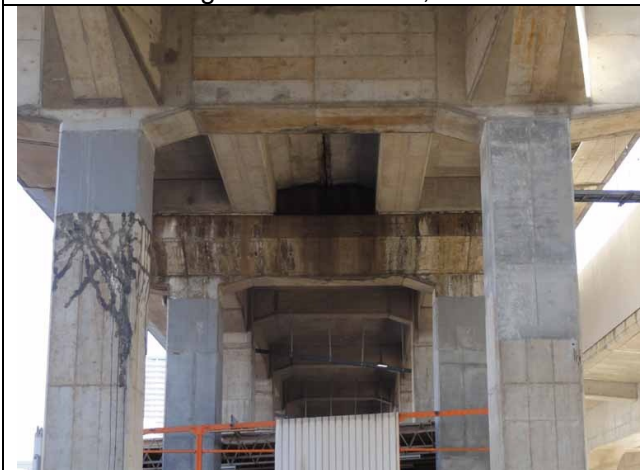
Asuto Nagamachi 2-chome, Taihaku-ku

Photo 11: Shinkansen Viaduct, right pier after the fracture of fiber reinforcement sheet (see Photo 9), and left pier after shear cracking (see Photo 10).

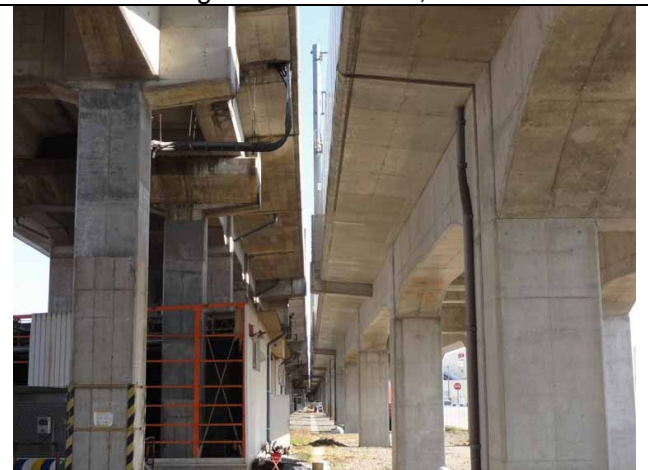
Asuto Nagamachi 2-chome, Taihaku-ku

Photo 12: Left is the Shinaknsen (1982) viaducts and right is the Tohoku Line (2006) viaducts

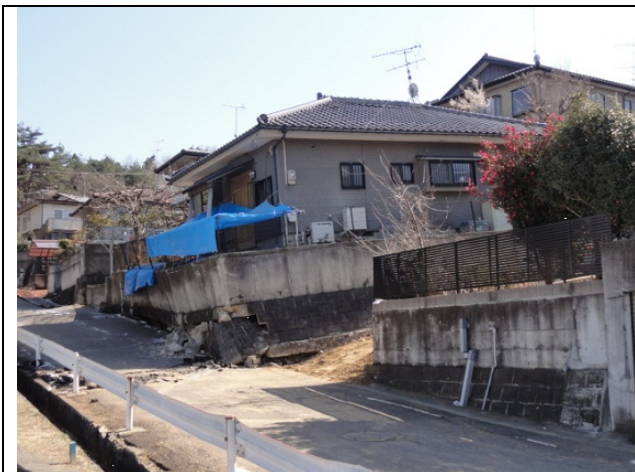
Photo 1: Failure of retaining walls.
Oritate 5-chome, Aoba-ku

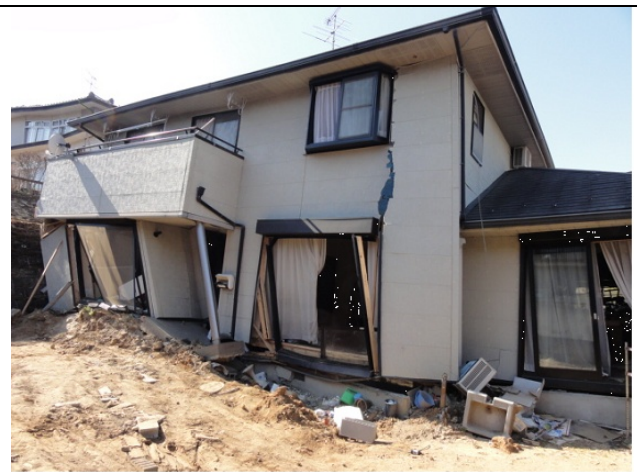
Photo 2: Damage of a house caused by land slide.
Oritate 5-chome, Aoba-ku

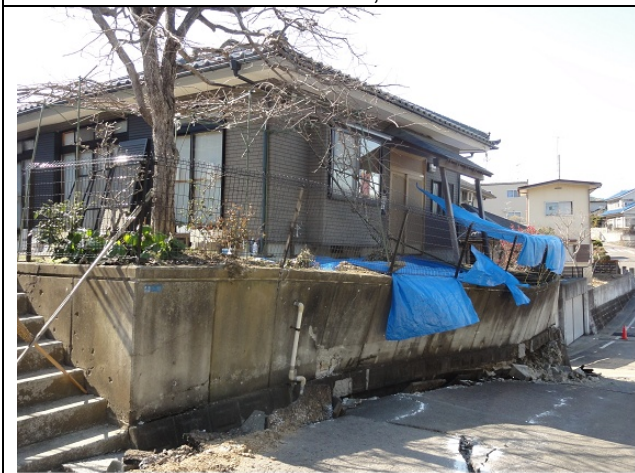
Photo 3: Failure of retaining walls.
Oritate 5-chome, Aoba-ku

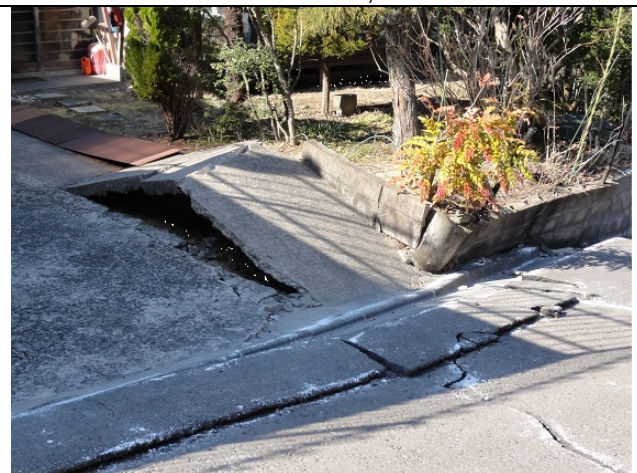
Photo 4: Damage of road surface.
Oritate 5-chome, Aoba-ku

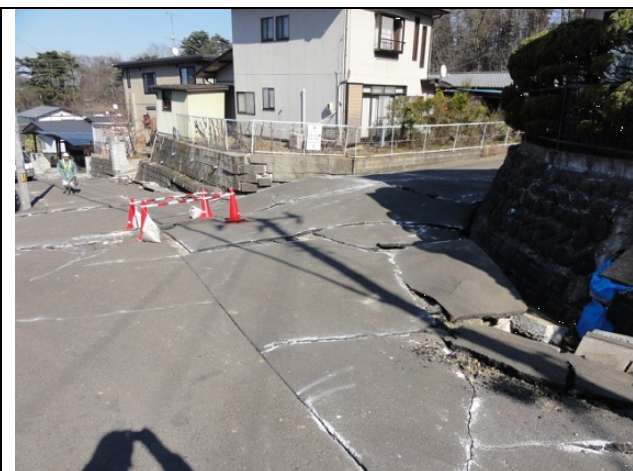
Photo 5: Failure of road surface.
Oritate 5-chome, Aoba-ku

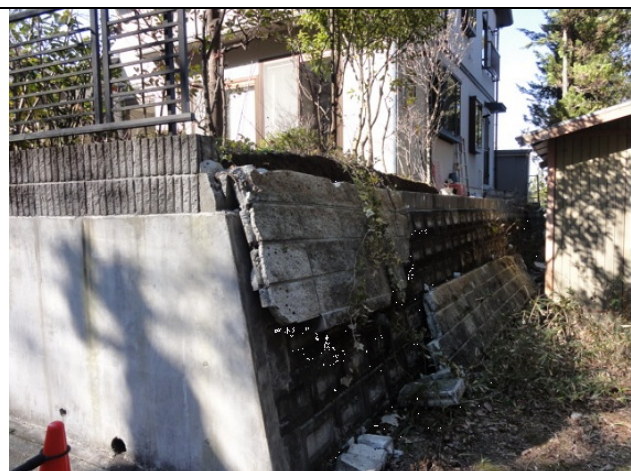
Photo 6: Fall of concrete block walls.
Oritate 5-chome, Aoba-ku

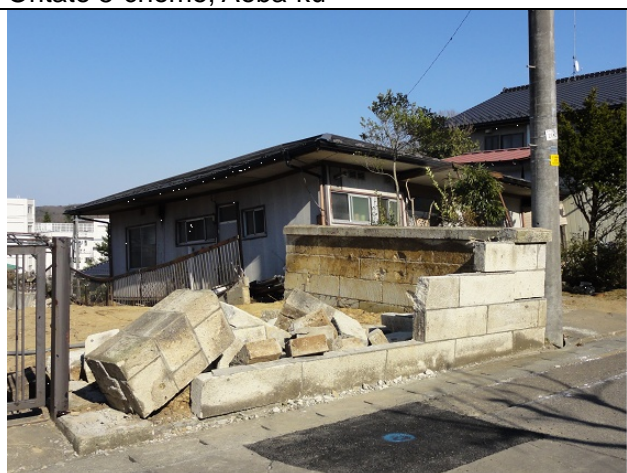
Photo 7: Fall of masonry walls and damage of a house due to land slide
Oritate 5-chome, Aoba-ku

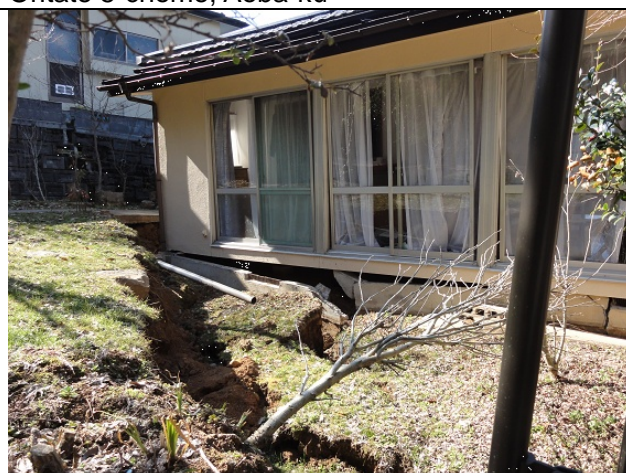
Oritate 5-chome, Aoba-ku

Photo 8: Ground settlement (80 cm).

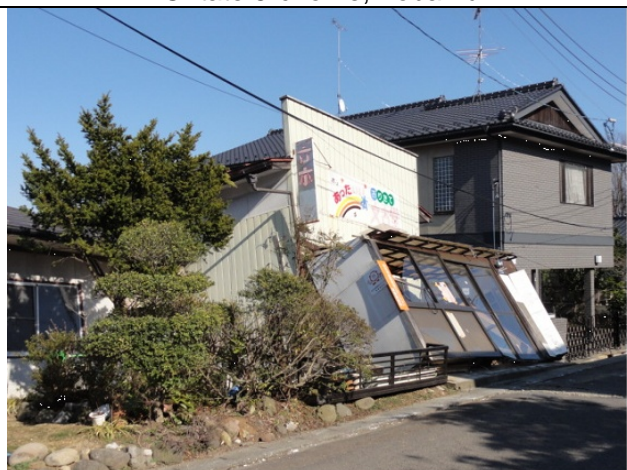
Photo 9: Damage of a house due to land slide.
Oritate 5-chome, Aoba-ku

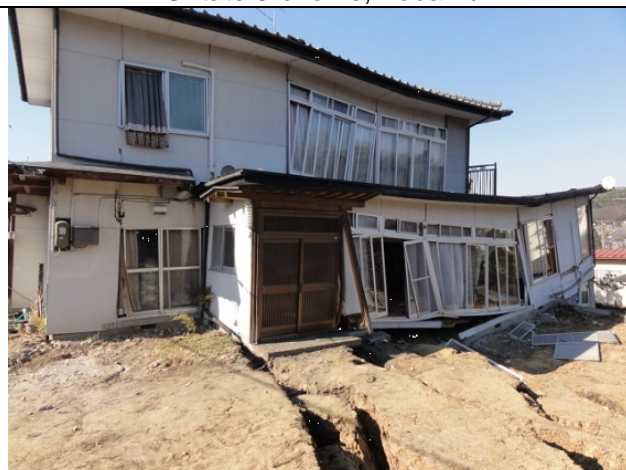
Photo 10: Damage of a house due to land slide
Oritate 5-chome, Aoba-ku

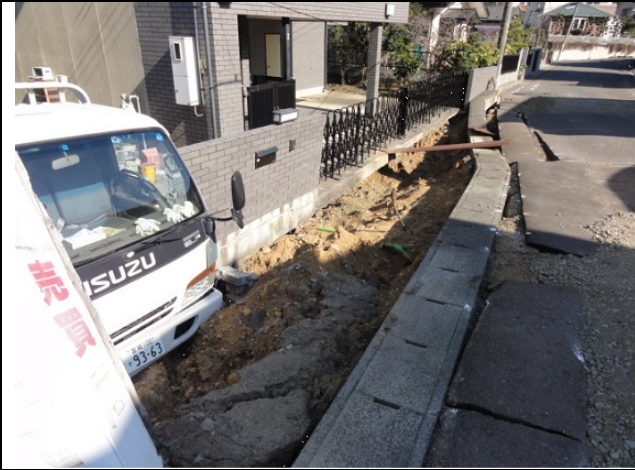
Photo 11: Land slide.
Oritate 5-chome, Aoba-ku

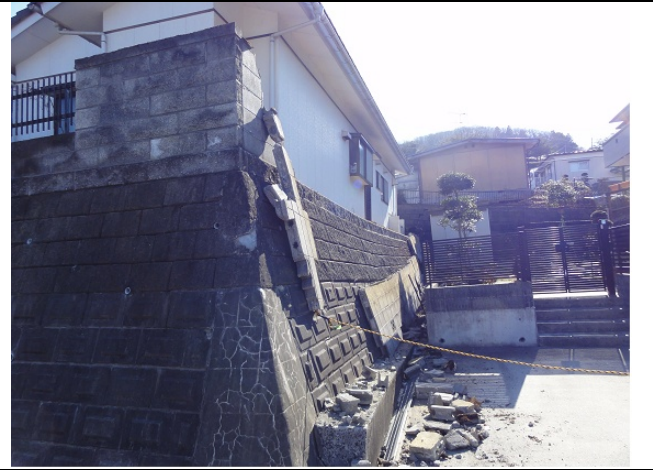
Photo 12: Fall of concrete block walls.
Oritate 5-chome, Aoba-ku

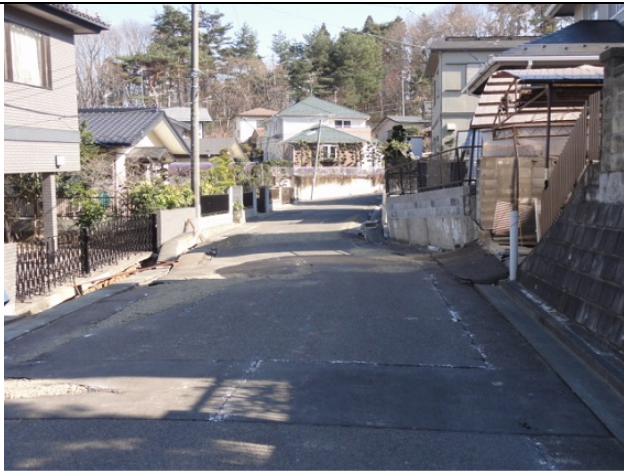
Oritate 5-chome, Aoba-ku

Photo 13: Land slide (previously straight road)

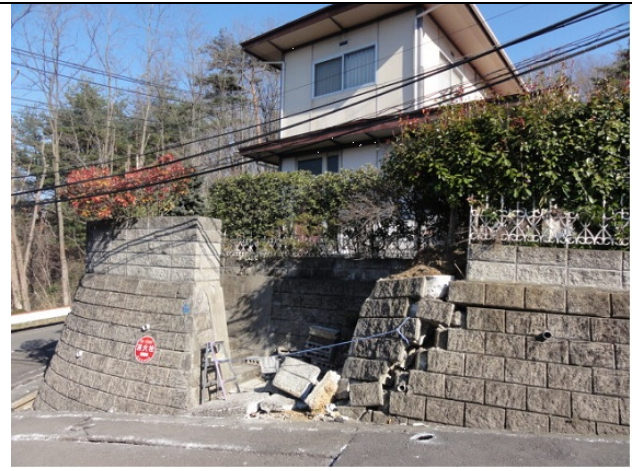
Oritate 5-chome, Aoba-ku

Photo 14: A house of relatively light damage in this area
