Tohoku Chapter, Architectural Institute of Japan  
Reconnaissance Report (17) on Ishinomaki City  
The 2011 off the Pacific Coast of Tohoku Earthquake  
Released on April 15, 2011

Disaster Committee, Tohoku Chapter  
Dr. Tomoyuki Obata, Vice President  
Yamagata Technical College,  
(Translated by Shunsuke Otani, University of Tokyo)

Ishinomaki City, Miyagi Prefecture, is located approximately 45 km to the north east of Sendai City. The population is 160,336; 2,482 were dead and 2,770 were missing as of April 5, 2011. Port and Airport Research Institute determined the tsunami height at Ishinomaki Harbor to be 5 m, and at Ogachi-machi, Ishinomaki City to be 16 m (run up).

The route map of Ishinomaki is shown in Fig. 1 at the end of this report. The damage was surveyed on April 8 (Friday). There was a magnitude 7.4 earthquake (Epicenter at Miyagi-ken Oki) at 23:30 on April 7. Therefore, the observed damage was caused by the March 11 main shock and also by the April 7 aftershock.

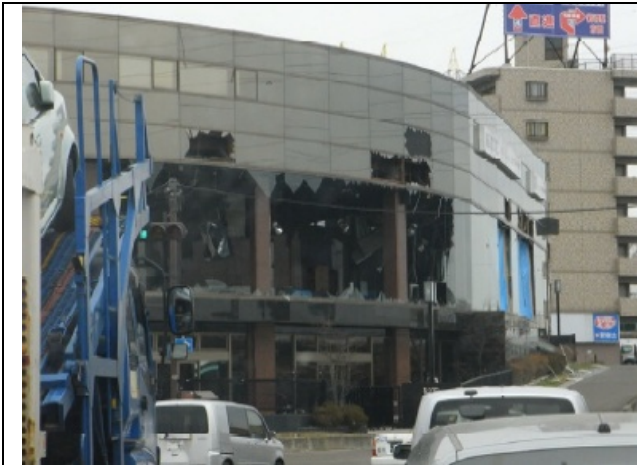
Photo 1: Exterior finishing was damaged by the April 6 aftershock in Sendai City.

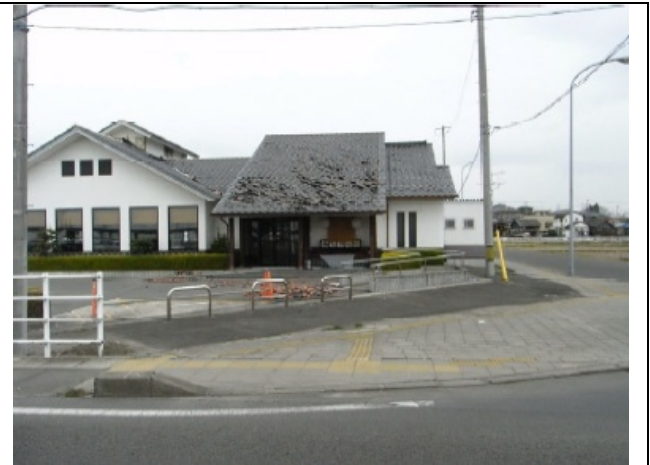
Photo 2: Fall of roof tiles and breakage of window glasses, probably due to the April 7 aftershock.

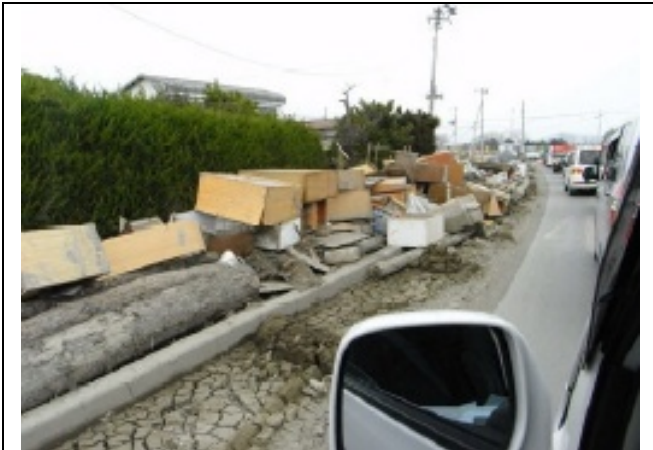
Photo 3: Piling of thrown items on the road side near Yamoto (Higashi-Matsushima City).

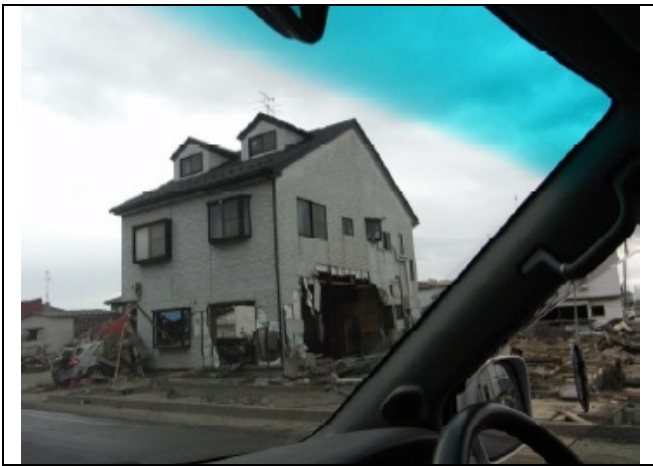
Photo 1: Damage by tsunami.

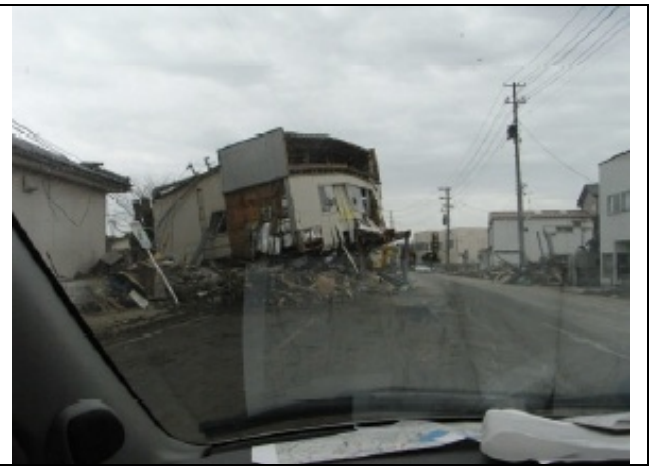
Photo 2: First story was broken.

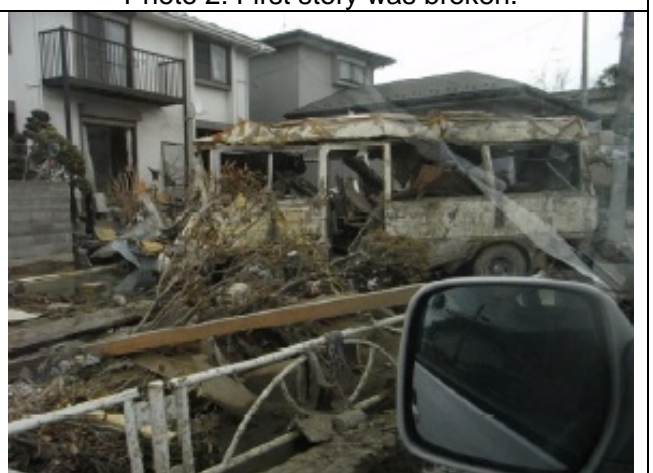
Photo 4: Damage in the first story was severe, damage was relatively light on hill side.

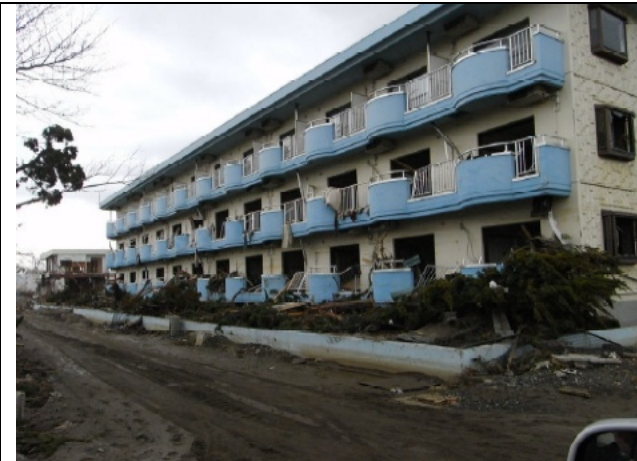
Photo 9: Damage was observed up to the second story (No.1 in route map).

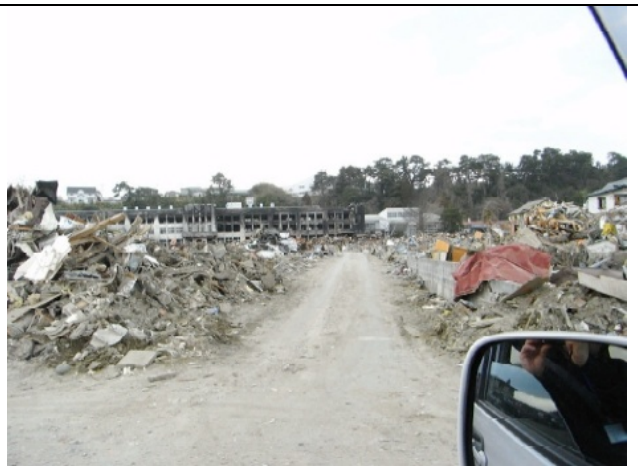
Photo 12: Devastation. Boundary of house lots was not clear.

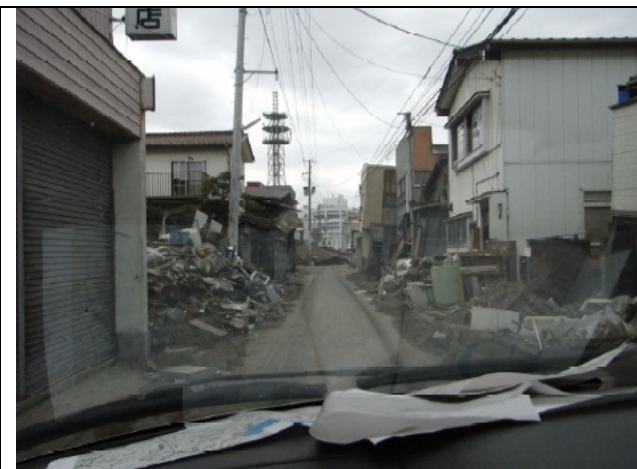
Photo 13: Damage in densely built up area. Roads were not passable (No. 2 in Route Map).

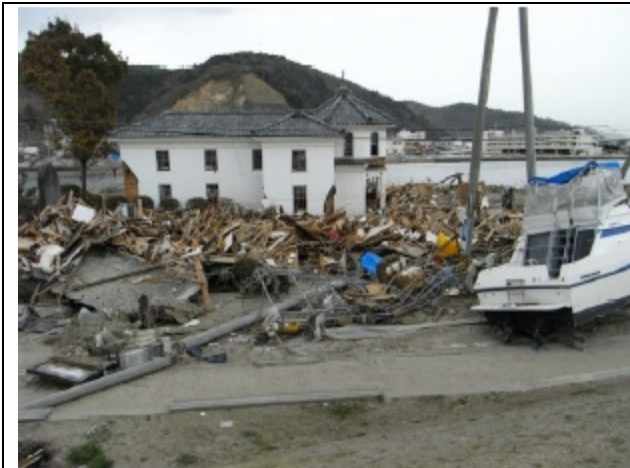
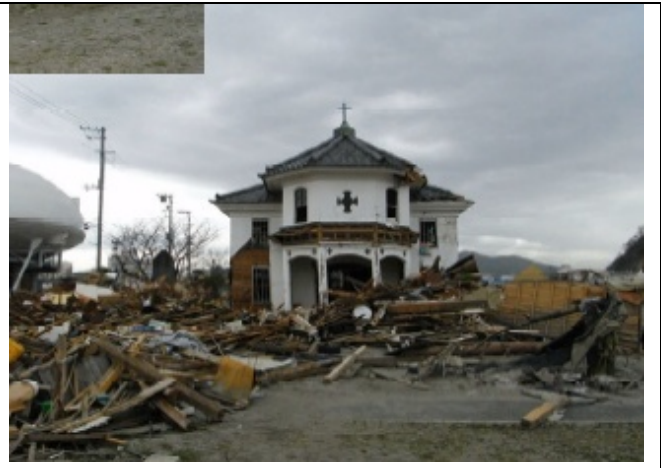
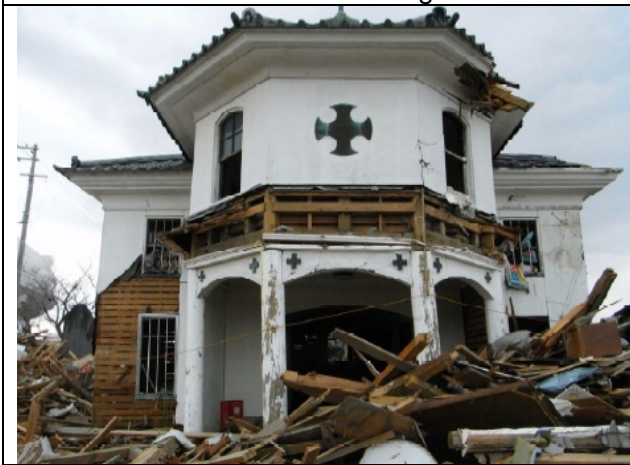
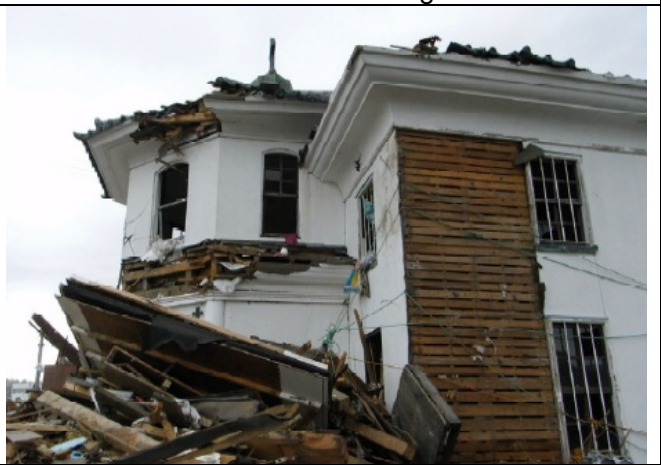
There was debris around the church and it was difficult to approach the church. Damage was severe on the sea side, and tsunami must have flowed through the building. Columns and walls were deformed. The columns appeared to support the building by visual observation. The building was damaged by the 1978 Miyagi-ken Oki Earthquake, and was reconstructed at this site. Temporary repair work appeared necessary to survive aftershocks.

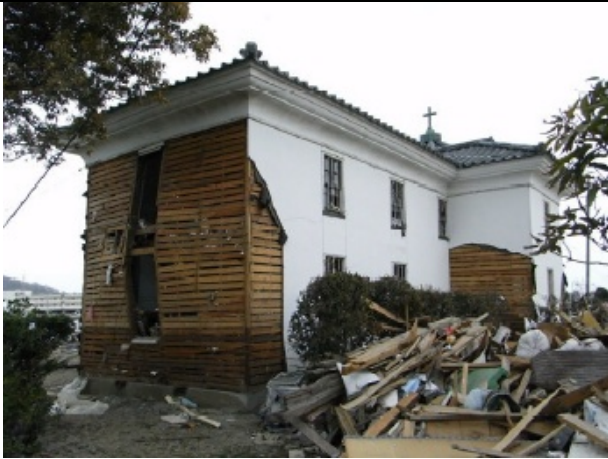
Photo 5: Damage in the back.

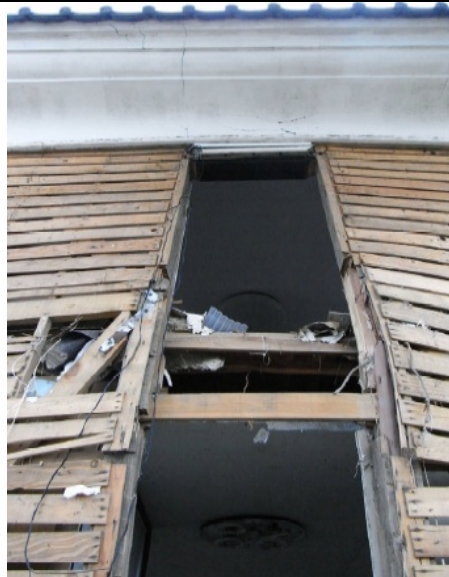
Photo 6: Damage in the back.

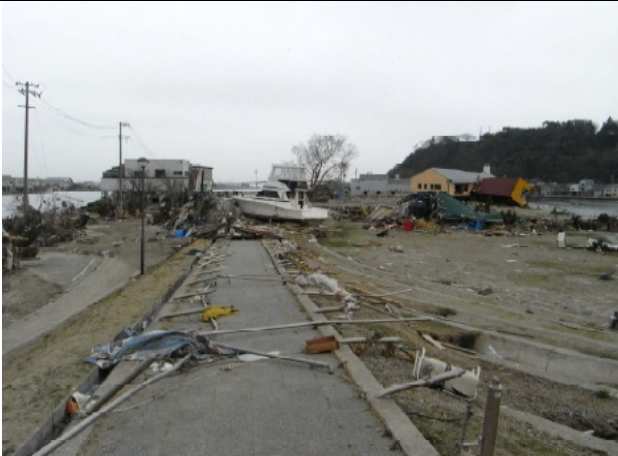
Photo 9: View of the sea shore from the church.  
Most buildings collapsed.

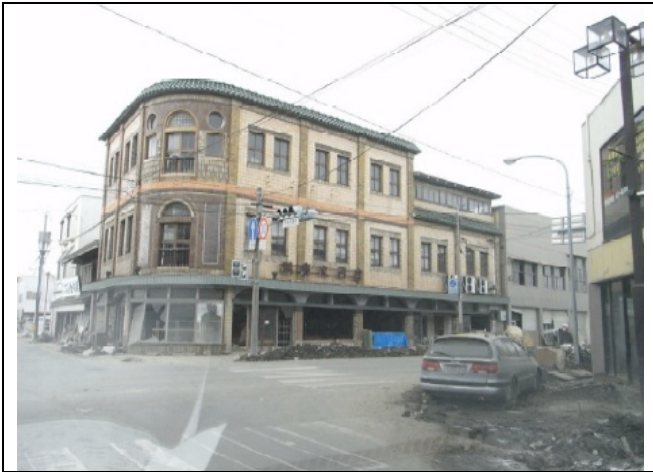
Photo 1: China-ware Kankei-maru, the damage in the first story due to inundation (N o. 4 in route map)

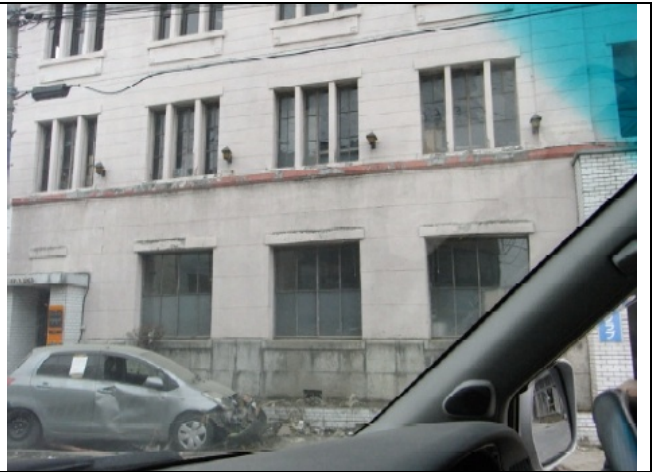
Photo 2: Daini SS building, many buildings suffered damage in the first story due to tsunami.
