Tohoku Chapter, Architectural Institute of Japan Reconnaissance Report (19) on Minami-Sanriku-cho, Miyagi prefecture The 2011 off the Pacific Coast of Tohoku Earthquake Released on April 20, 2011

> Disaster Committee, Tohoku Chapter Mr. Yukihiro Take, Guest Researcher, and Mr. Ryota Yamaya, Guest Researcher, Tohoku Institute of Technology (Translated by Shunsuke Otani, University of Tokyo)

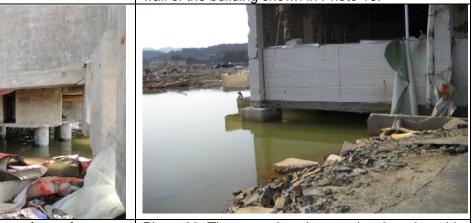
(7) The foundation and prestressed concrete piles of a tsunami evacuation building was exposed by wash out of ground soil (Photo 22, No. 4 in Fig. 2).

(8) Muddy sea water stays in the sank ground and could not be drained. The puddle was repeatedly filled with high tide (Photos 23 and 24, No. 9 in Fig. 2).

Photo 22: The foundation of a four-story reinforced concrete condominium building near the sea shore; the foundation is exposed. Photo 23: The ground settlement developed muddy puddle.

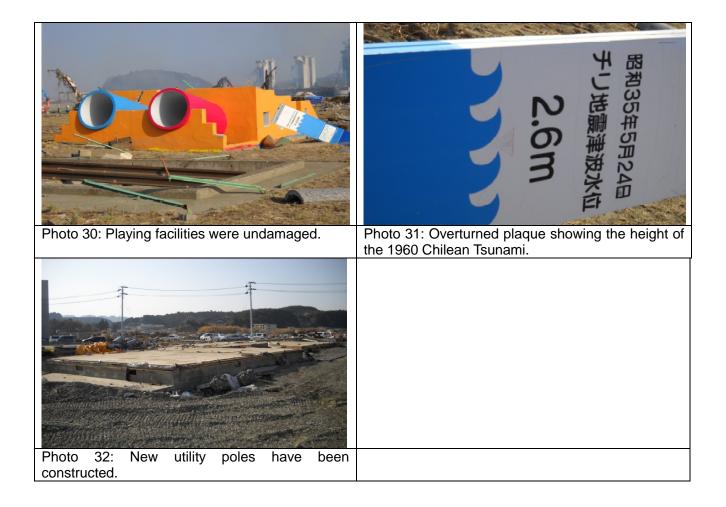
(10) In Matsubara (pine field) Park, all pine trees were washed away from roots, monuments and exhibited items were either moved, overturned or washed away (Photos 25 to 31, No. 10 in Fig. 2).(11) New utility poles are under erection, and electricity will be soon recovered (Photo 32, No. 8 in Fig.

Photo 28: A Chile-Japan friendship monument was undamaged Photo 29: Moai Statute on the base remained standing (right), the top of a tower monument was flowed out (left).

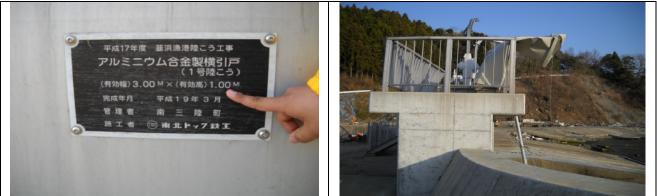
(1) 1-m high tide embankment with sliding doors was constructed, but tsunami wave passed over the embankment and caused damage (Photos 1 and 2; location No. 11 in Fig. 3)

Photo 1: 1-m high tidal embankment with sliding door was constructed, but of no use. Photo 2: Tsunami wave passed over the tidal embankment and caused the damage.
