Damage in Sendai Areas Reported by Dr. Daiki Sato

20110324 Summary by Shunsuke Otani, University of Tokyo

(1) Miyagi Agricultural High School, Natori City (March 20)

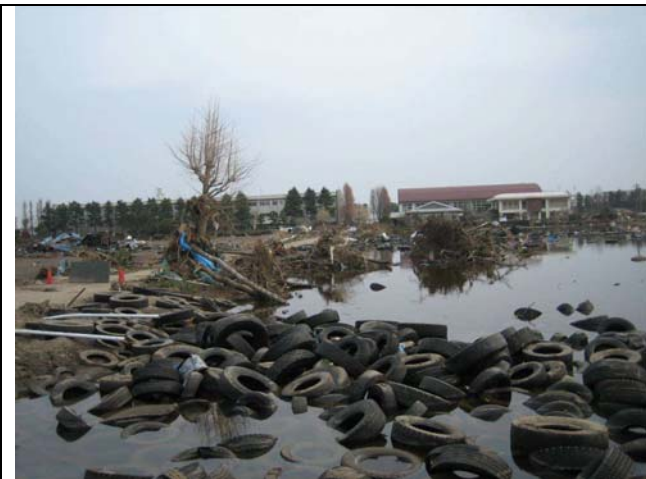
Photo 1: Campus after the tsunami attack

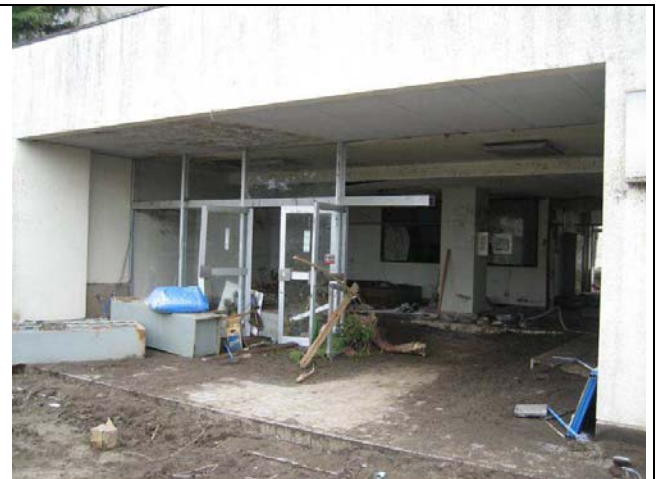
Photo 2: Entrance damaged by the tsunami

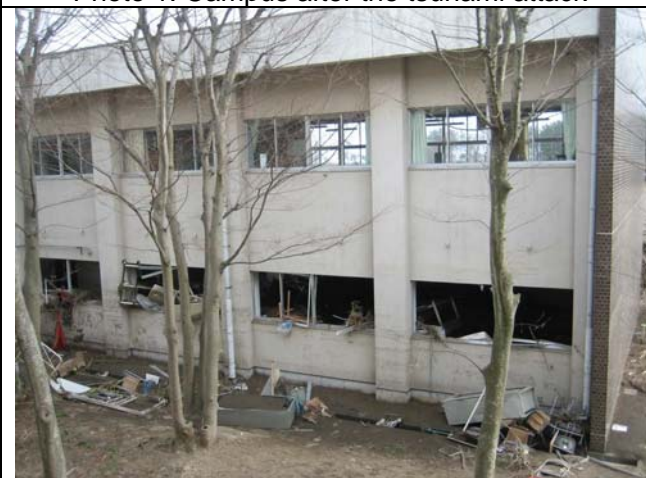
Photo 3: Broken windows in the 1-st story (north face of the South Building)

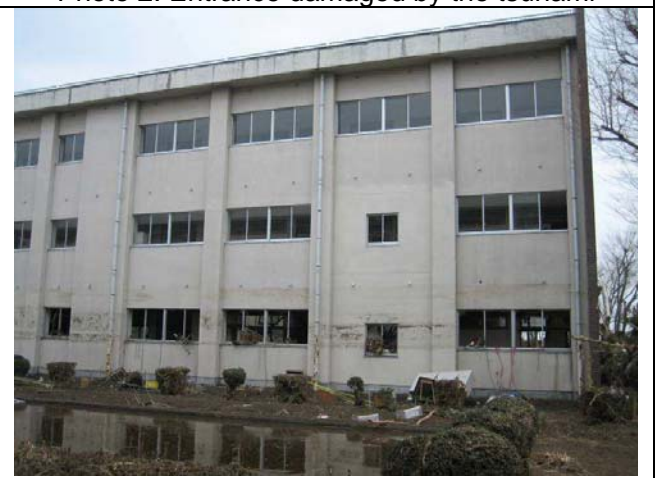
Photo 4: North face of the Central Building (the tsunami reached approx. 1 m above the first story windows)

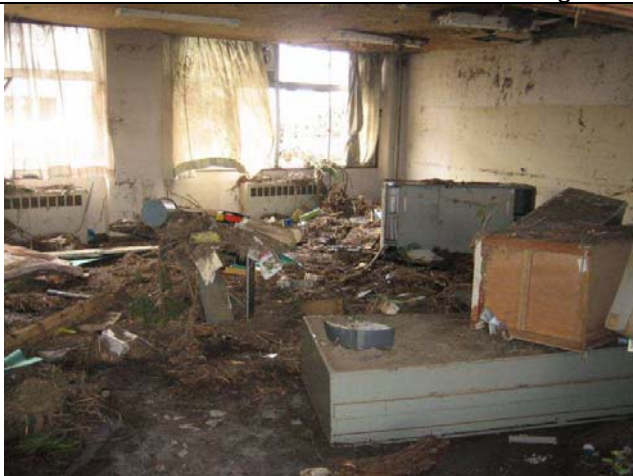
Photo 7: Inside of the North Building

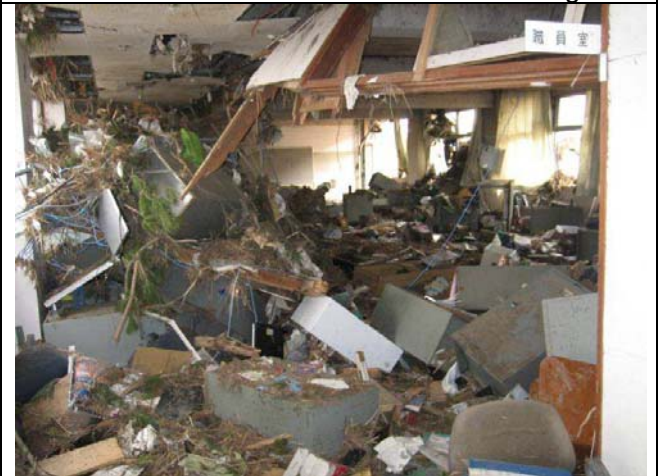
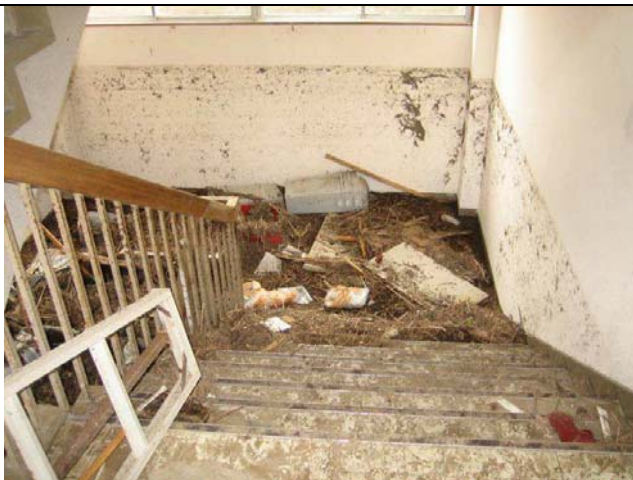
Photo 8: Inside of the Central Building

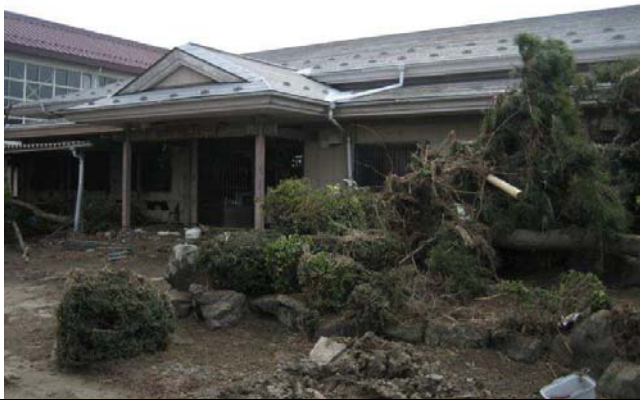
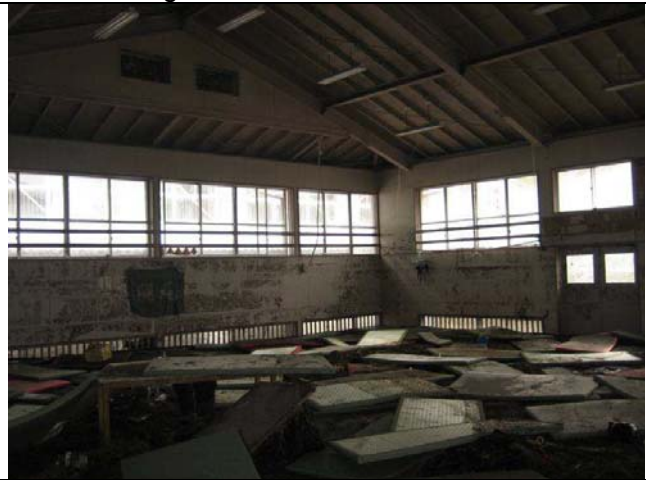
Photo 10: Gymnasium for military arts (No lighting fixture fell)

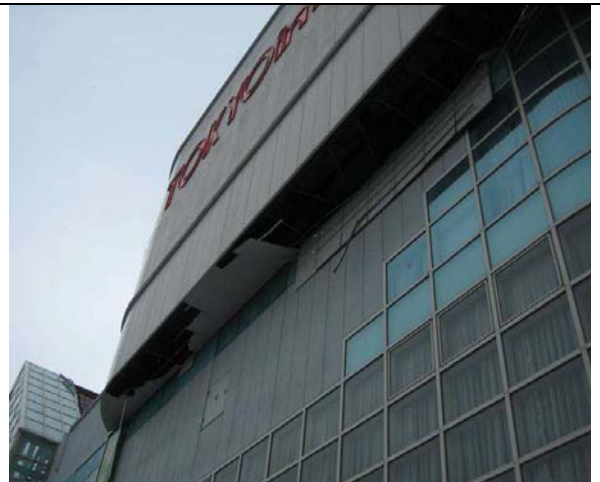
Photo 2: Fall of ceiling (Building 1)

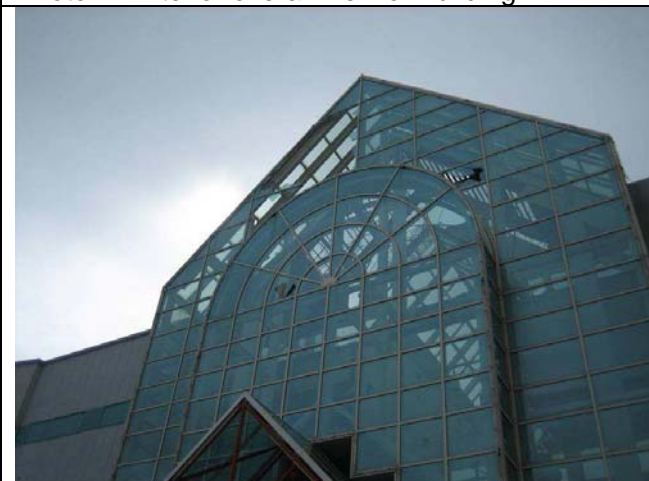
Photo 3: Drop of exterior glasses

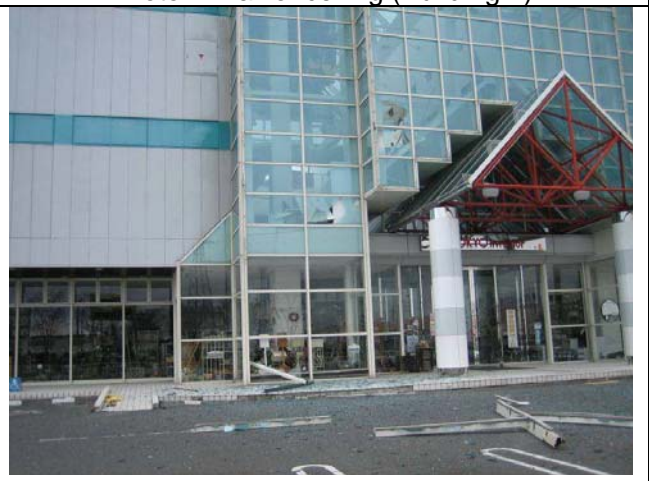
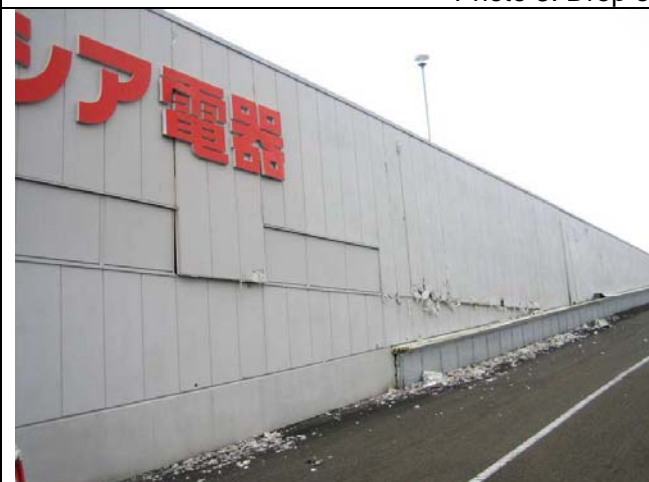
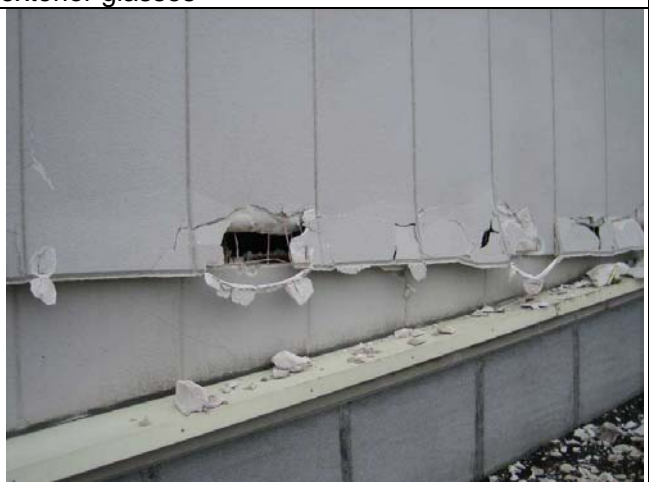
Photo 4: Breakage of ALC (autoclaved light-weight concrete) panel (Building 2)

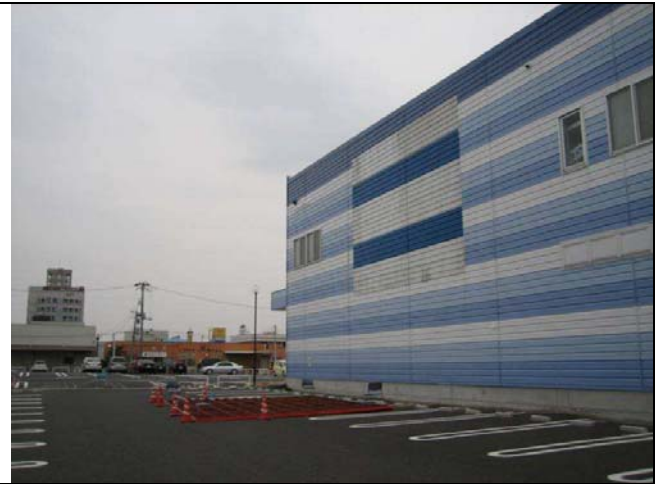
Photo 12: Fall of exterior panel to parking lot

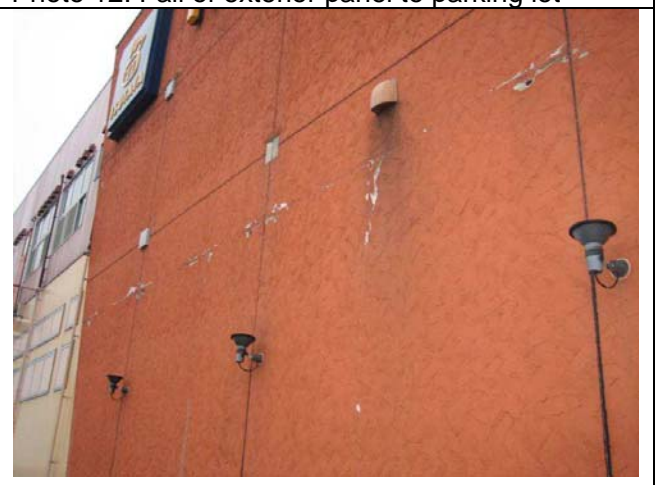
Photo 12: Cracking in ALC exterior panels

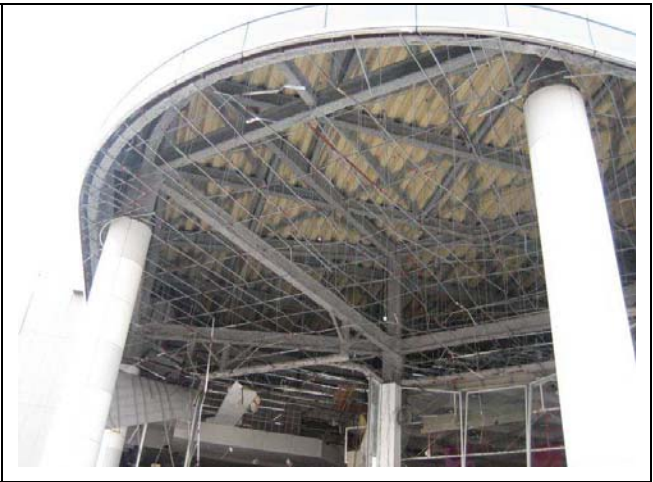
Photo 2: The ceiling dropped and roof skeleton is exposed

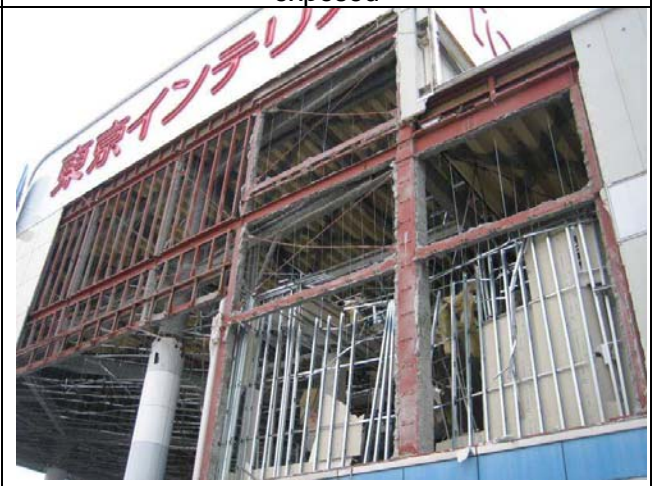
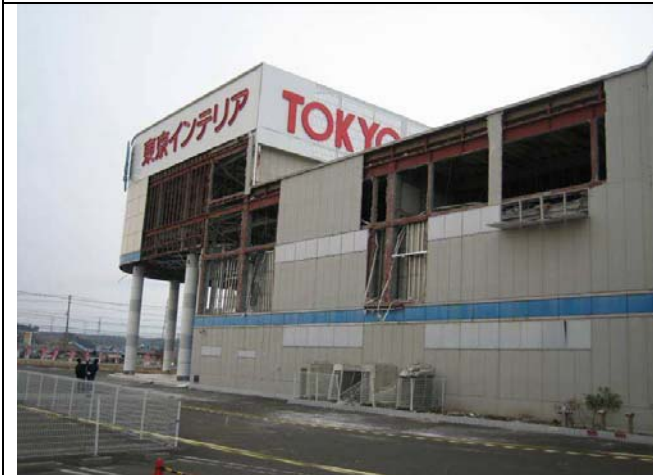
Photo 4: Fall of exterior curtain walls

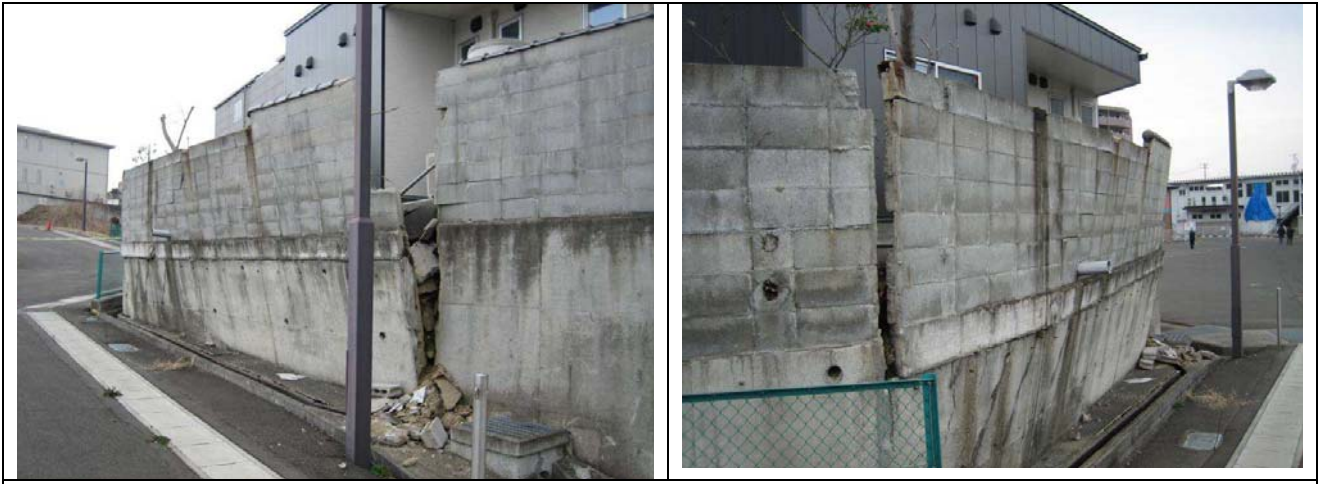
Photo 5: Fall of concrete block walls in the neighborhood
