# **Technical Information**

## **for Disaster Mitigation of Masonry Structures**

**Architectural Institute of Japan**

**Managing Committee on Box-Shaped Wall Structures**

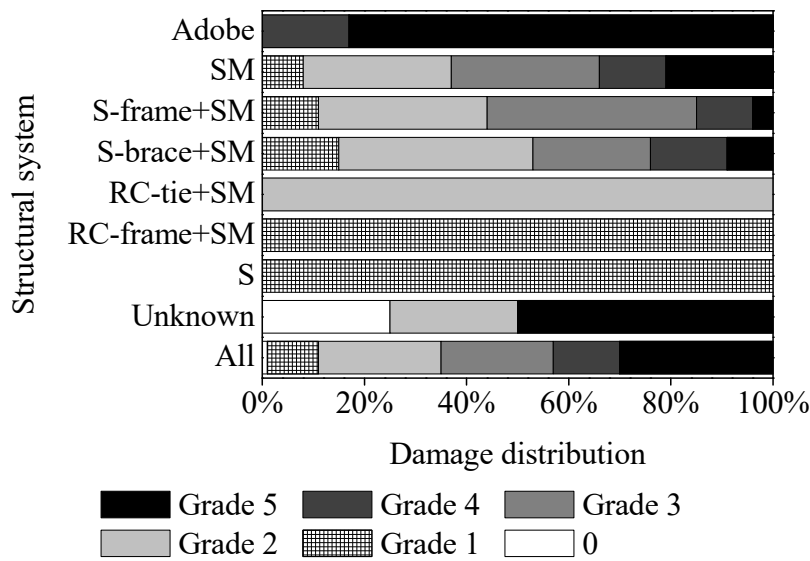
Figure 2.4 Damage Distribution of Each Structural System

Figure 2.4 shows the damage grade distribution for each structural system, where a building without damage is classified into 0. All Adobe buildings were classified into Grade 4 and Grade 5. Sum of the ratios of Grade 4 and Grade 5 in SM buildings exceeded 30%, which was much smaller than Adobe buildings. The damage ratios of S-frame+SM and S-brace+SM buildings were expected to be much less than that of SM buildings, however, there were no significant differences among them. This was caused by brittle fracture of poor welded connections in a few S-frame+SM and S-brace+SM buildings. On the other hand, the damages of RC-tie+SM and RC-frame+SM buildings were quite slightly damaged because connections in these buildings were constructed monolithically. These results, however, were derived from the only one case in each system. The damage level of one S building, which was the gymnasium structure, was Grade 1.

The survey results above clearly indicated the importance of usage of engineered materials; nevertheless, low quality of construction caused severe damage to buildings in spite of application of engineered materials. These seemed to be common key issues to improve the seismic performance of building in other developing countries as well as in Bam, Iran.

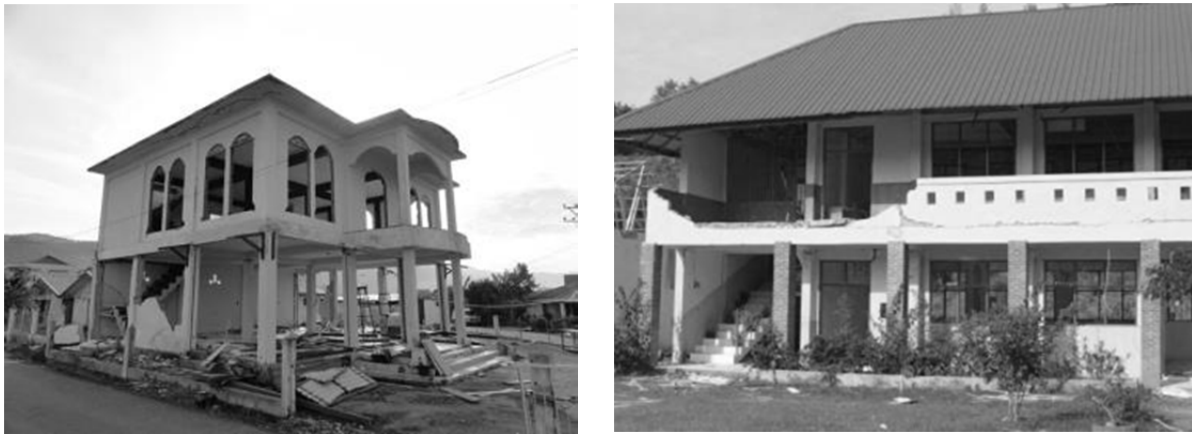
Photo 2.4 Damage to Nonstructural Walls in RC Buildings Preventing Immediate Occupancy

Photo 2.3(a) shows an example of typical RC buildings whose major damage was observed to non-structural masonry walls as well as structural columns. Severe damage to non-structural walls prevented RC buildings from immediate occupancy, as shown in Photo 2.4.

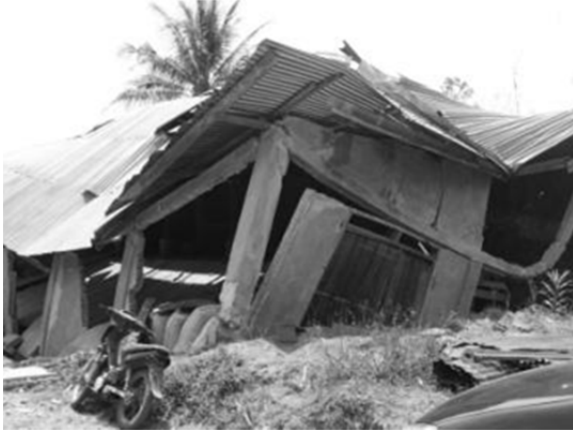
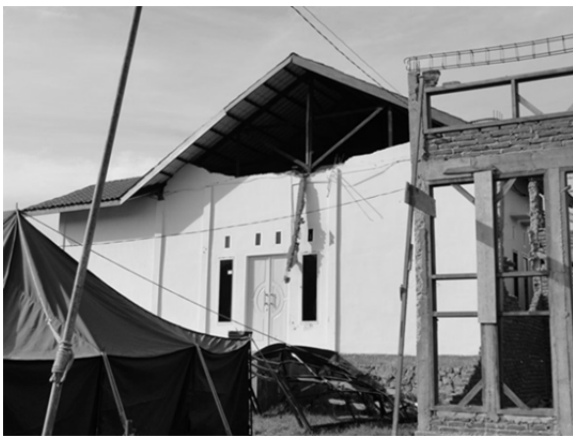
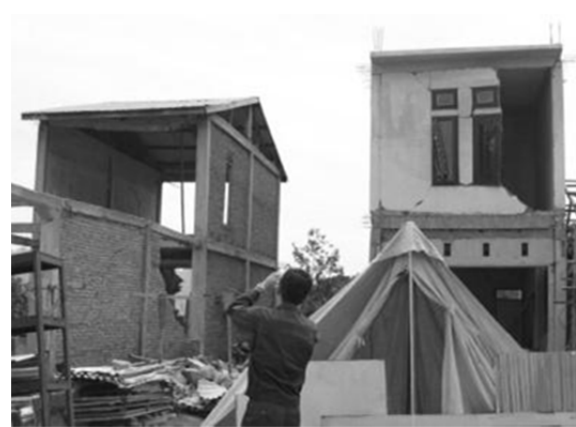
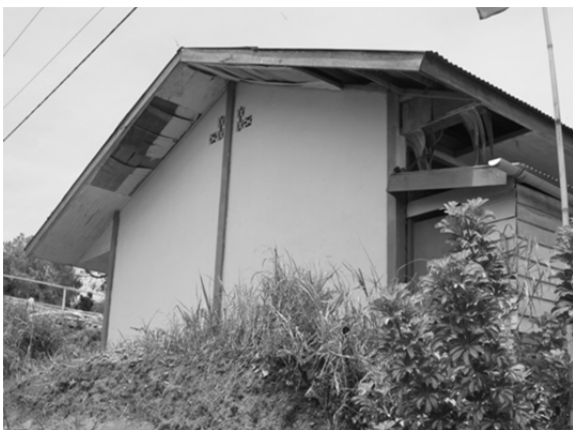
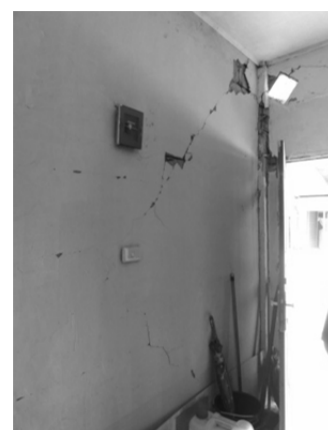
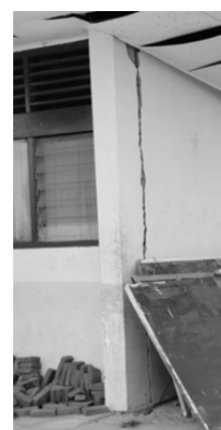
Photo 2.5 Typical Damage to Confined Masonry

(a) Complete Collapse

(b) Collapse of Confining Elements

(c) Out-of-Plane Failure of Gable Wall

(d) Out-of-Plane Failure of Walls

(e) Leaning of wall

(f) Shear Crack on Wall

(g) Separation

CM houses consist of brick walls with slender RC tie columns/beams, which are provided along the perimeters of masonry walls, and a wooden/aluminum roof truss with tiles/zinc plates or an RC roof slab, as shown in Photo 2.3(b). This type of construction suffered moderate to heavy damage such as: complete collapse, collapse of confining elements, out-of-plane failure of walls, etc., as shown in Photo 2.5. Photos 2.3(c) and 2.3(d) show T and T+M houses, respectively. Both systems consist of wooden walls and a roof made with tiles/zinc plates, while the latter has brick spandrel walls under wooden walls. Although damage to these systems was generally lighter, some of them leaned due to ground settlement or damage to masonry spandrel walls, as shown in Photo 2.6.

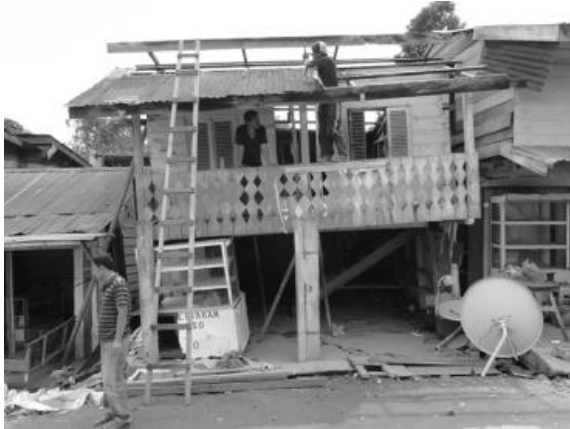
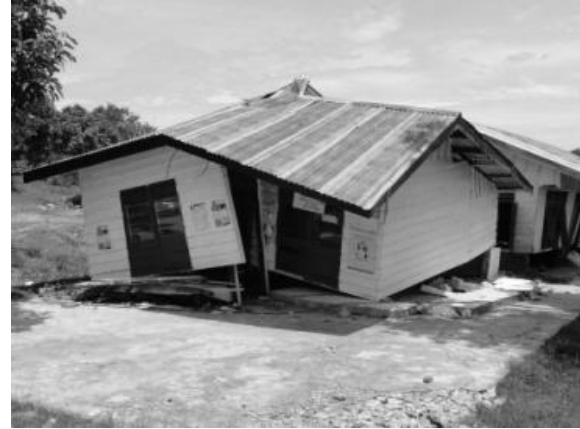
Photo 2.6 Damage to Timber Constructions

(a) Timber House Damaged Due to  
Ground Settlement

(b) T+M Type House Leaning with Failure of  
Spandrel Walls

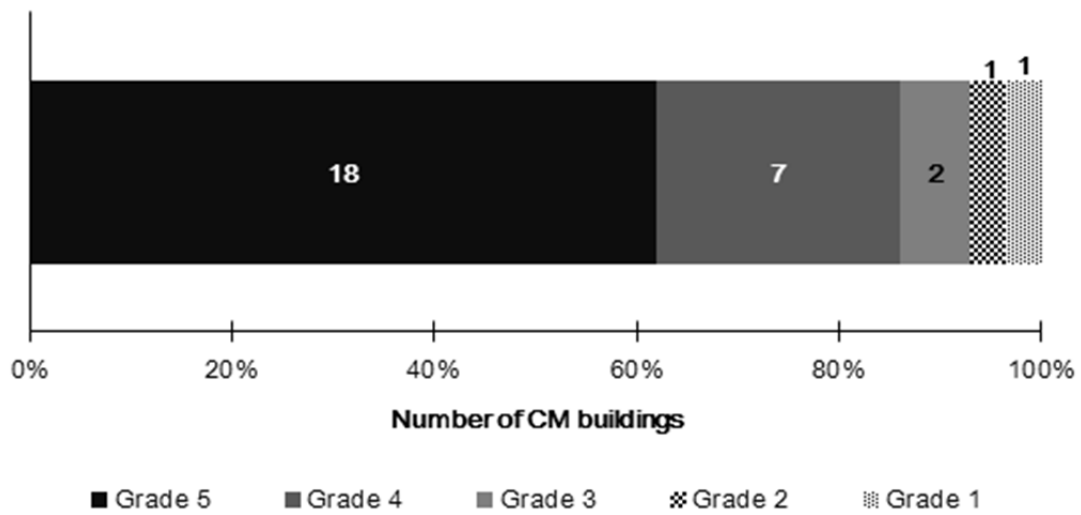
Figure 2.8 Distribution of Damage Grades for CM Construction

Damage to CM structures was classified into five grades based on European Macroseismic Scale 1998 (EMS-98, refer to Appendix.1), as show in Table 2.1. Figure 2.8 shows the distribution of damage grades for CM structures which are exemplified in Photo 2.5. Most of CM structures suffered severe damage: Grades 5 and 4 for 62% and 24% of the total, respectively. Photos 2.5(c) to 2.5(g) summarize typical damage to masonry walls. Figure 2.9 shows the ratio of such observed wall damage: out-of-plane failure, leaning, shear cracking, and separation between wall and boundary elements. Out-of-plane failure and leaning of walls were clearly caused by out-of-plane direction loads and generally lead higher damage grades of 5 to 3. On the other hand, walls with shear/separation cracks were judged as smaller grades of 2 to 1, which might be caused by in-plane direction loads. Only two samples were obtained for the latter case according to the investigation results. Moreover, complete collapses with damage grade of 5 also seemed to be related to out-of-plane failure of walls, while it is impossible to exactly identify particular causes of collapses. Therefore, upgrading the out-of-plane performance of masonry walls is essential to effectively reduce severe damage to masonry structures.

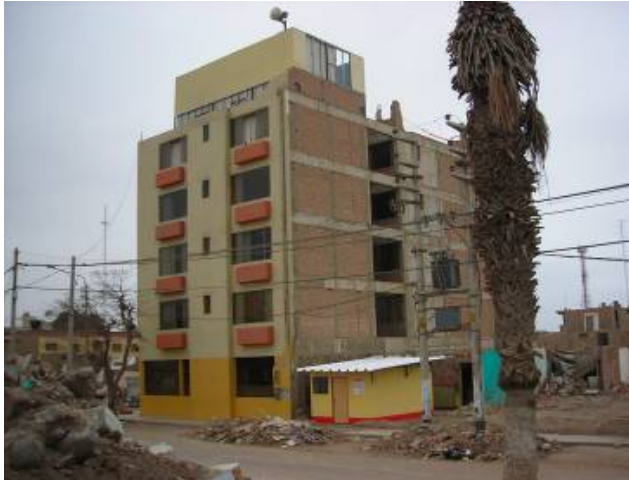
(a)

Damage is found at only penthouse part (not visible in photo), main building is almost not damaged.

Concrete shear wall exists in central part. Damage grade is G2.

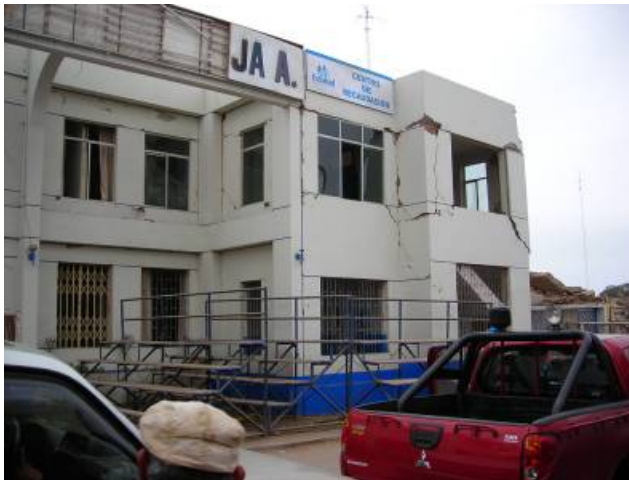
(b)

If shear cracks extends to the structure frame, be G4. In the case of damage of finish only, it can be determined as G3 damage.

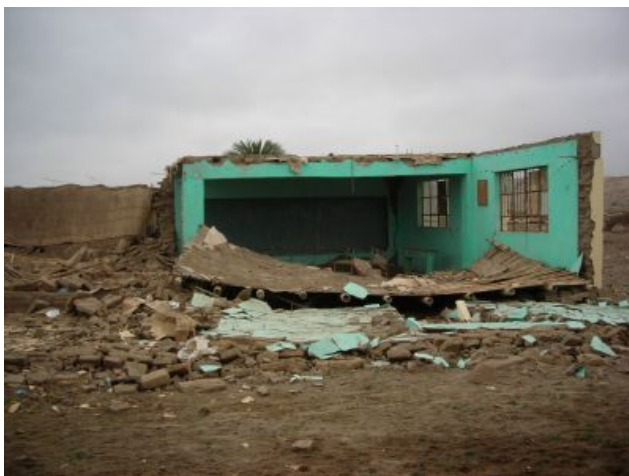
#### (c) Adobe building

Identified as G5 damage due to the near total collapse.

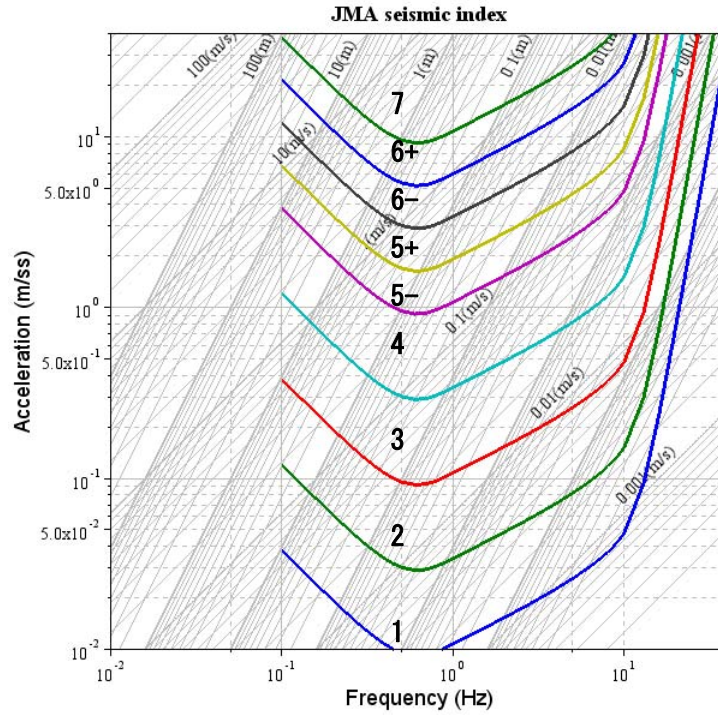
Figure 2.10 The relation between the maximum acceleration and the JMA Seismic Intensity Scale

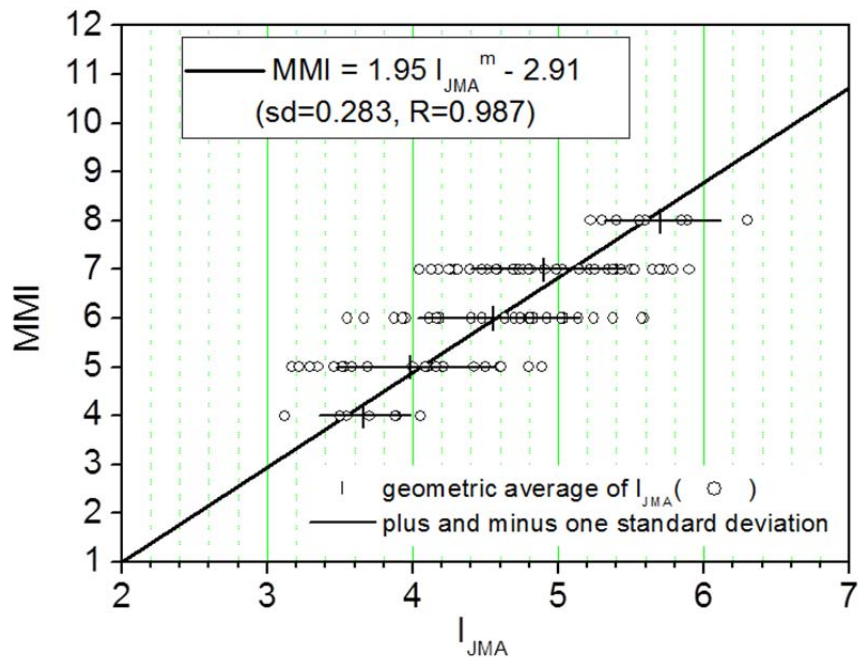
Figure 2.11 The linear relation between the MMI and the  $I_{JMA}$ . The bars represent the geometric average of  $I_{JMA}$  for a given MMI unit. Horizontal lines show the range of mean plus

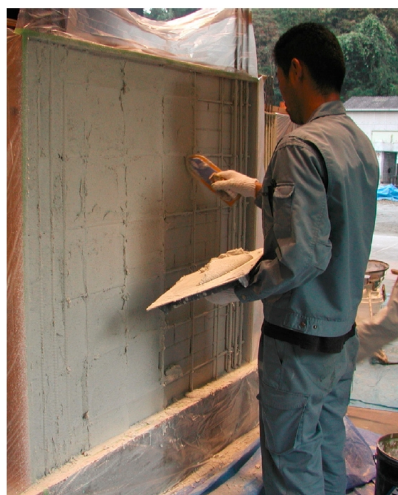
Figure 1 Construction of reinforced PCM wall

The study is to investigate the seismic performance of unreinforced masonry (URM) wall retrofitted with reinforced polymer-cement mortar (PCM). Four unreinforced clay brick masonry wall specimens with 100 mm in wall thickness were constructed first, then three of them were retrofitted with PCM applied on one of their surfaces forming a thickness of 40 mm, in which different vertical and horizontal steel bars had been arranged. The specimens were tested under cycle reversal loading method. Test results demonstrate that the application of reinforced PCM wall provides higher lateral load carrying capacity to URM wall, and also different failure modes were observed in three retrofit wall specimens.

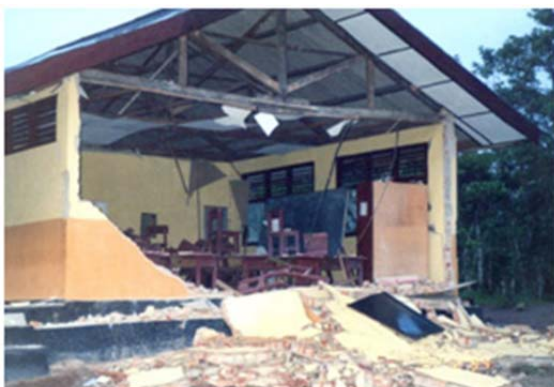
Fig.7.3 (a) Out-of-plane failure of brick masonry wall, 1994 Liwa Earthquake, Indonesia

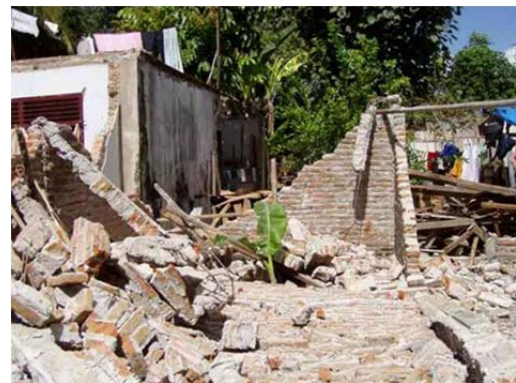
Fig.7.3 (b) Out-of-plane failure of brick masonry wall, 2006 Central Java Earthquake, Indonesia

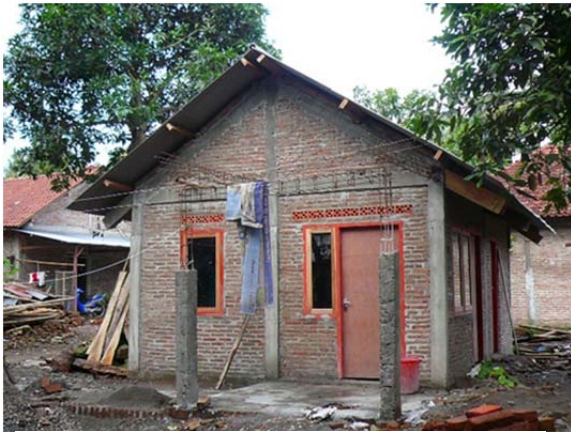
Fig.7.4 (a) Construction of confined masonry, Single story house, Aceh, Indonesia

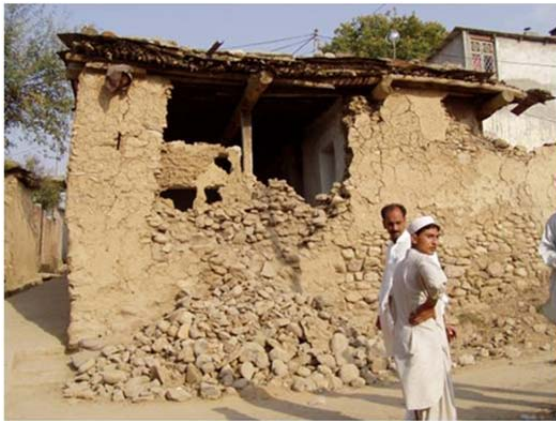
Fig.7.5 (a) Damage to stone masonry : Un-reinforced stone masonry 2005 Northern Pakistan Earthquake

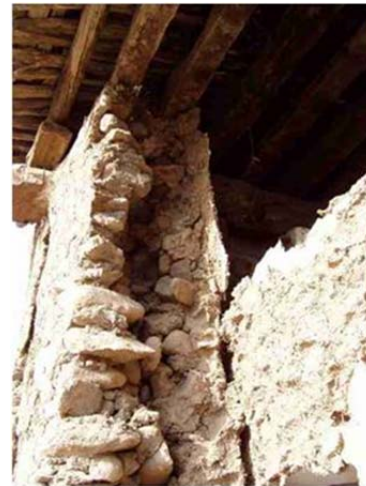
Fig.7.5 (b) Damage to stone masonry : Damage to the stone masonry wall 2005 Northern Pakistan Earthquake

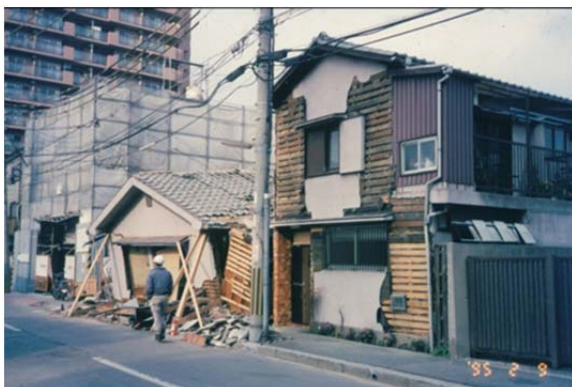
Fig..7.6 (a) Damage to wooden houses Damage concentrated to the first storey 1995 Kobe Earthquake, Japan

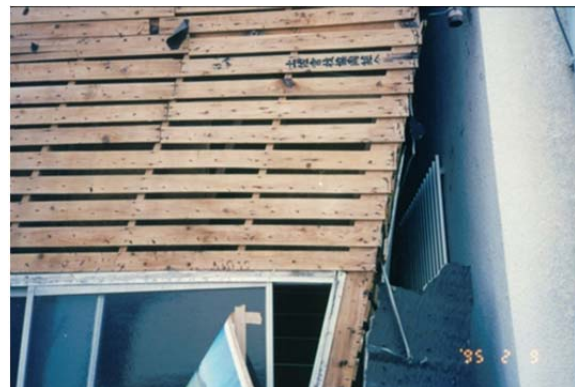
Fig.7.6 (b) Damage to wooden houses Detail of the damaged wooden house 1995 Kobe Earthquake, Japan

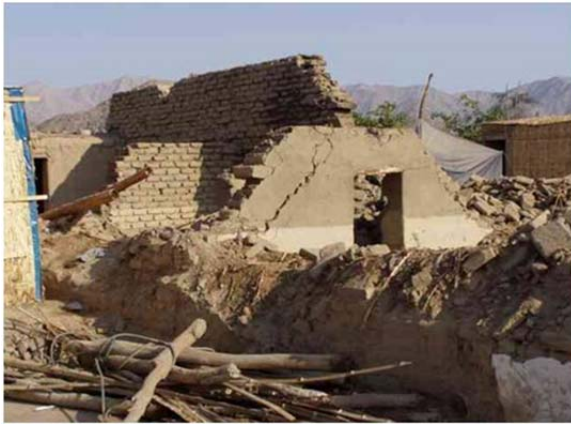
Fig.7.7 (a) Damage to earthen buildings: Damaged adobe  
2007 Pisco Earthquake, Peru

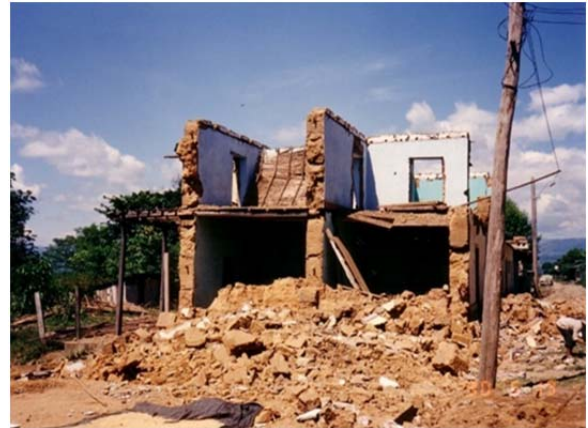
Fig.7.7 (b) Damage to earthen buildings:  
Damaged tapial, 1990 Rioja  
Earthquake, Peru
