Tohoku Chapter, Architectural Institute of Japan Reconnaissance Report (03) of Sendai City
The 2011 off the Pacific Coast of Tohoku Earthquake
Released on March 22, 2011

Professor Masato Motosaka, Tohoku University
(Translated by Shunsuke Otani, University of Tokyo)

March 12, Saturday, Preliminary Investigation

Preliminary Investigation on March 13, 2011

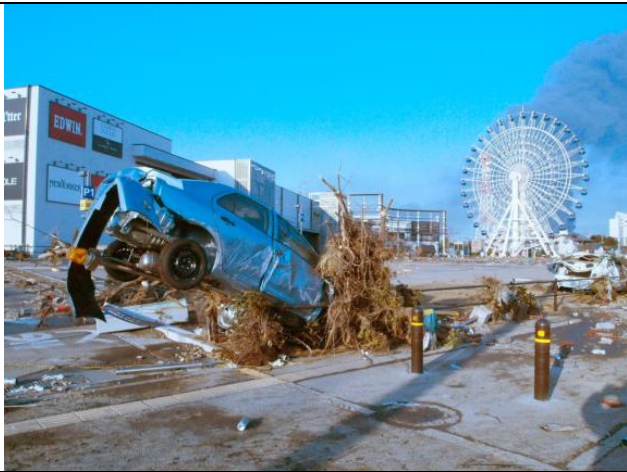
Tsunami water reached 1.0 m high in a large shopping mall, Mitsui Outlet. Some cars were floated and moved in the parking area by the tsunami wave. However, water did not go into shops. No vibration damage is observed in the buildings (Photos 20 and 21).

Photo 20: The parking area of the Mitsui Outlet shopping mall

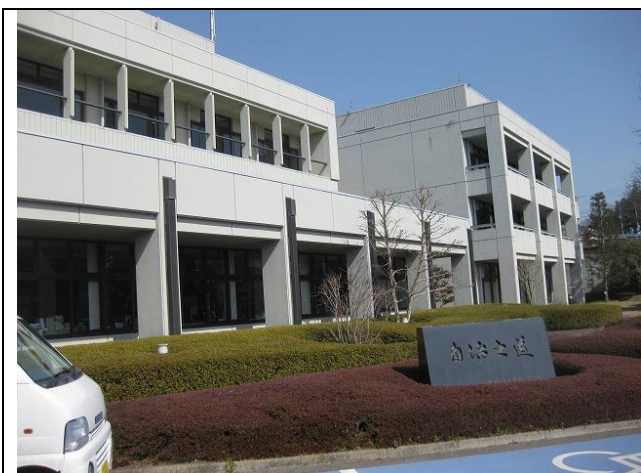
Seismic intensity (Japan Meteorological Agency Scale, JMA scale) of higher 6 was measured by the municipal intensity instrument. The municipal office is in a two-story reinforced concrete building (Photo 1); no major cracks were observed. No serious damage has been reported in the village.

Photo 1: External view of the Ohhira Village Municipal Office Building

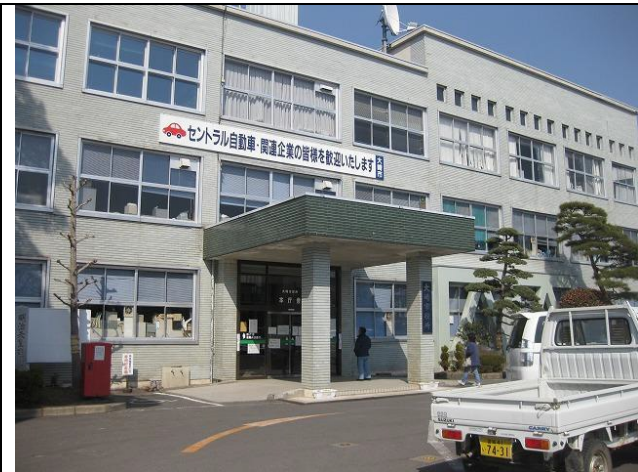
Photo 4: Ohsaki City Municipal Building

There are old houses used for combination of shop and residence, and godowns (storehouse made of mud walls) in Furukawa Mikka-machi and Nanoka-machi near the Ohsaki City Municipal Building. Many of these houses collapsed. The Furukawa No.1 Elementary School of two-story timber construction was prohibited to enter due to possible collapse during aftershocks. A seismic intensity instrument at Mikka-machi recoded the ground shaking of intensity higher 6 (JMA intensity scale).

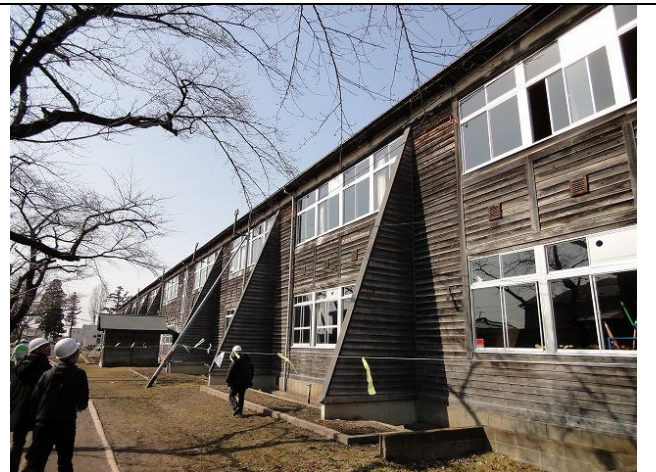
Photo 5: Ohsaki City Municipal Furukawa No.1 Elementary School (two-story timber construction)

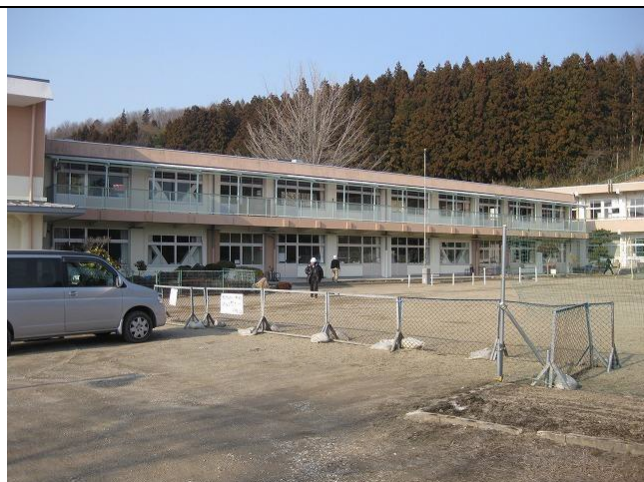
The Kaminome Elementary School building suffered serious damage in the 2008 Iwate- Miyagi Inland Earthquake. The damage was repaired and steel braces were used for retrofit. No damage was observed in this earthquake.

Photo 14: Overview of Uenome Elementary School (No damage)
