Tohoku Chapter, Architectural Institute of Japan
Reconnaissance Report (12) on Tsunami
The 2011 off the Pacific Coast of Tohoku Earthquake
Released on April 3, 2011

Disaster Committee, Tohoku Chapter
Dr. Reiji Tanaka, Professor
Mr. Ryota Yamaya, Guest Researcher,
Tohoku Institute of Technology
(Translated by Shunsuke Otani, University of Tokyo)

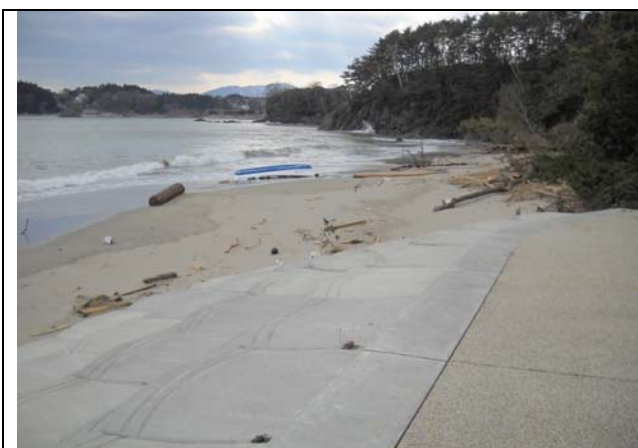
A view of the sea from a breakwater near the Ohtani Coast is shown in Photo 10. Flown out items were found in the tide-water control forest (Photo 11).

Photo 10: View of the sea near the Ohtani Coast.

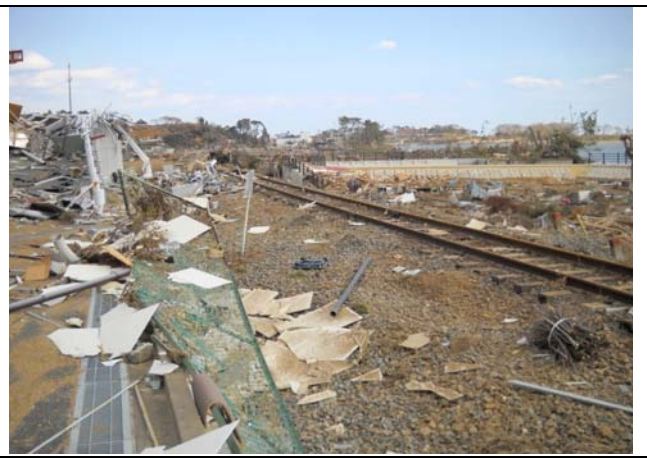
A train runs on the hill (2.5 m high) behind the arbor shown in Photo 13. An automobile was flown out across the rail road (Photo 14); a tunnel in the photo was not damaged. The view from the tunnel to the opposite side is shown in Photo 15. A railway bridge collapsed, and in this area. A three-story hotel building on the hill behind the arbor in Photo 13 is shown in Photo 16; the second floor veranda is supported by three columns in the front, and the windows in the second story were broken. A view of the hotel from the hill side is shown in Photo 17. The second and third stories are of steel construction. From the damage in the second story, the tsunami wave height must have reached approximately 20.5 m (see Fig. 2). There was a concrete block warehouse at 10 m from the sea level (Photo 18); the building was undamaged. There was a timber house next to the concrete block warehouse, but the house was washed away leaving only the foundation (Photo 19). As can be seen in Photo 19, there is a reinforced concrete retaining wall near the concrete block warehouse. There is a two-story reinforced concrete old-age home

Photo 15: A view from the tunnel side.

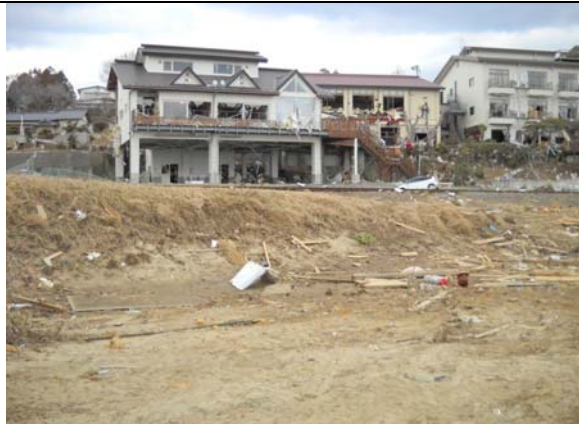
Photo 16: A view of a hotel building from the coast.

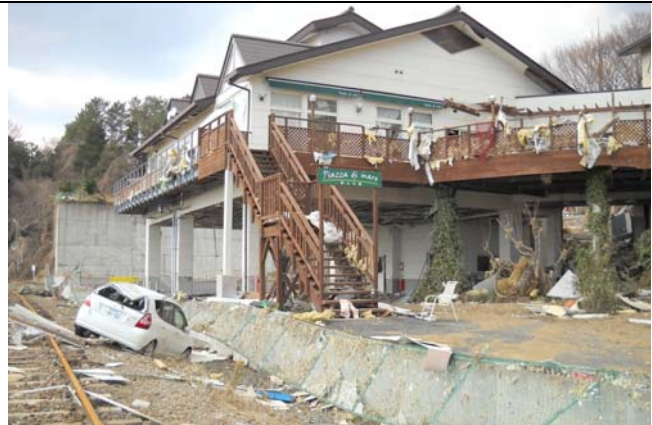
Photo 17: A view of the hotel from land side

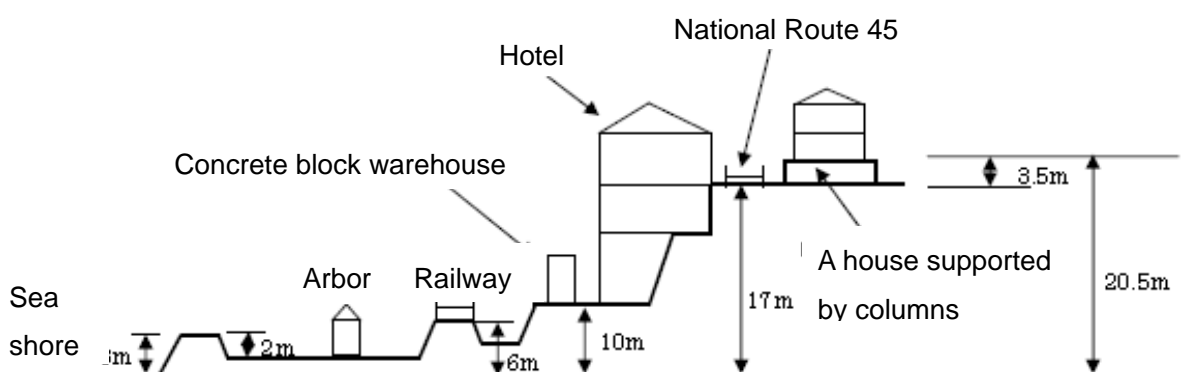
Fig. 2: Cross section of the land from sea shore to the hill

Behind the hotel and the old-age home, and across national route 45 (see Fig. 2), there is a two-story timber house standing on a one-story reinforced concrete elevated foundation (Photo 22); the tsunami wave came to the one-story foundation, but the timber house did not suffer any damage from tsunami wave attacks. The occupants of the house live an ordinary life. An adjacent timber house suffered heavy damage from the tsunami (Photo 23). Building a house on an elevated reinforced concrete foundation is a possible way to avoid tsunami wave attacks.
