Tohoku Chapter, Architectural Institute of Japan  
Reconnaissance Report (17) on Ishinomaki City  
The 2011 off the Pacific Coast of Tohoku Earthquake  
Released on April 15, 2011

Disaster Committee, Tohoku Chapter  
Dr. Tomoyuki Obata, Vice President  
Yamagata Technical College,  
(Translated by Shunsuke Otani, University of Tokyo)

Ishinomaki City, Miyagi Prefecture, is located approximately 45 km to the north east of Sendai City. The population is 160,336; 2,482 were dead and 2,770 were missing as of April 5, 2011. Port and Airport Research Institute determined the tsunami height at Ishinomaki Harbor to be 5 m, and at Ogachi-machi, Ishinomaki City to be 16 m (run up).

The route map of Ishinomaki is shown in Fig. 1 at the end of this report. The damage was surveyed on April 8 (Friday). There was a magnitude 7.4 earthquake (Epicenter at Miyagi-ken Oki) at 23:30 on April 7. Therefore, the observed damage was caused by the March 11 main shock and also by the April 7 aftershock.

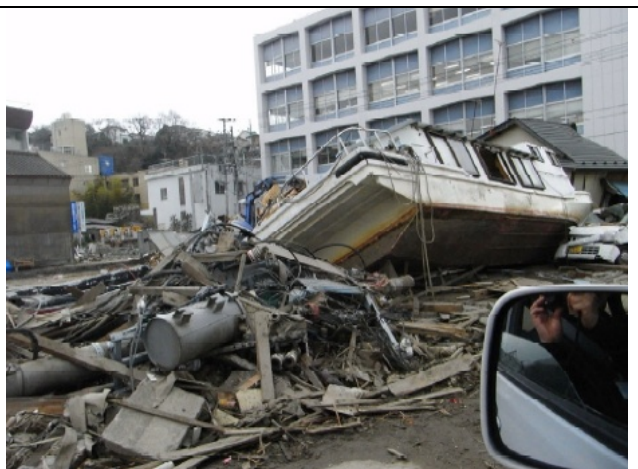
Photo 14: A reinforced concrete building in the back was in use.

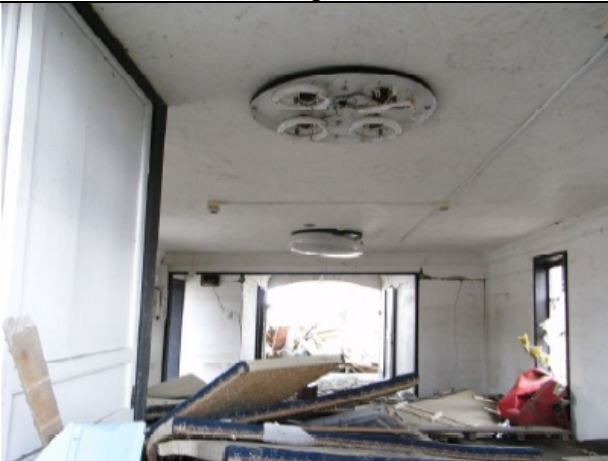
Photo 7: View from back to front.

There was debris around the church and it was difficult to approach the church. Damage was severe on the sea side, and tsunami must have flowed through the building. Columns and walls were deformed. The columns appeared to support the building by visual observation. The building was damaged by the 1978 Miyagi-ken Oki Earthquake, and was reconstructed at this site. Temporary repair work appeared necessary to survive aftershocks.
