Reconnaissance Report  
on Damage to Steel Building Structures Observed  
from the 1995 Hyogoken-Nanbu (Hanshin/Awaji)  
Earthquake

Steel Committee of Kinki Branch  
the Architectural Institute of Japan (AIJ)

**Reconnaissance Report  
on Damage to Steel Building Structures Observed  
from the 1995 Hyogoken-Nanbu (Hanshin/Awaji) Earthquake**

**Steel Committee of Kinki Branch  
the Architectural Institute of Japan (AIJ)**

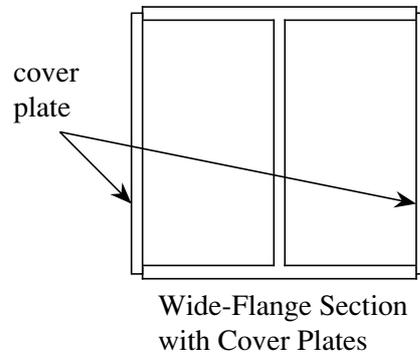
*In old practices prior to the introduction of cold-formed square-tubes in Japan, a pair of steel plates were often welded to the flanges of a wide-flange cross-section to form a tube (see FigT1). Such built-up column shapes were abandoned approximately twenty years ago.*

Fig.T1 Wide-Flange Section with Cover Plates

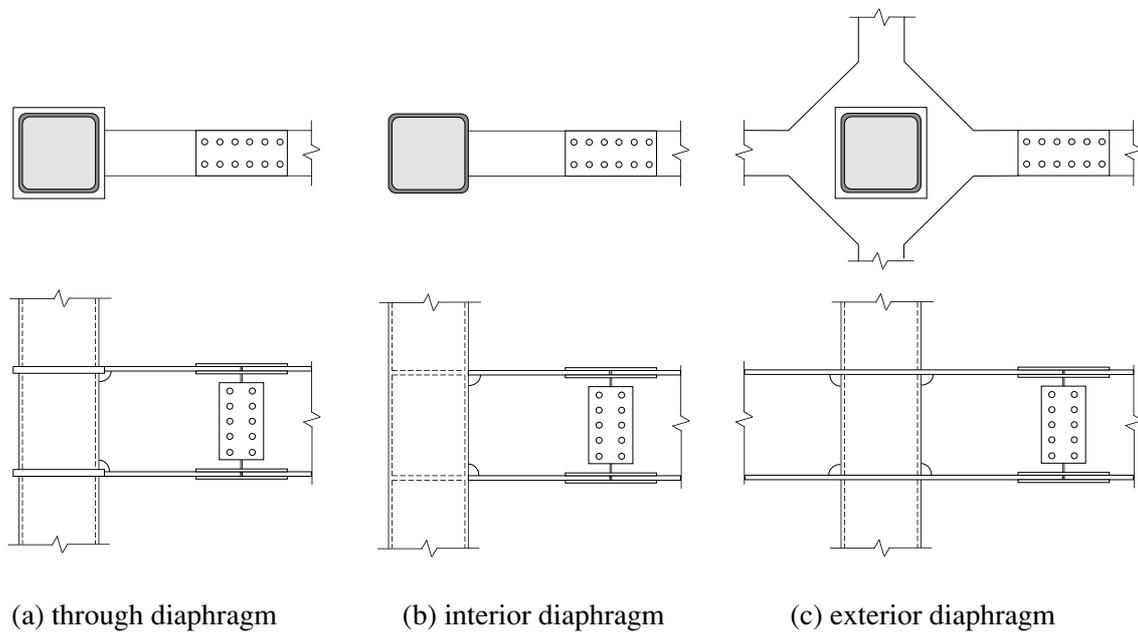
In Japan, following three types of detail are commonly used for beam-to-column connections when combined with square-tube columns, namely: "through-diaphragm" type, "interior diaphragm" type, and "exterior diaphragm" type (see Fig.T2). Among those, the "through-diaphragm" type is most popular as indicated in Table 4.7. In the through-diaphragm connection, a long square-tube is cut into three pieces: one used for the column of the lower story, one for the connection's panel zone (a short piece, often called a dice in Japan), and one for the column of the upper story. Two diaphragm plates are inserted between the three separated pieces and shop-welded all around. The "interior diaphragm" and "exterior diaphragm" types are self-explanatory.

Fig.T2 Types of Beam-to-Column Connections

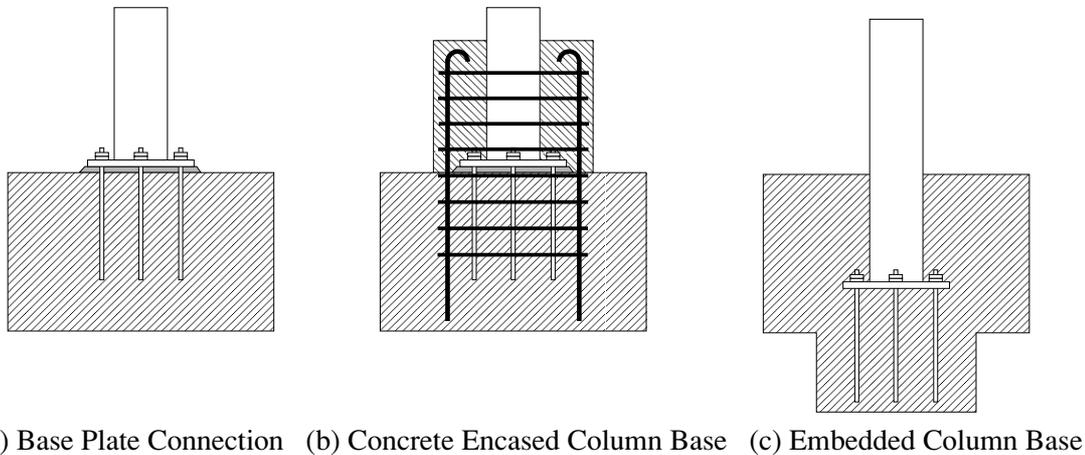
*In Japan, three types of column base connection are commonly adopted (Fig.T3), that is: standard base plate connection, concrete encased column base connection, and embedded column base connection.*

(a) Base Plate Connection (b) Concrete Encased Column Base (c) Embedded Column Base

Fig.T3 Types of Column Base Connections
