# Tohoku Chapter, Architectural Institute of Japan Quick Reconnaissance Report of East Japan Earthquake Disaster March 21, 2011

Professor Reiji Tanaka, Tohoku Institute of Technology Chairman of Disaster Committee of AIJ Tohoku Chapter (Translated by Shunsuke Otani, University of Tokyo)

March 12 and 13, 2011

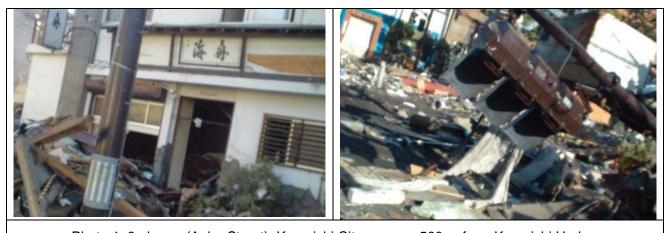
Photo 1: 3-chome (Aoba Street), Kamaishi City, approx. 560 m from Kamaishi Harbor

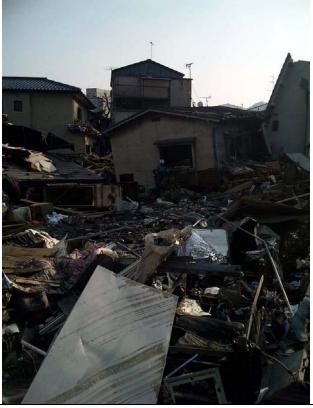
Photo 1: Tadakoshi-machi 3-chome. Kamaishi City

Tadakoshi-machi 3-chome. Kamaishi City, is located approximately 400 m from Kamaishi Harbor.
